ORCUTT UNION SCHOOL DISTRICT SITE ASSESSMENT & MASTER PLAN

SVA ARCHITECTS, INC.

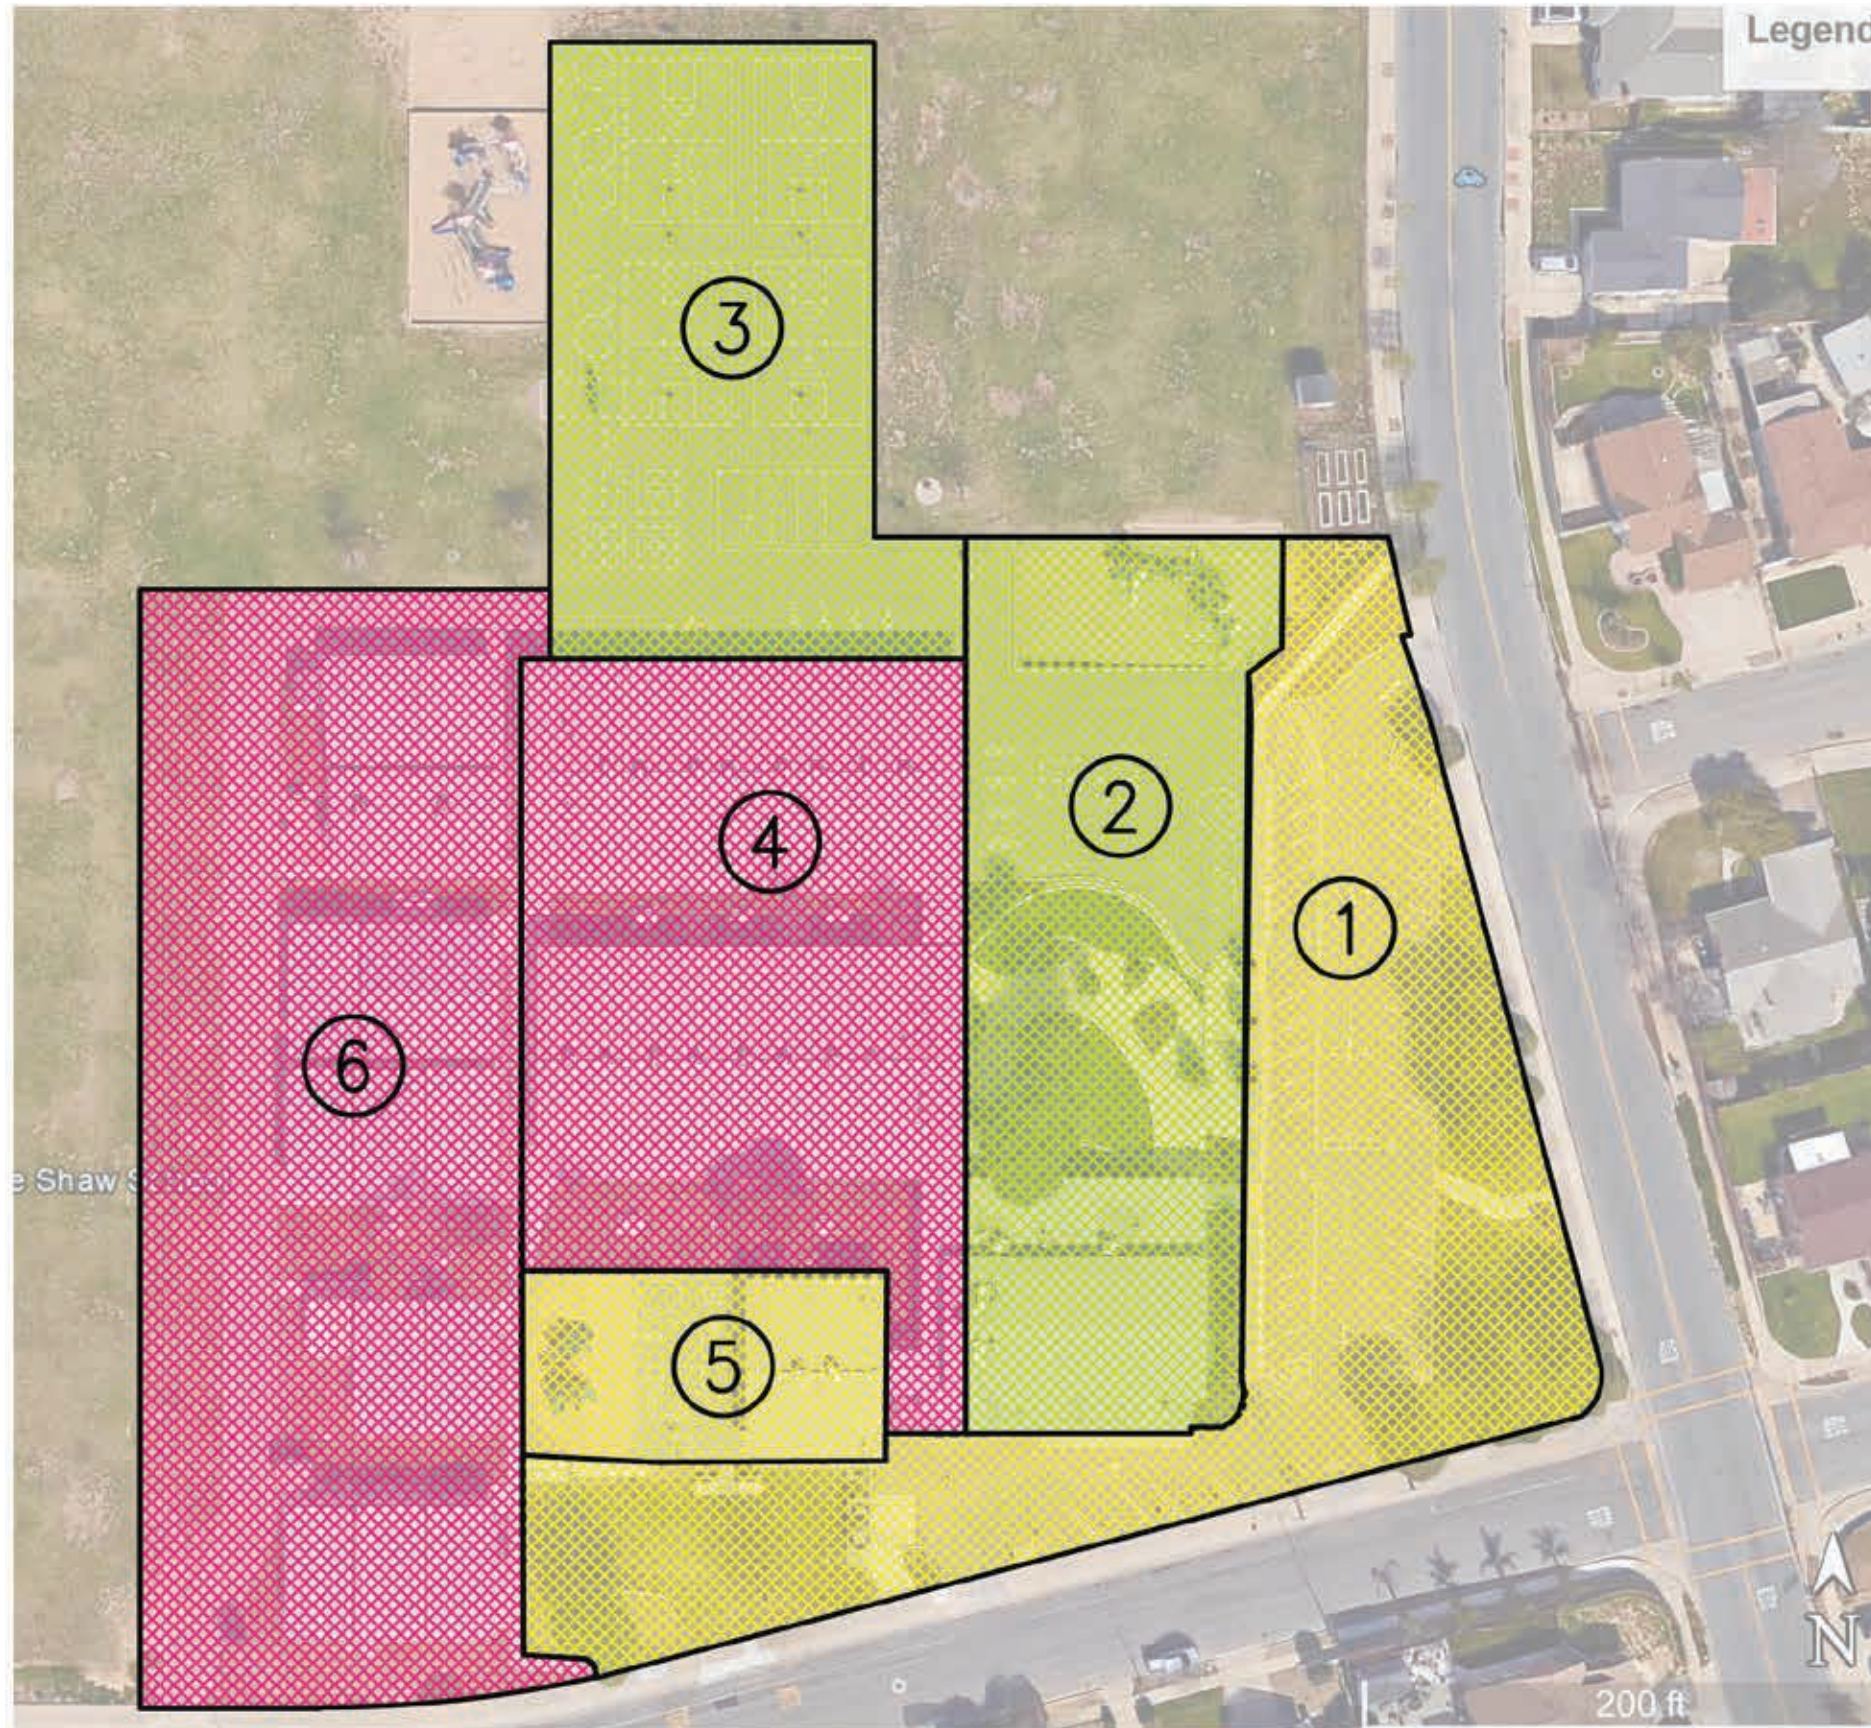
CIVIL ASSESSMENT

SUB-AREA	GENERAL DESCRIPTION	SUGGESTED REPAIR / MAINTENANCE
1	The existing ADA stalls are too short and need to be lengthened which will impact landscaping. Asphalt is in good condition - seal coat within 3 years. Asphalt tripping hazards need to be ground down.	Double Seal Coat Asphalt Lengthen ADA Stalls Grind Asphalt Lip Re-Stripe
2	The asphalt in this area is in good condition.	Double Seal Coat Asphalt Re-Stripe
3	The asphalt in this area is in good condition.	Double Seal Coat Asphalt Re-Stripe
4	There is flooding in front of rooms 3 and 9 due to surface runoff. The roof drains need to drain under the sidewalk, and into the landscaped area. Grade swale with inlets and french drain or infiltrators.	Drainage System
5	The condition of the asphalt in this area is moderate. Crack seal, seal coat, and striping needed within 3 years.	Crack Seal Double Seal Coat Asphalt Re-Stripe

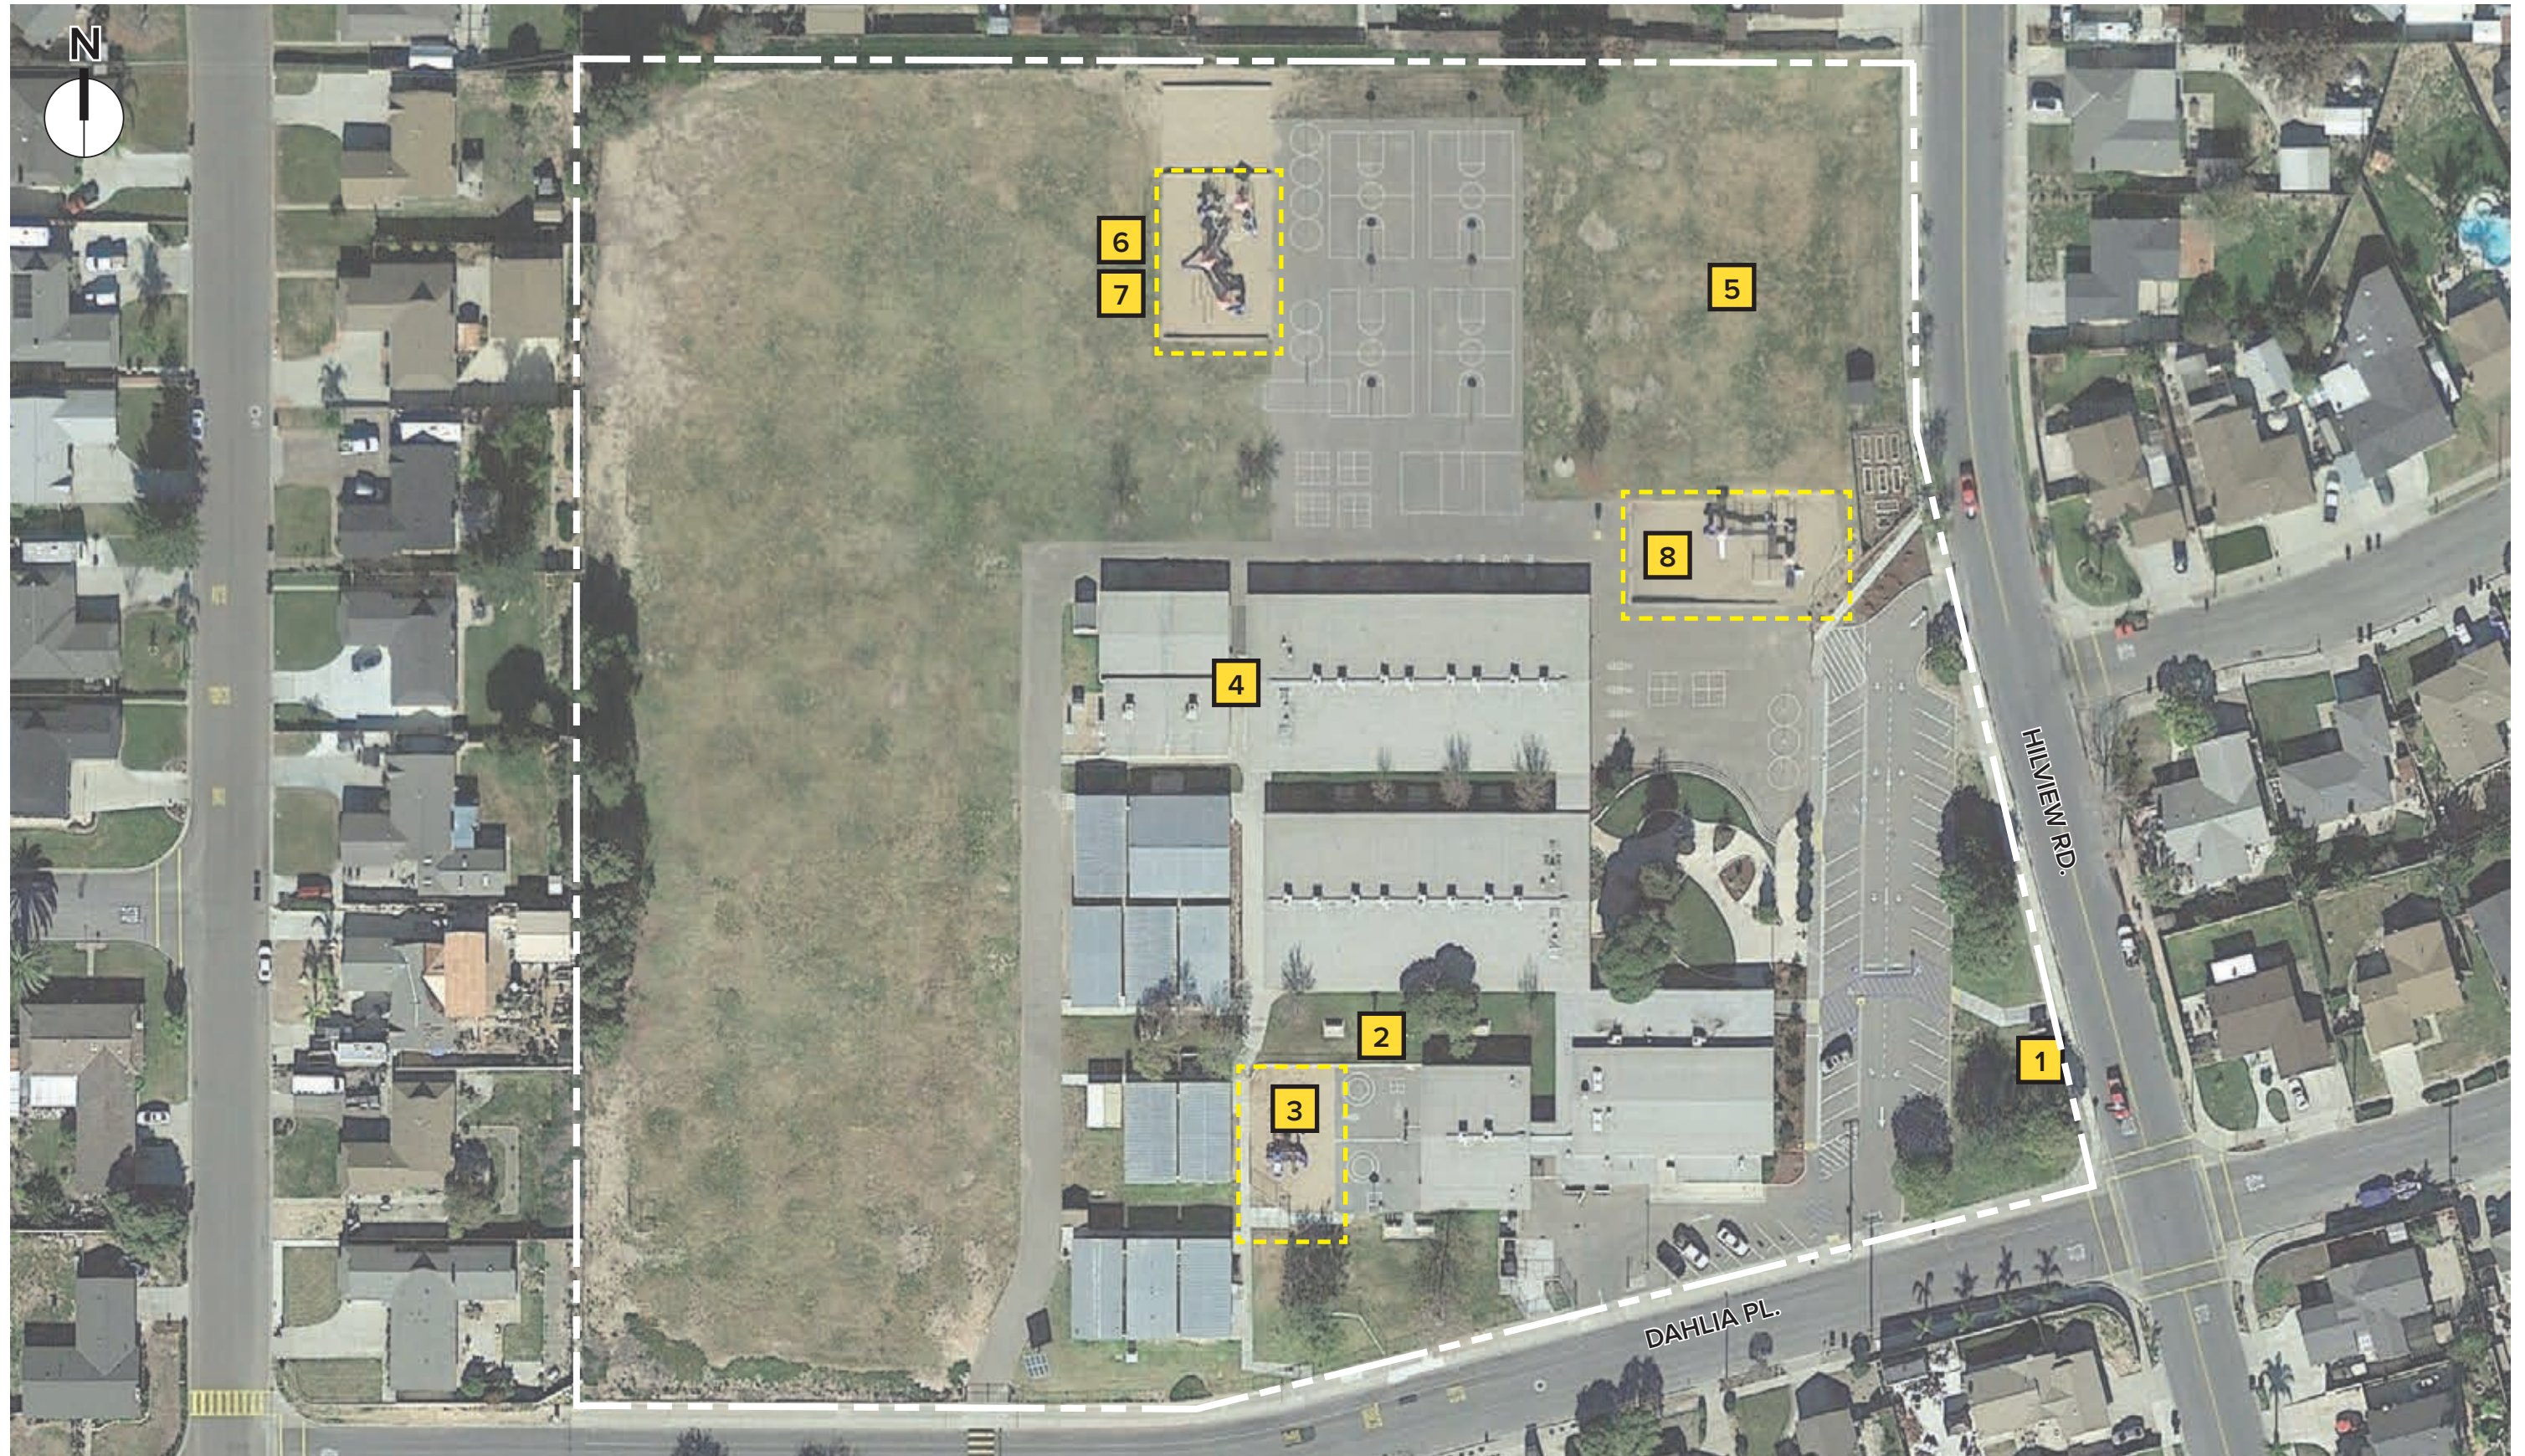
1. LANDSCAPE AREA ALONG HILLVIEW ROAD

Existing Condition:
Dilapidated turf area with no shrub planting. Turf appears in fair condition.

Existing Condition:
Dilapidated turf, compacted soil, and irrigation coverage is lacking.

Existing Condition:
Existing tables located in turfgrass area. Non-accessible locations.

Recommendation:
Add low-water use plant material as a compliment to the existing turf. Add new drip irrigation system for shrub planting and reconfigure spray system for the turf.

Recommendation:
Till and amend the soil, repair irrigation systems and re-sod and or re-seed the entire area.

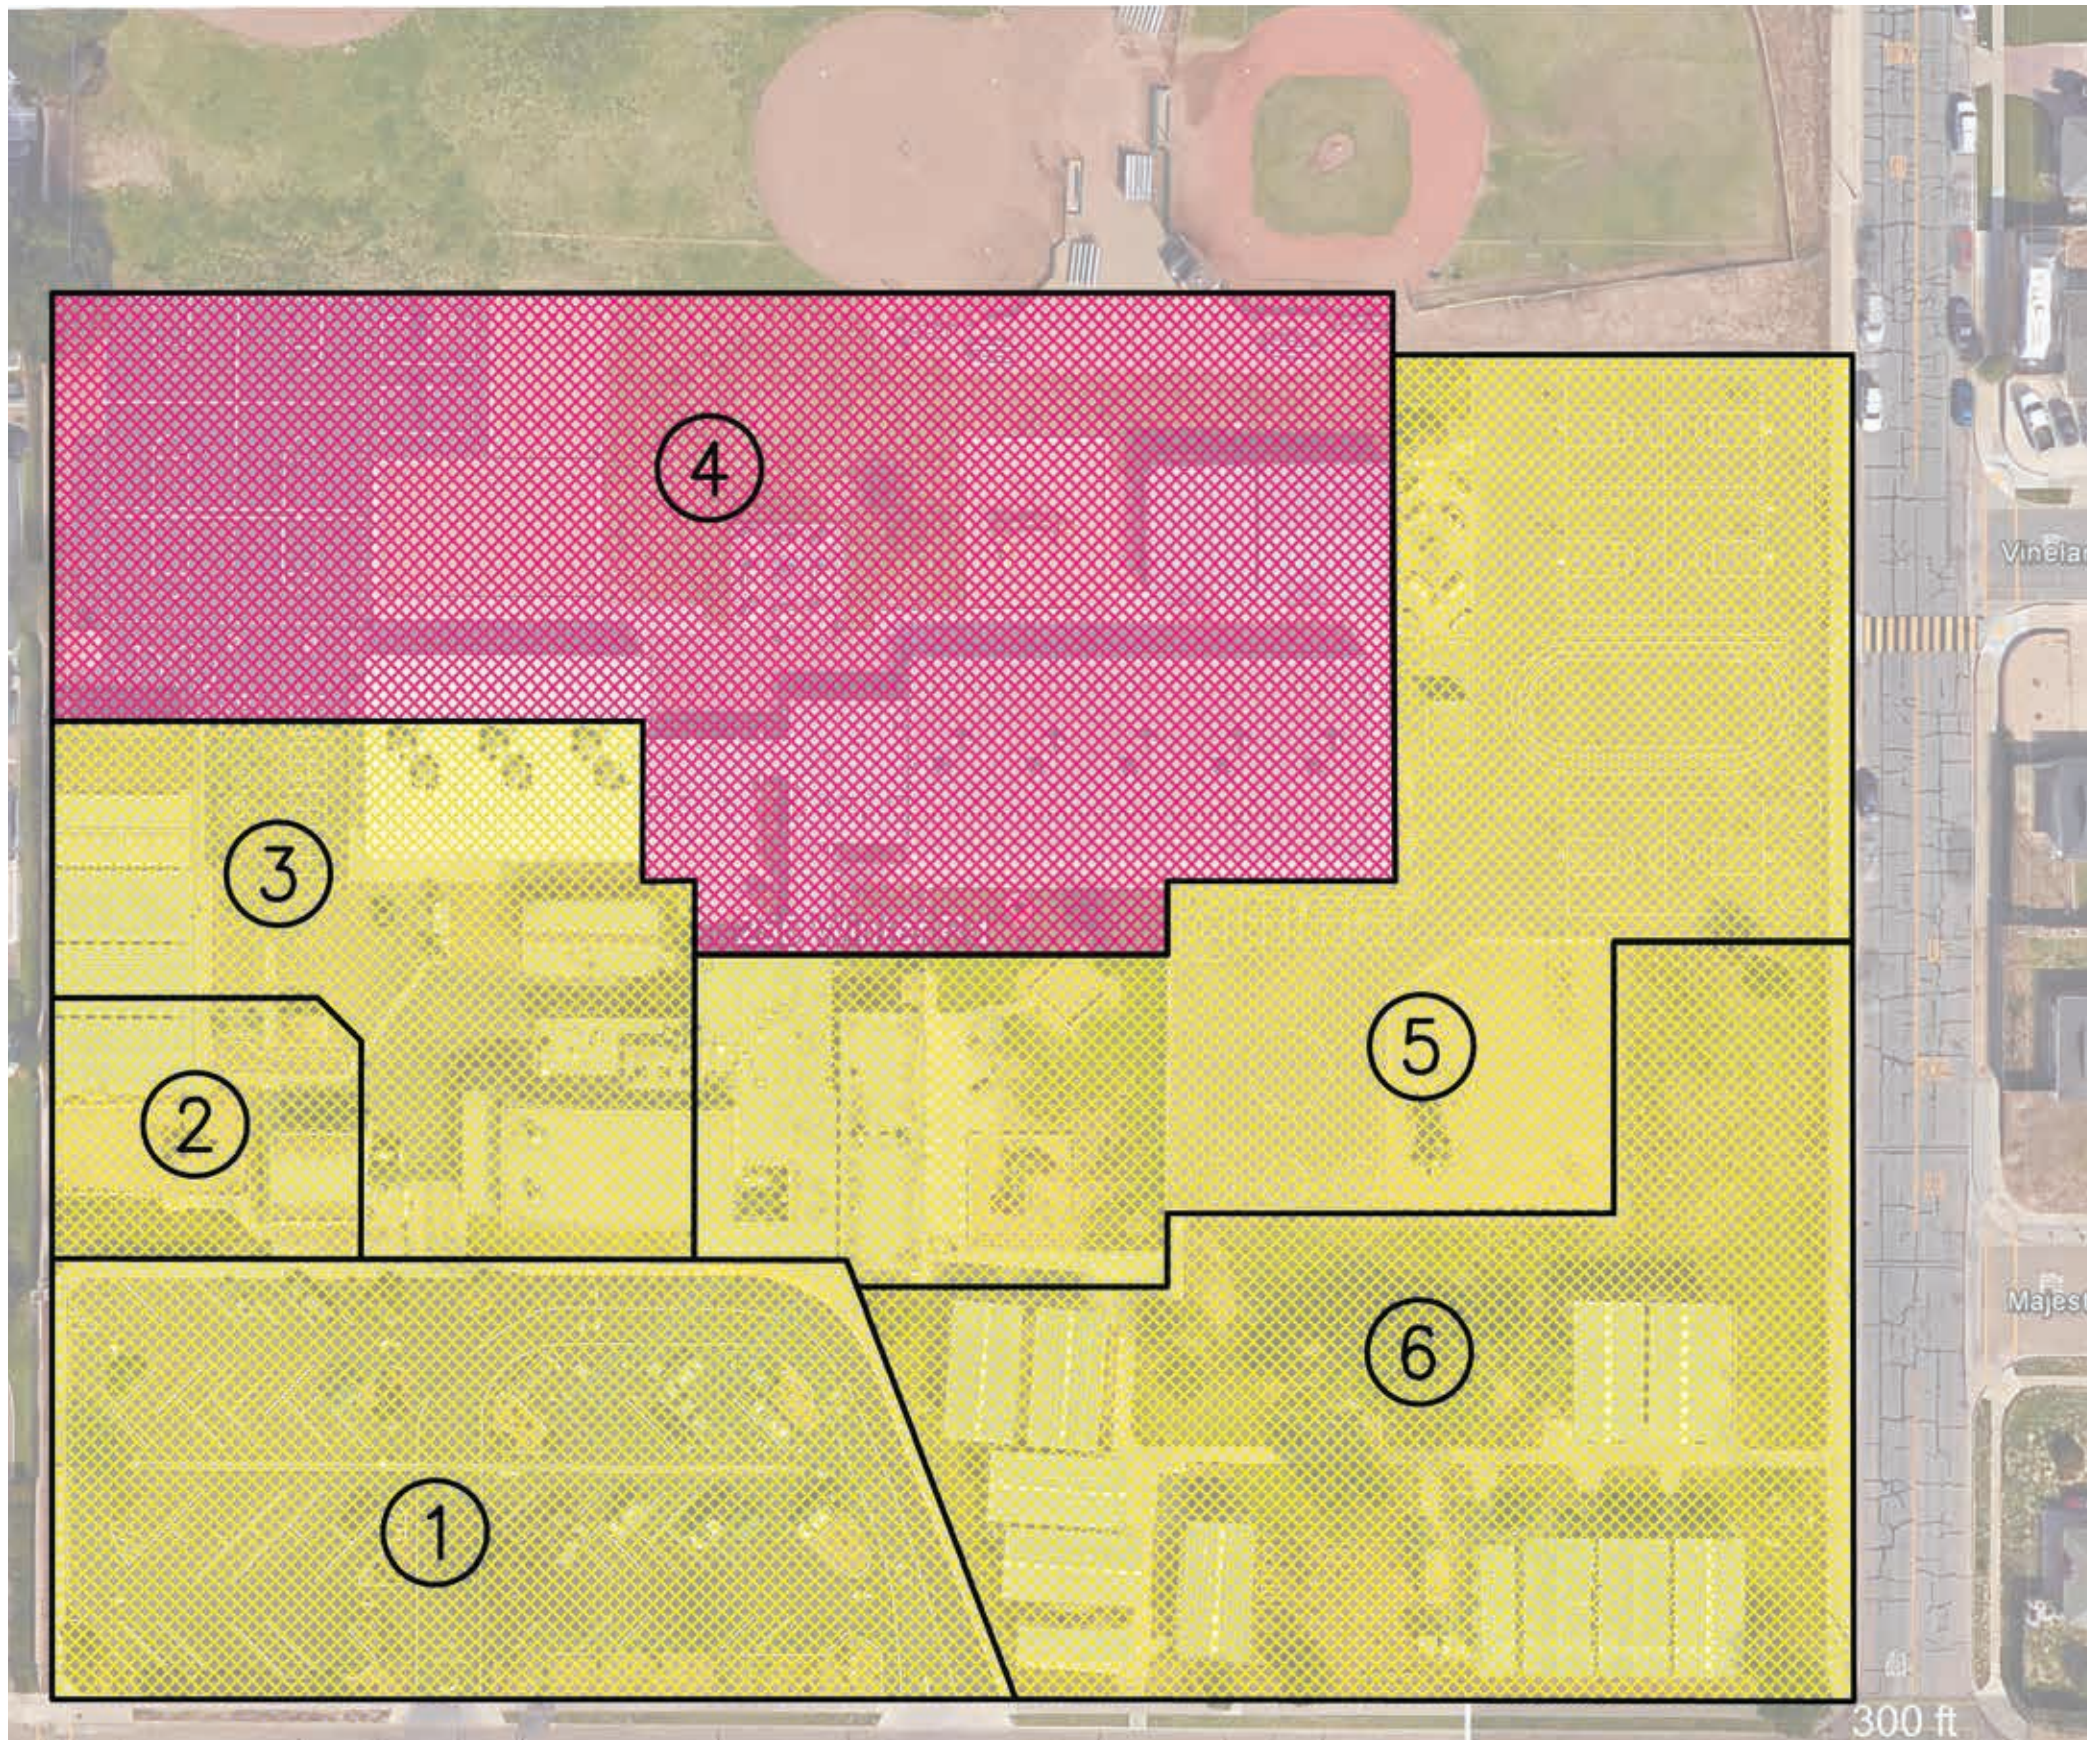
CIVIL ASSESSMENT

SUB-AREA	GENERAL DESCRIPTION	SUGGESTED REPAIR / MAINTENANCE
1	The pavement is in good condition but the drive aisle is too narrow between the parking stripes. School staff complain of vehicle accidents and parents cutting through the parking lot instead of staying in the main travel path.	Remove and Replace Sidewalk Grind Existing Striping Relocate Parking Islands Double Seal Coat Stripe New Parking Lot
2	Sidewalk around Room 33 and near playground not ADA compliant.	Grind Asphalt Lip Remove and Replace Sidewalk Install ADA Handrail
3	Sidewalks around Rooms 28-32, Room 14, and near the custodian room are not ADA compliant. Asphalt needs crack sealing, double seal coat, and striping.	Extend Concrete Gutter in front of Rooms 31-32. Remove and Replace Sidewalk Double Seal Coat Asphalt Grind Asphalt Lip Re-Stripe
4	The asphalt pavement should be replaced within three years. Significant ponding occurs in multiple walking path locations within this area. Grades do not allow for surface drains. An underground infiltration system or detention basins are needed.	Remove and Replace Sidewalk Remove and Replace Asphalt Re-Stripe Install 6" Wide Strip Drains Install Large Underground Infiltration System

5	Asphalt is in new and good condition, but there is ponding that occurs. Proper drainage is needed to minimize ponding.	Remove and Replace Asphalt Install Large Underground Infiltration System
6	The sewer backs up and needs investigation. The concrete is cracked in front of Rooms 17 and 18, and may need replacement. There are multiple locations where the sidewalk is not ADA compliant.	Remove and Replace Sidewalk Flush Sewer Cleanout and Investigate Failures Repair Sewer Failures

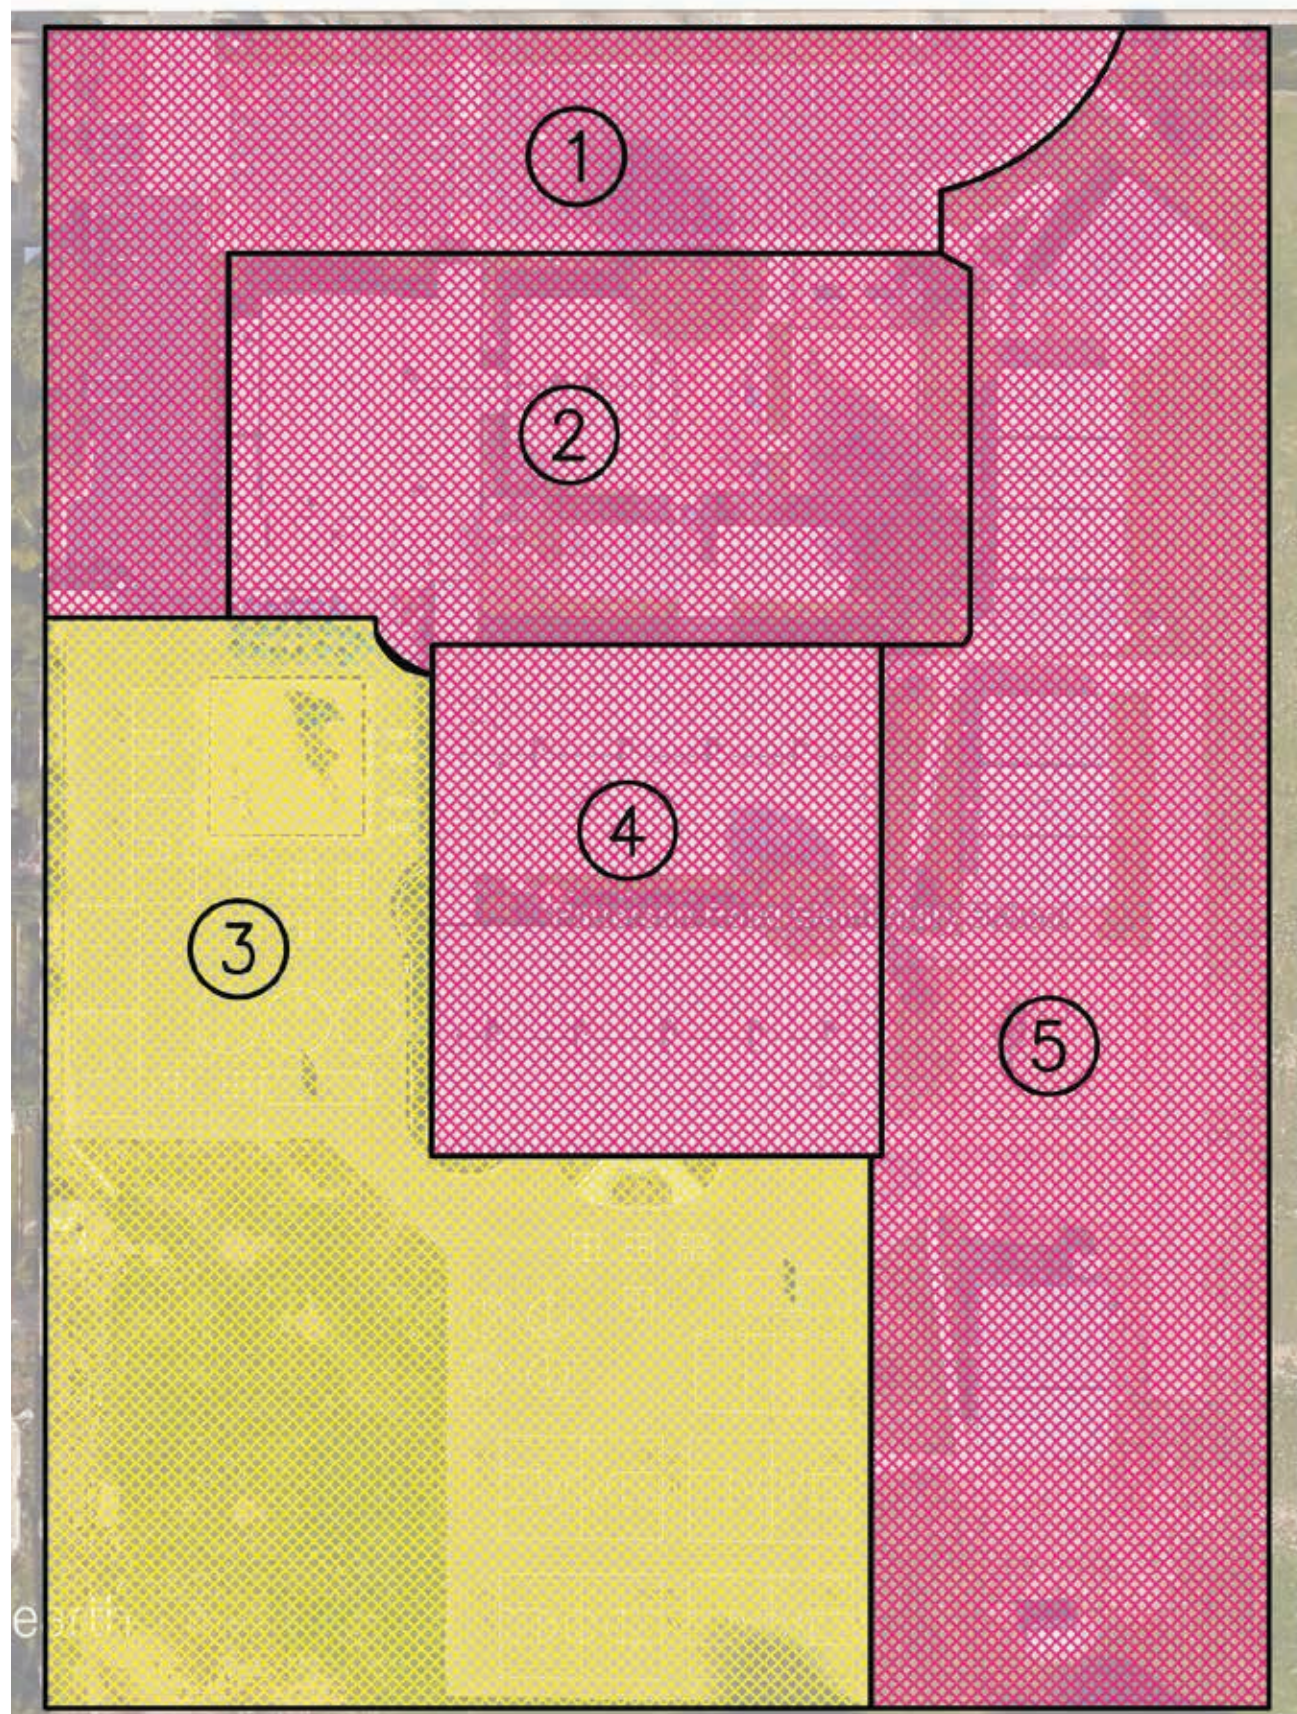
CIVIL ASSESSMENT

SUB-AREA	GENERAL DESCRIPTION	SUGGESTED REPAIR / MAINTENANCE
1	Asphalt concrete in parking lot is in good condition. Pedestrian ramp in center of parking lot and ADA parking stalls in west parking lot are not ADA compliant. Concrete sidewalk along east side of parking lot and along north side of gym (in parking	Remove and Replace PCC Sidewalk Ramp Remove and Replace Remove and Replace ADA parking stall and crosswalk
2	Pedestrian walkway to office entrance is not ADA compliant. Drainage issues reported between office and Kindergarden classrooms. Landing on north side of Kindergarden classrooms not ADA compliant. Evidence of ponding/erosion along south side of	Remove and Replace Ramp Remove and Replace PCC Sidewalk Regrading
3	Asphalt concrete is in good condition. Ramps to the portables are not ADA compliant.	
4	Drainage issues reported between new PCC sidewalk ramps and old PCC sidewalk ramps. Sidewalks along buildings are not ADA compliant.	Remove and Replace PCC Sidewalk Regrade around ramps

5	Ramped access to classrooms are not ADA compliant. Slopes on landings with domes are not ADA compliant. Asphalt concrete needs to be replaced near fire hydrant. Portable classroom drain screens need cleaning.	Remove and Replace PCC Sidewalk

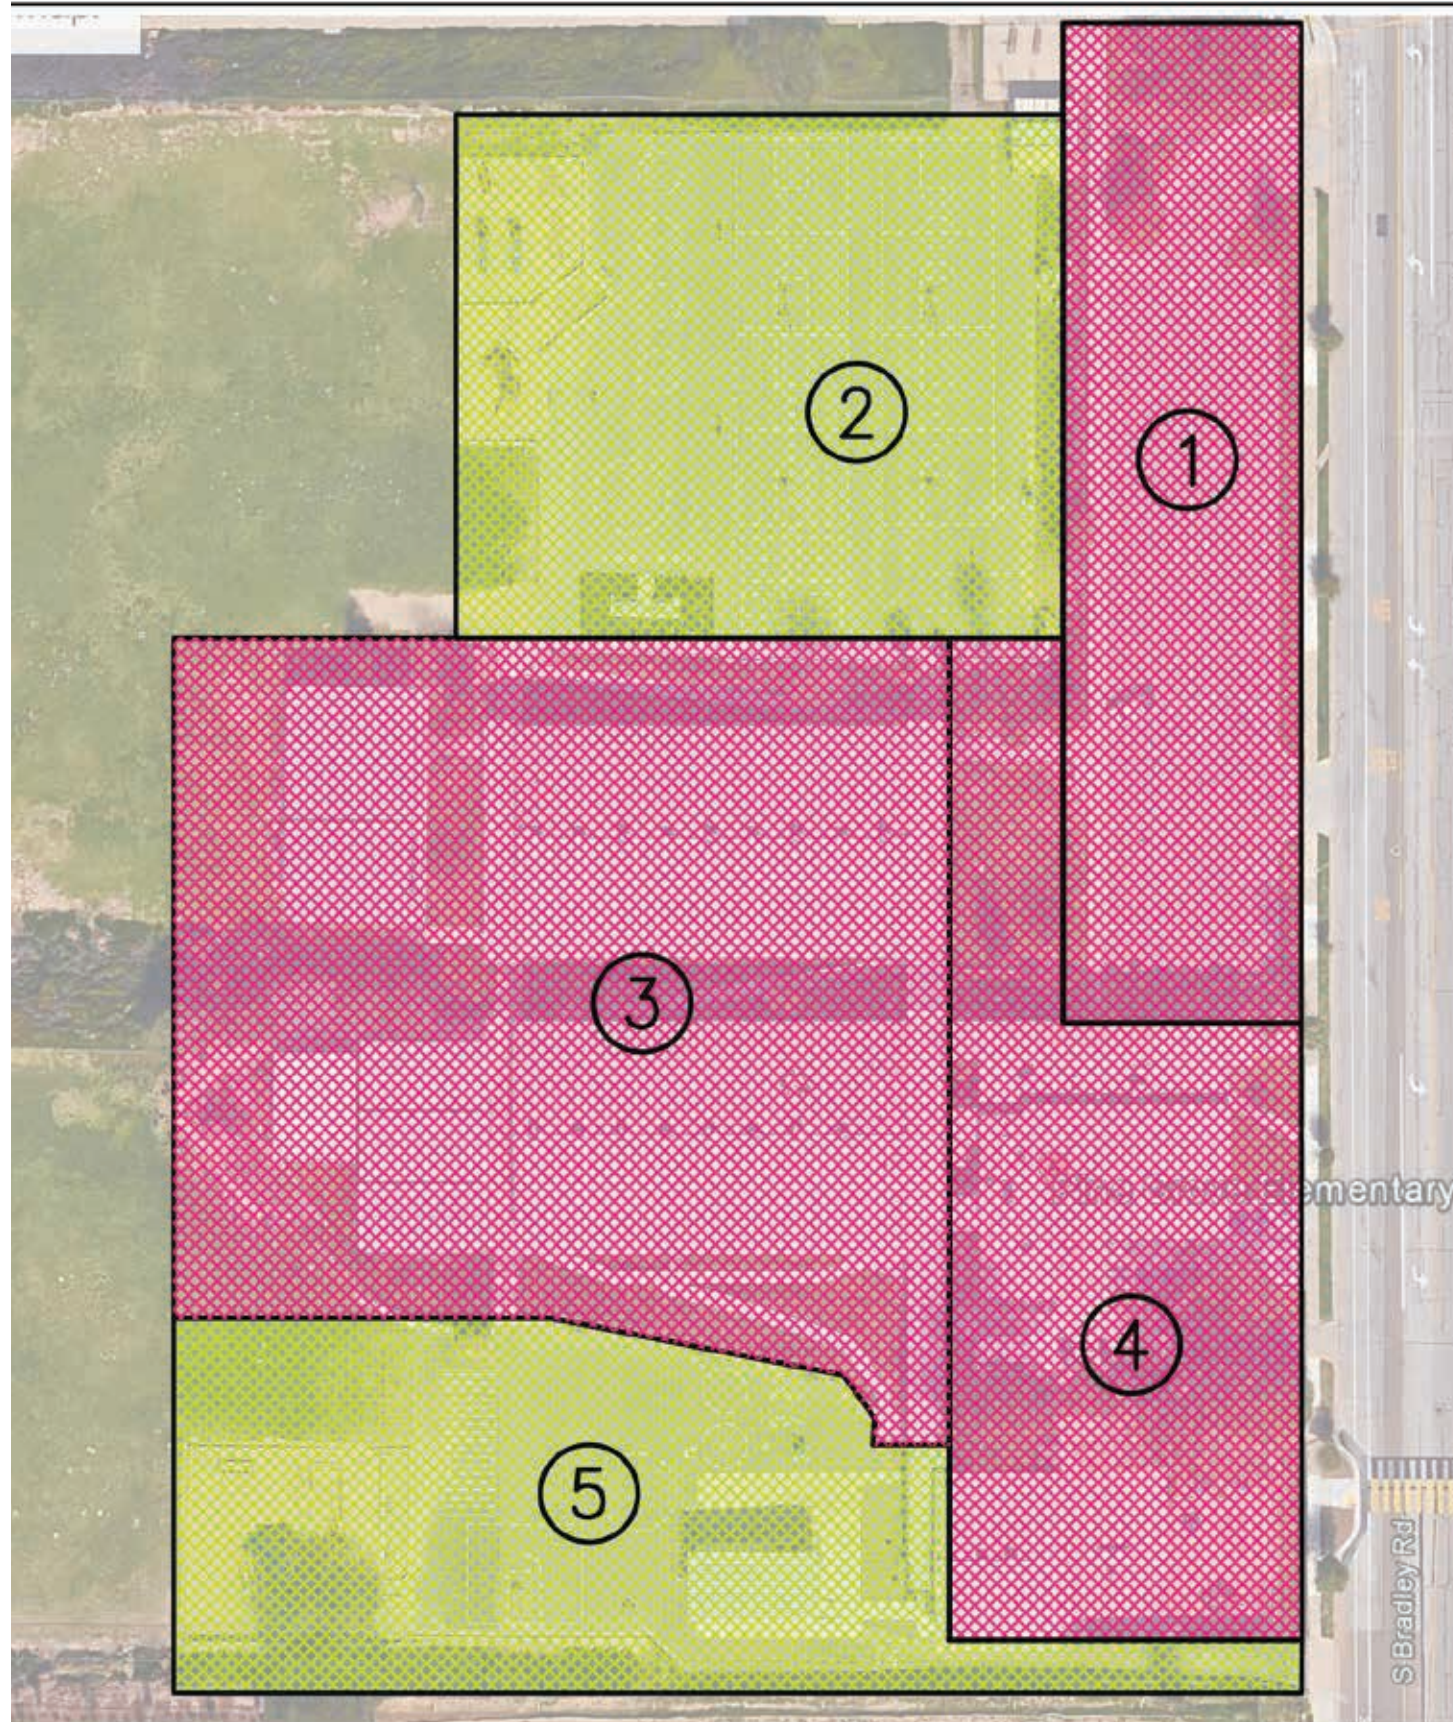
CIVIL ASSESSMENT

SUB-AREA	GENERAL DESCRIPTION	SUGGESTED REPAIR / MAINTENANCE
1	Asphalt pavement is in fair condition. Pedestrian ramps and sidewalks to/from R/W are not ADA compliant.	Remove and replace sidewalk Double Seal Coat ADA ramp truncated domes Handrails Re-stripe ADA Ramp landing
2	Evidence of erosion at southwest corner of playground. Playground A/C in good condition.	
3	Evidence of ponding between classroom buildings. Pedestrian ramps are not ADA compliant.	Remove and replace sidewalk Regrade between buildings ADA ramp landings
4	Evidence of ponding due to poor drainage conditions at base of stairs. Pedestrian ramps are not ADA compliant.	Remove and replace sidewalk Regrade between buildings Remove and replace ramp
5	Pavement is in good condition. Seal coat within 3 years.

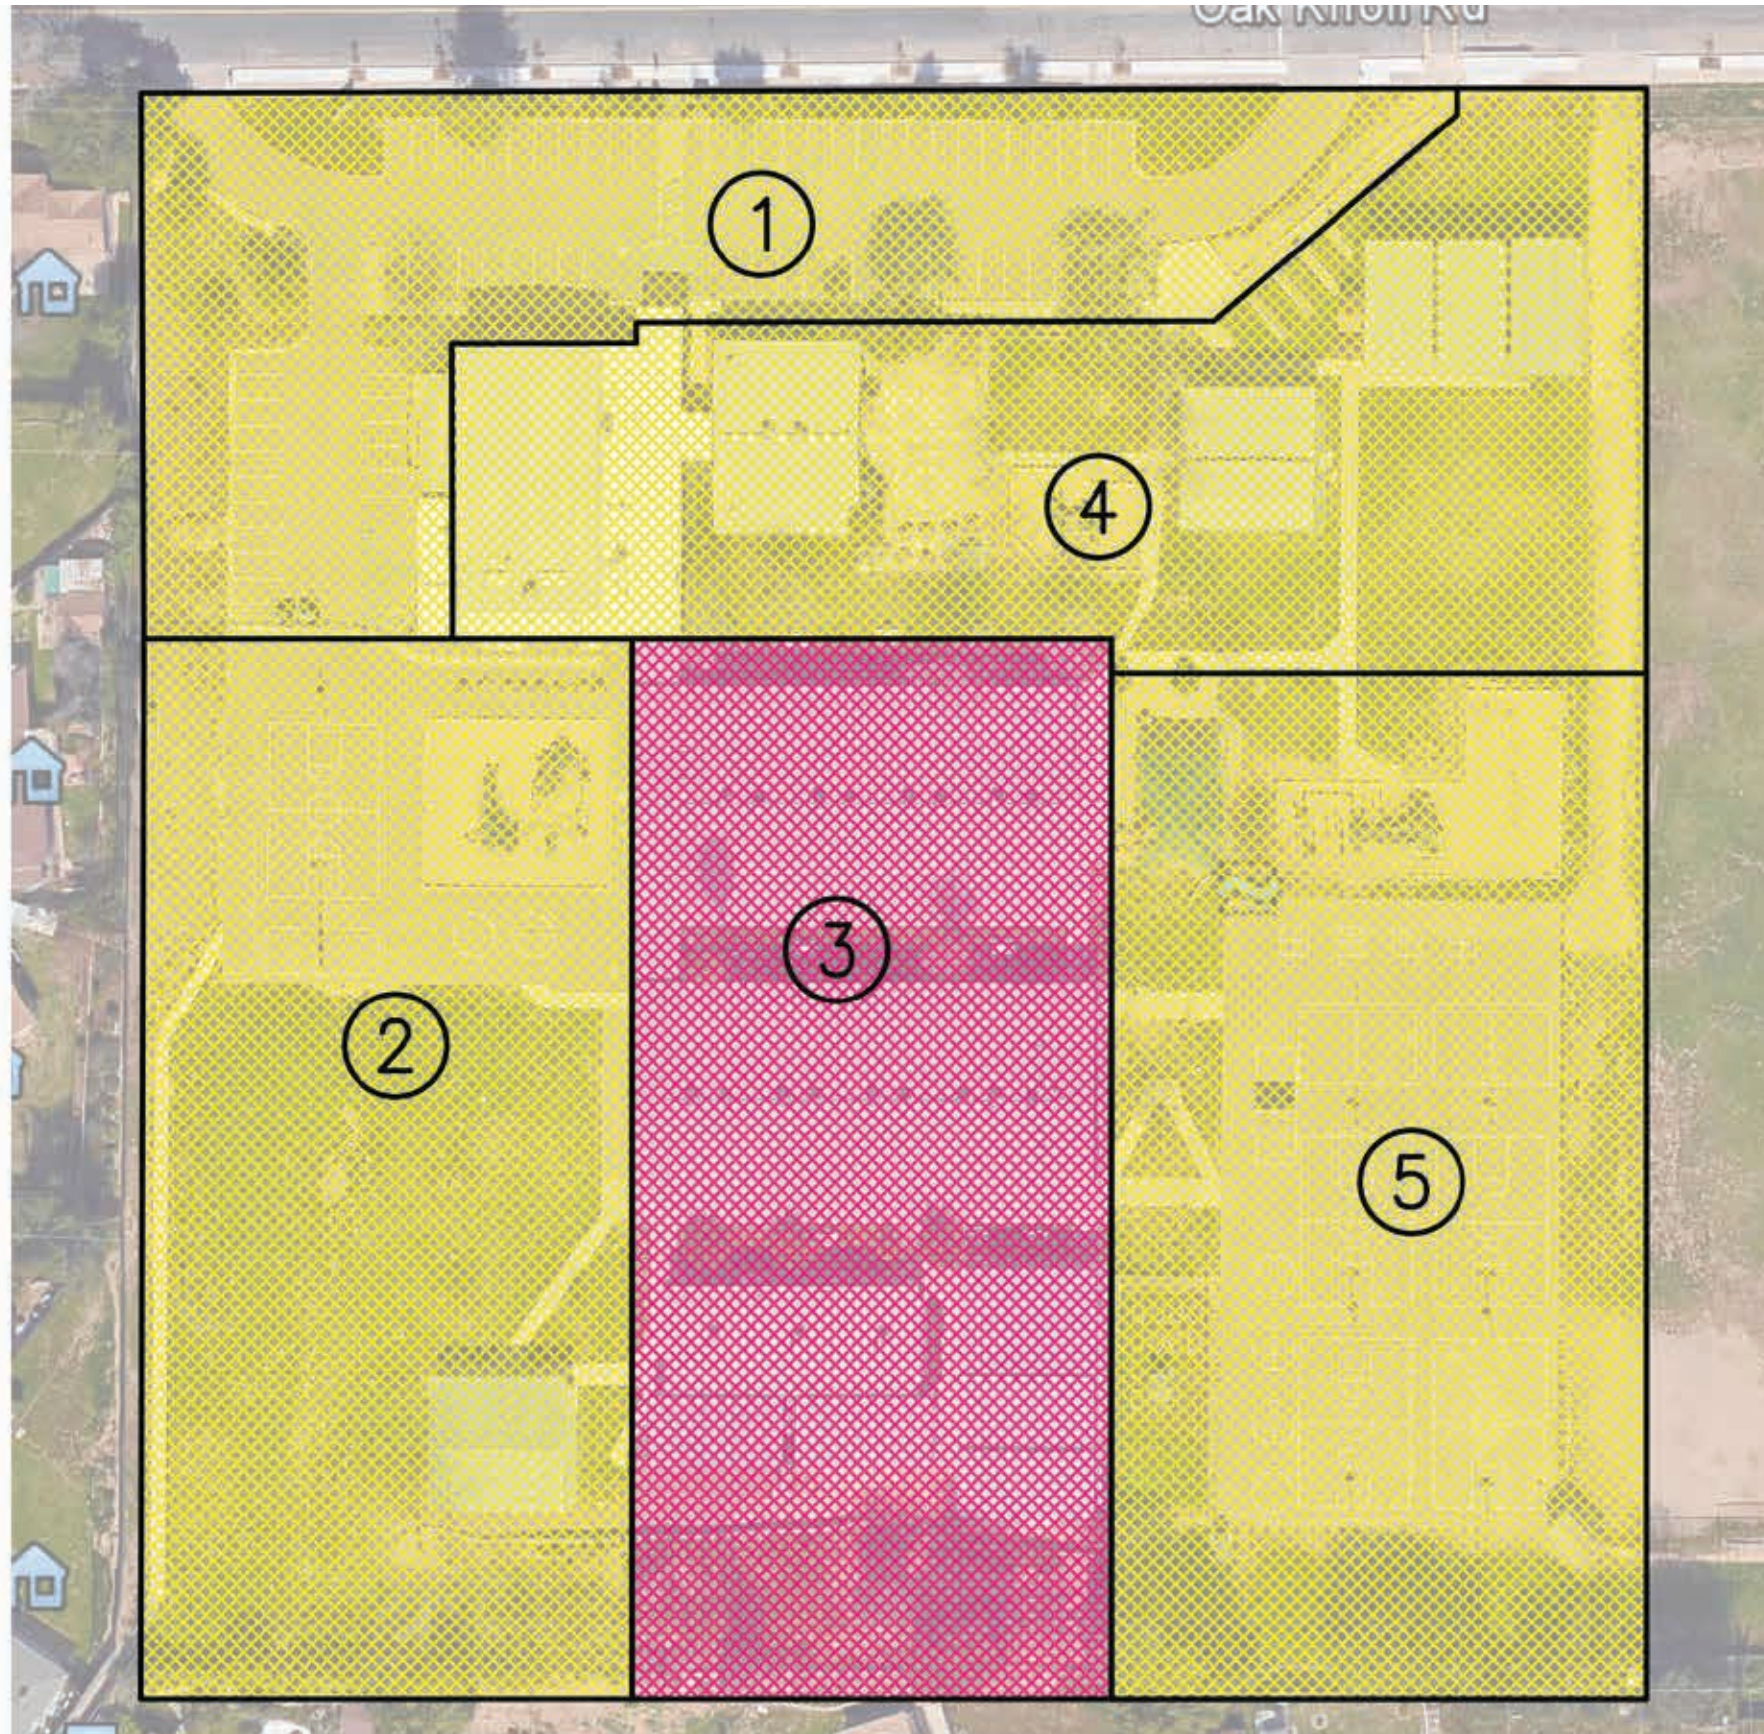
CIVIL ASSESSMENT

SUB-AREA	GENERAL DESCRIPTION	SUGGESTED REPAIR / MAINTENANCE
1	Pavement is in fair condition. Evidence of ponding in the northwest corner of parking lot. ADA stall in front to the office and the ADA path of travel on in the eastern parking lot is not ADA compliant. The sidewalks on the east side of parking lot (from R/W) and at rear of cafeteria are not ADA compliant. Storm drain outlet east of cafeteria (in landscape area) is broken, and clogged.	Remove and Replace Sidewalk Additional Curb Souble Seal Coat Remove and Replace Storm Drain Restripe
2	The pavement is in fair condition. The ADA path of travel (sidewalk) from the adjacent neighborhood does not have an appropriate landing.	Seal Coat Asphalt Remove and Replace Sidewalk
3	There is ponding in front of the library and along the classroom building. The sidewalk adjacent to classroom buildings in not compliant in some areas. Ponding occurs between classroom buildings	Remove and Replace Sidewalk Regrade

4	Ponding occurs in the Kindergarden play area. Concrete landings to classrooms is not ADA compliant.	Remove and Replace Sidewalk Add Concrete Gutter
5	Playground access ramp is not ADA compliant. Pavement is in good condition with evidence of minor ponding.	Remove and Replace Sidewalk Seal Coat Asphalt
