ORCUTT UNION SCHOOL DISTRICT SITE ASSESSMENT & MASTER PLAN

SVA ARCHITECTS, INC.

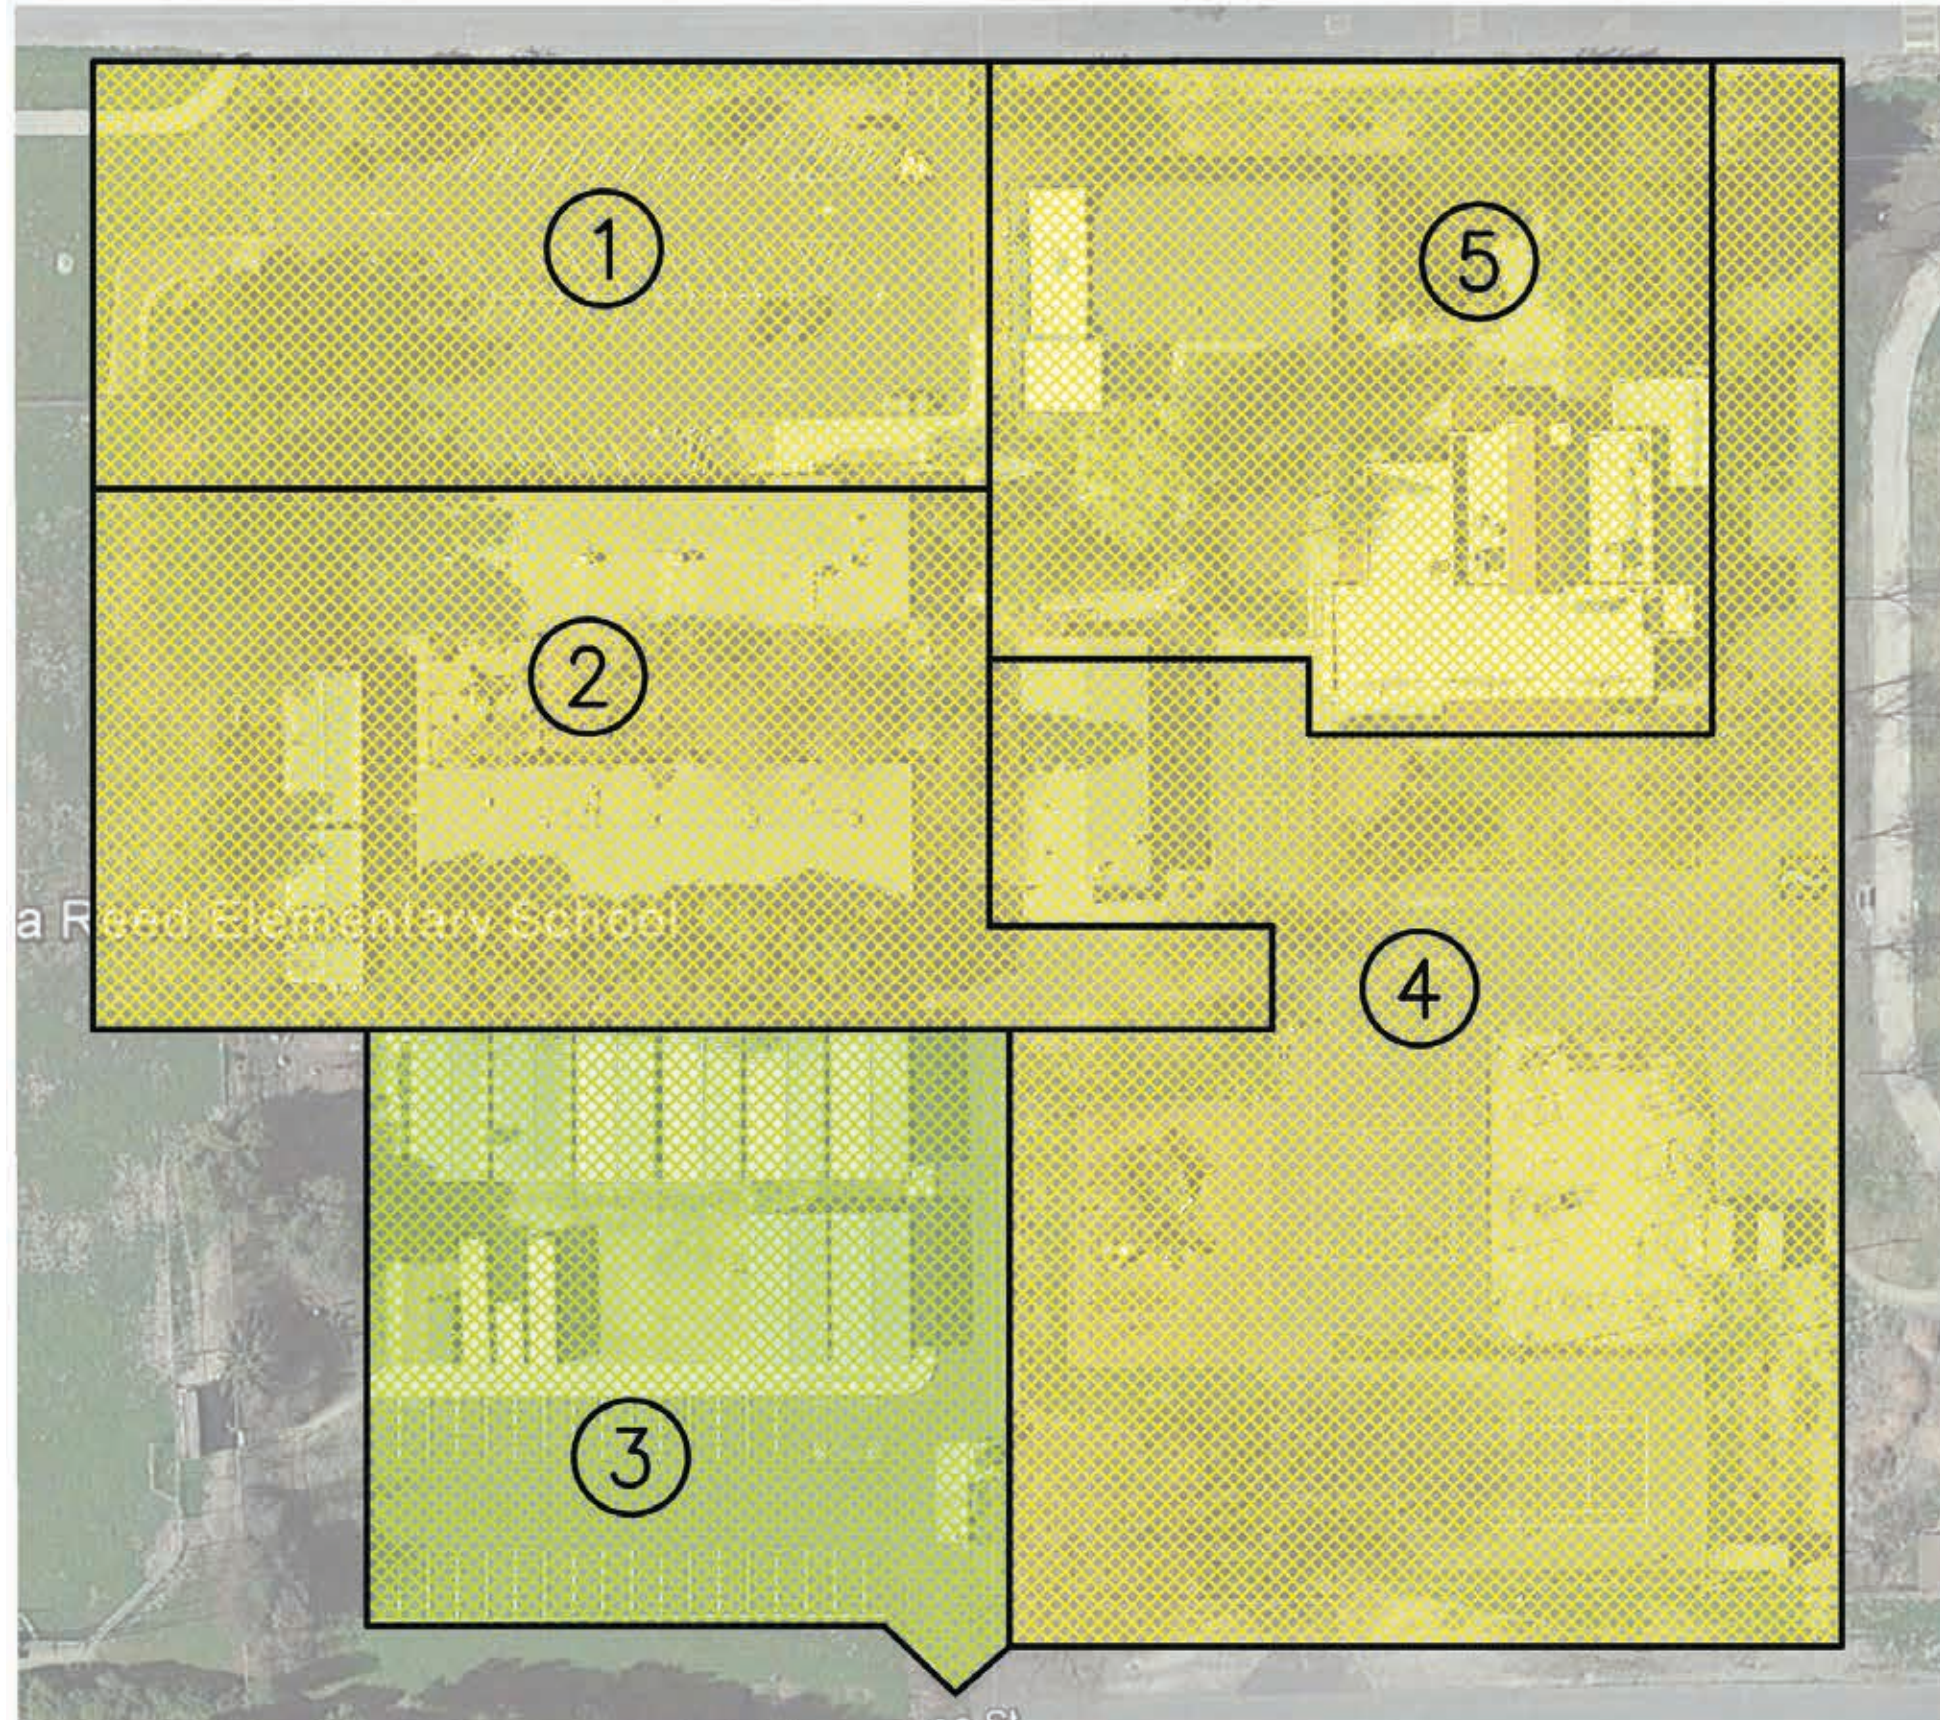
CIVIL ASSESSMENT

SUB-AREA	GENERAL DESCRIPTION	SUGGESTED REPAIR / MAINTENANCE
1	Parking lot is in good condition, however, a concrete surface drainage swale is needed to limit the water damage that will occur to the asphalt. A spillway in the NW corner needs to be constructed into the existing culvert. ADA stalls are not ADA compliant.	Construct New Concrete Swale Reconstruct ADA Stalls Reconstruct ADA Case C Curb Ramp Construct New Concrete Spillway
2	Pavement condition is moderate and needs maintenance and replacement in some areas. Water ponds in some locations. Portions of the sidewalk are not ADA compliant.	Remove and Replace Sidewalk Remove and Replace Asphalt Install Handrail Crack Seal and Double Seal Coat
3	Parking lot asphalt is in good condition. There are very minor ponding concerns in the DG path, near the dumpster pad, and at the east exit of the parking lot.	Regrade DG Path to Drain Remove and Replace Asphalt Regrade Landscape to Drain

4	Asphalt is in fair condition but there are some drainage concerns. Asphalt north of the cafeteria has steep transition and needs to be replaced. The cafeteria entrance is not ADA compliant.	Remove and Replace Sidewalk and Ramps Double Seal Coat Remove and Replace Asphalt Remove and Replace Concrete Sidewalk Re-Stripe
5	Sidewalk around the gym has ponding water and portions of the sidewalk are not ADA compliant.	Remove and Replace Concrete Sidewalk Remove 2' Retaining Wall West of Gym Regrade Landscape to Drain

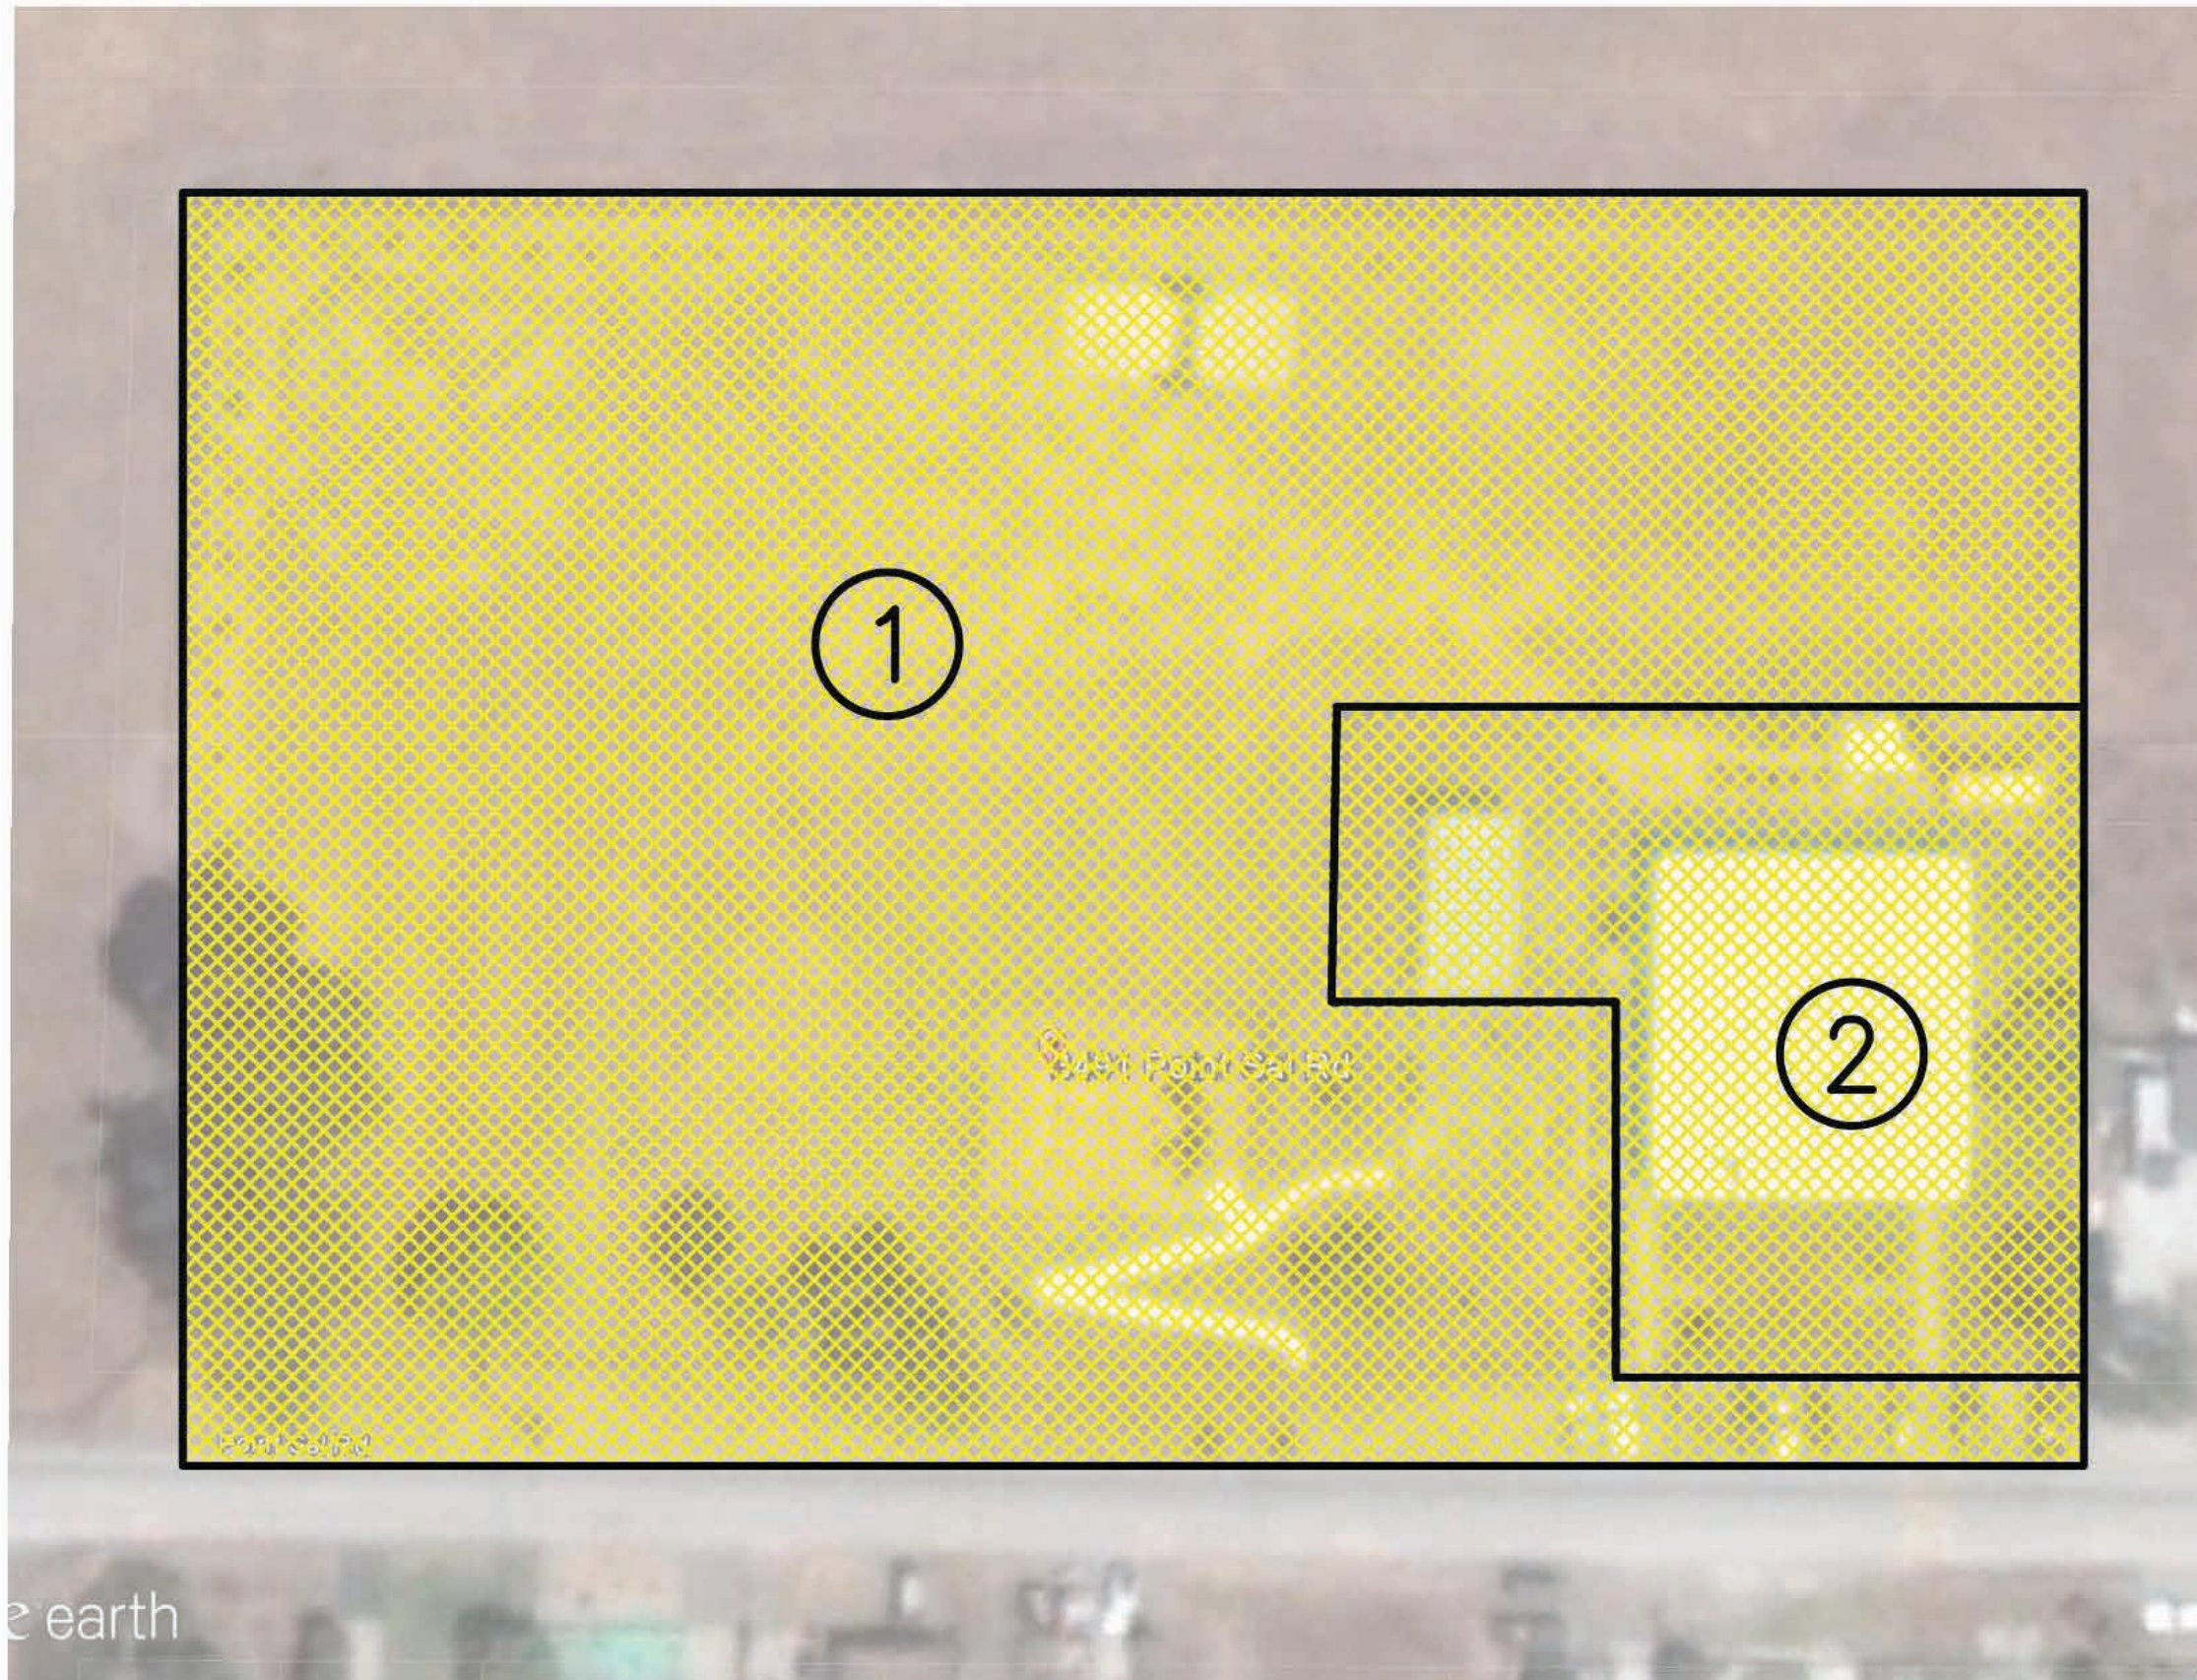
CIVIL ASSESSMENT

SUB-AREA	GENERAL DESCRIPTION	SUGGESTED REPAIR / MAINTENANCE
1	The asphalt in this area needs crack sealing and seal coat maintenance. The sidewalk is ADA compliant with one exception at the landing. Another ADA sidewalk access is needed for emergency access. Minor improvements needed.	Remove and replace ADA sidewalk Crack Seal and Double Seal Coat Replace Ex. Chain Link Fence with 6' Wide Gate Grade and Construct New Concrete Sidewalk
2	Asphalt pavement needs to be removed and replaced. Minor ponding occurs in the sidewalk around the building.	Remove and Replace Asphalt Remove and Replace Sidewalk Regrade Landscape to Drain

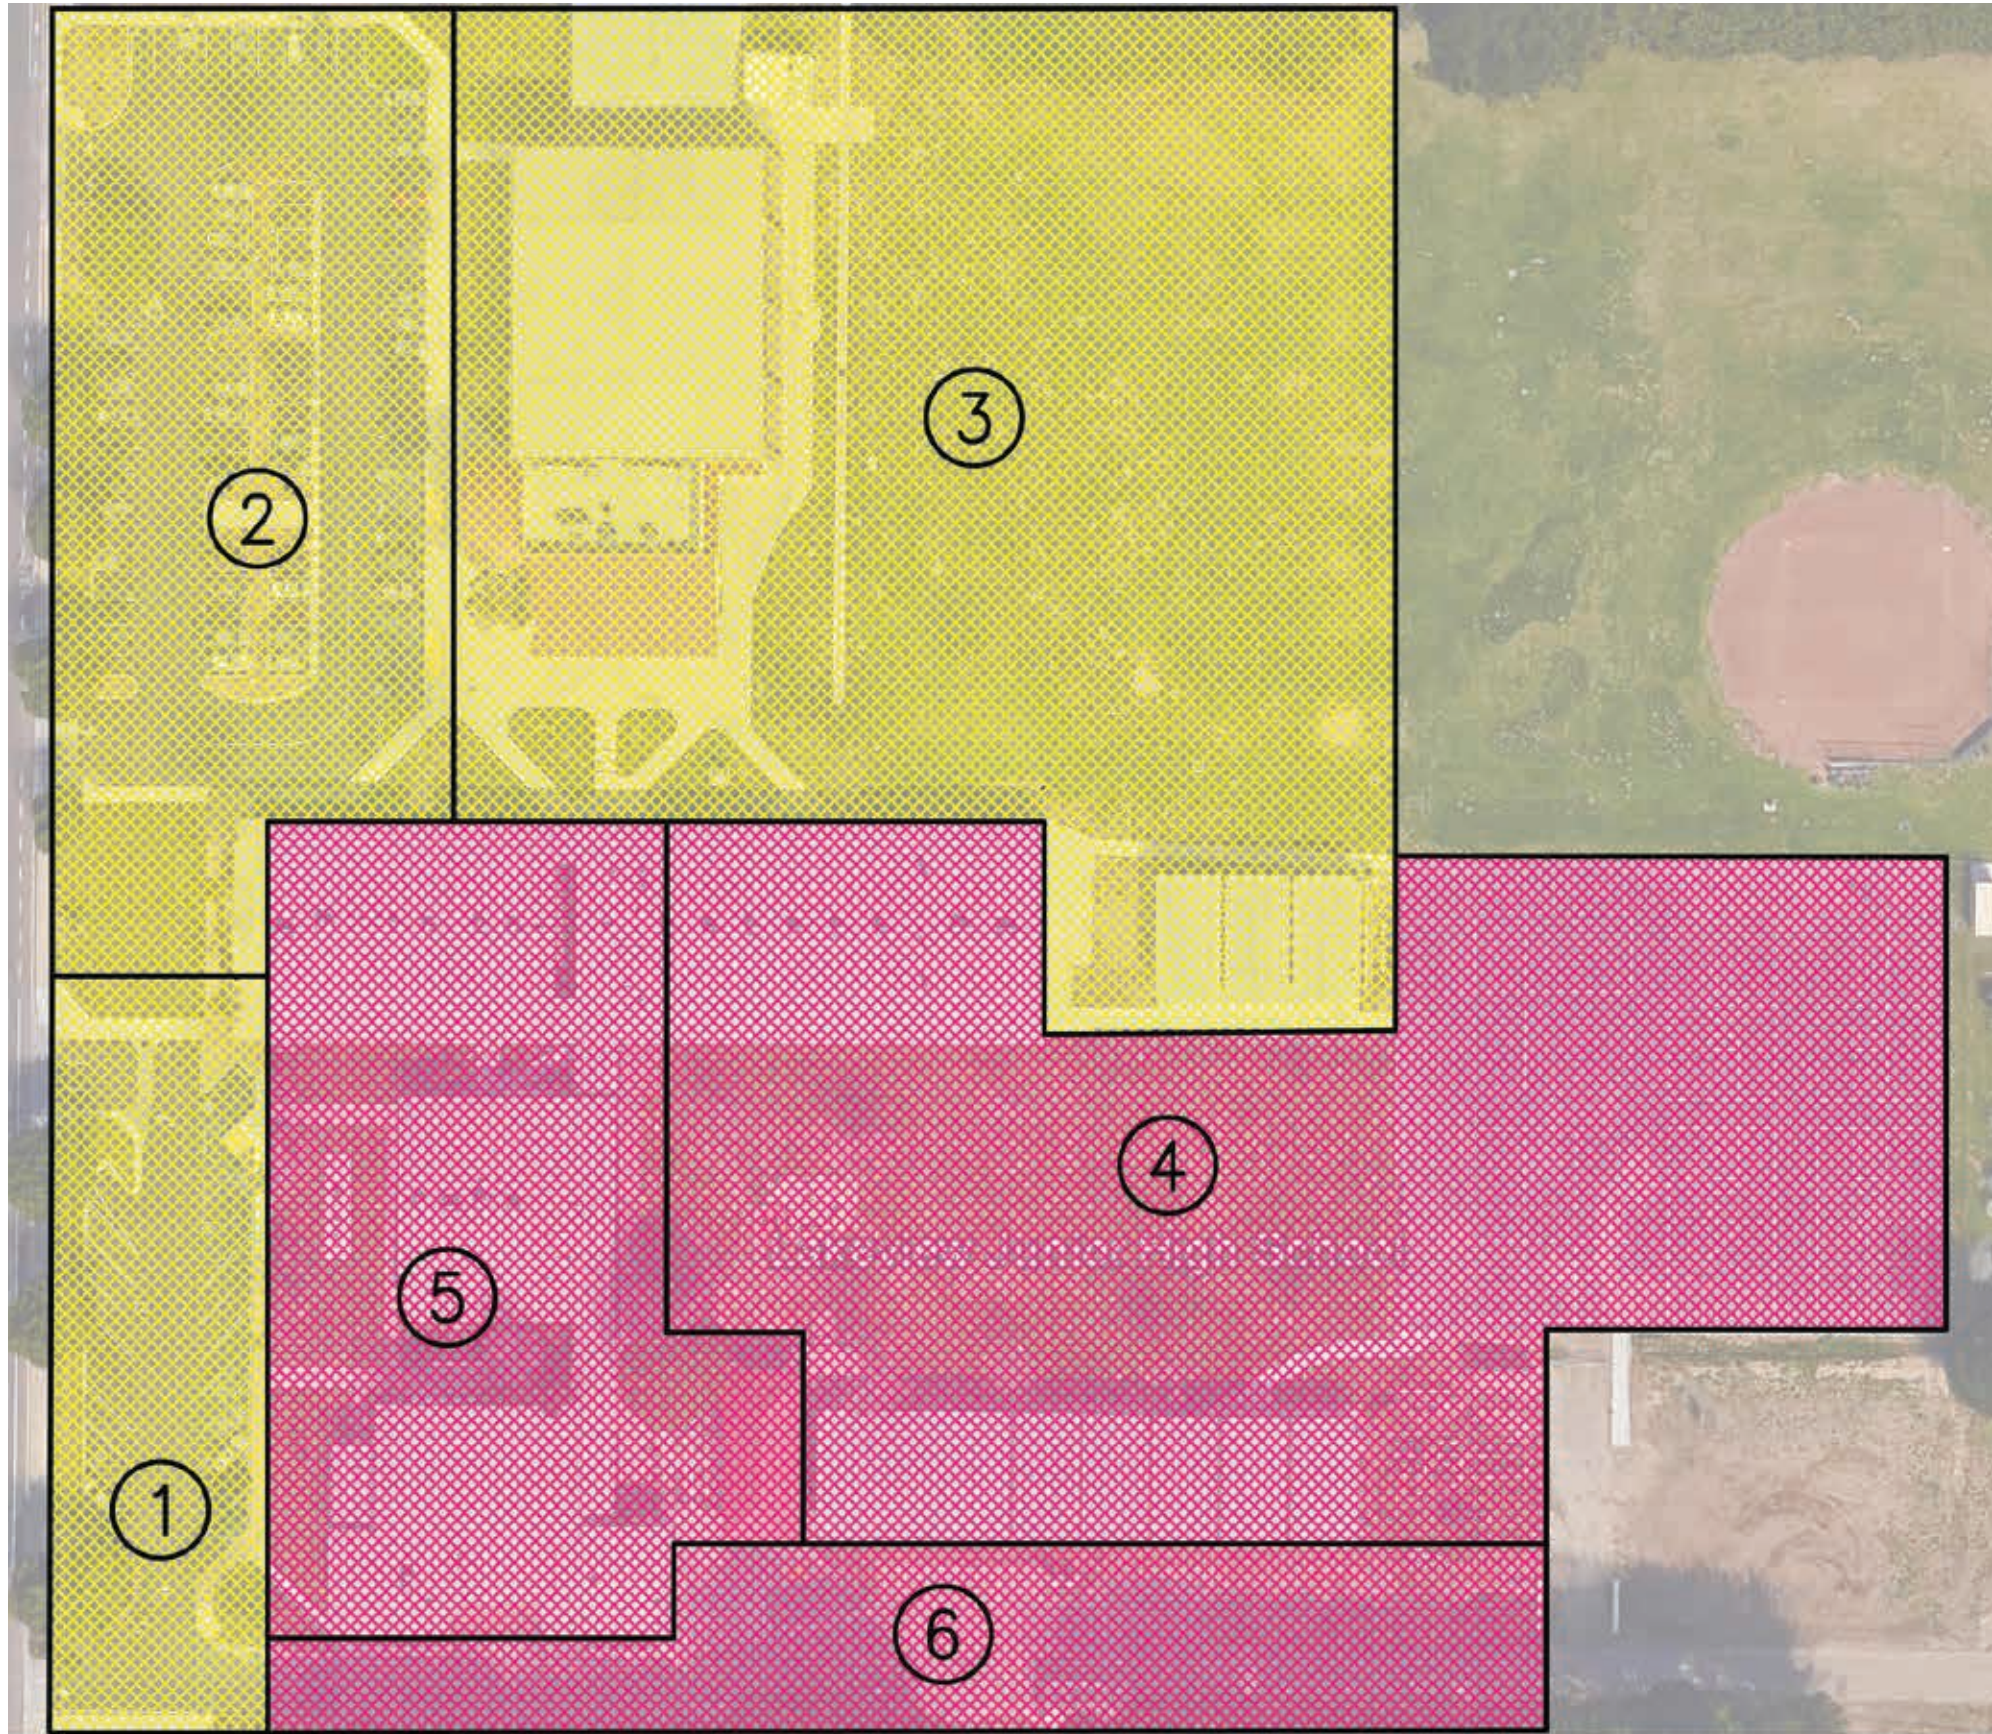
CIVIL ASSESSMENT

SUB-AREA	GENERAL DESCRIPTION	SUGGESTED REPAIR / MAINTENANCE
1	ADA parking stalls and ramps are not ADA compliant and need replacement. Minor drainage problem needs repair in the parking lot. Asphalt is in good condition.	Remove and Replace Asphalt Remove and Replace Sidewalk Remove and Replace Curb and Gutter
2	The asphalt is good condition. There are portions of sidewalk that are not ADA compliant. The pedestrian walk path in the parking lot needs truncated domes.	Remove and Replace Sidewalk Add Truncated Domes
3	The sewer emits an odor during heavy rain; this will need investigation. Some sidewalk is not ADA compliant.	Remove and Replace Sidewalk Investigate Sewer Failure Repair Sewer Failure
4	Water ponds in the sidewalk in front of Rooms 13 and 16 as well as in the asphalt pavement basketball and volleyball courts.	Asphalt Skin Patch Double Seal Coat Re-Stripe Grade New Landscape Culvert Detention Basin Remove and Replace Sidewalk

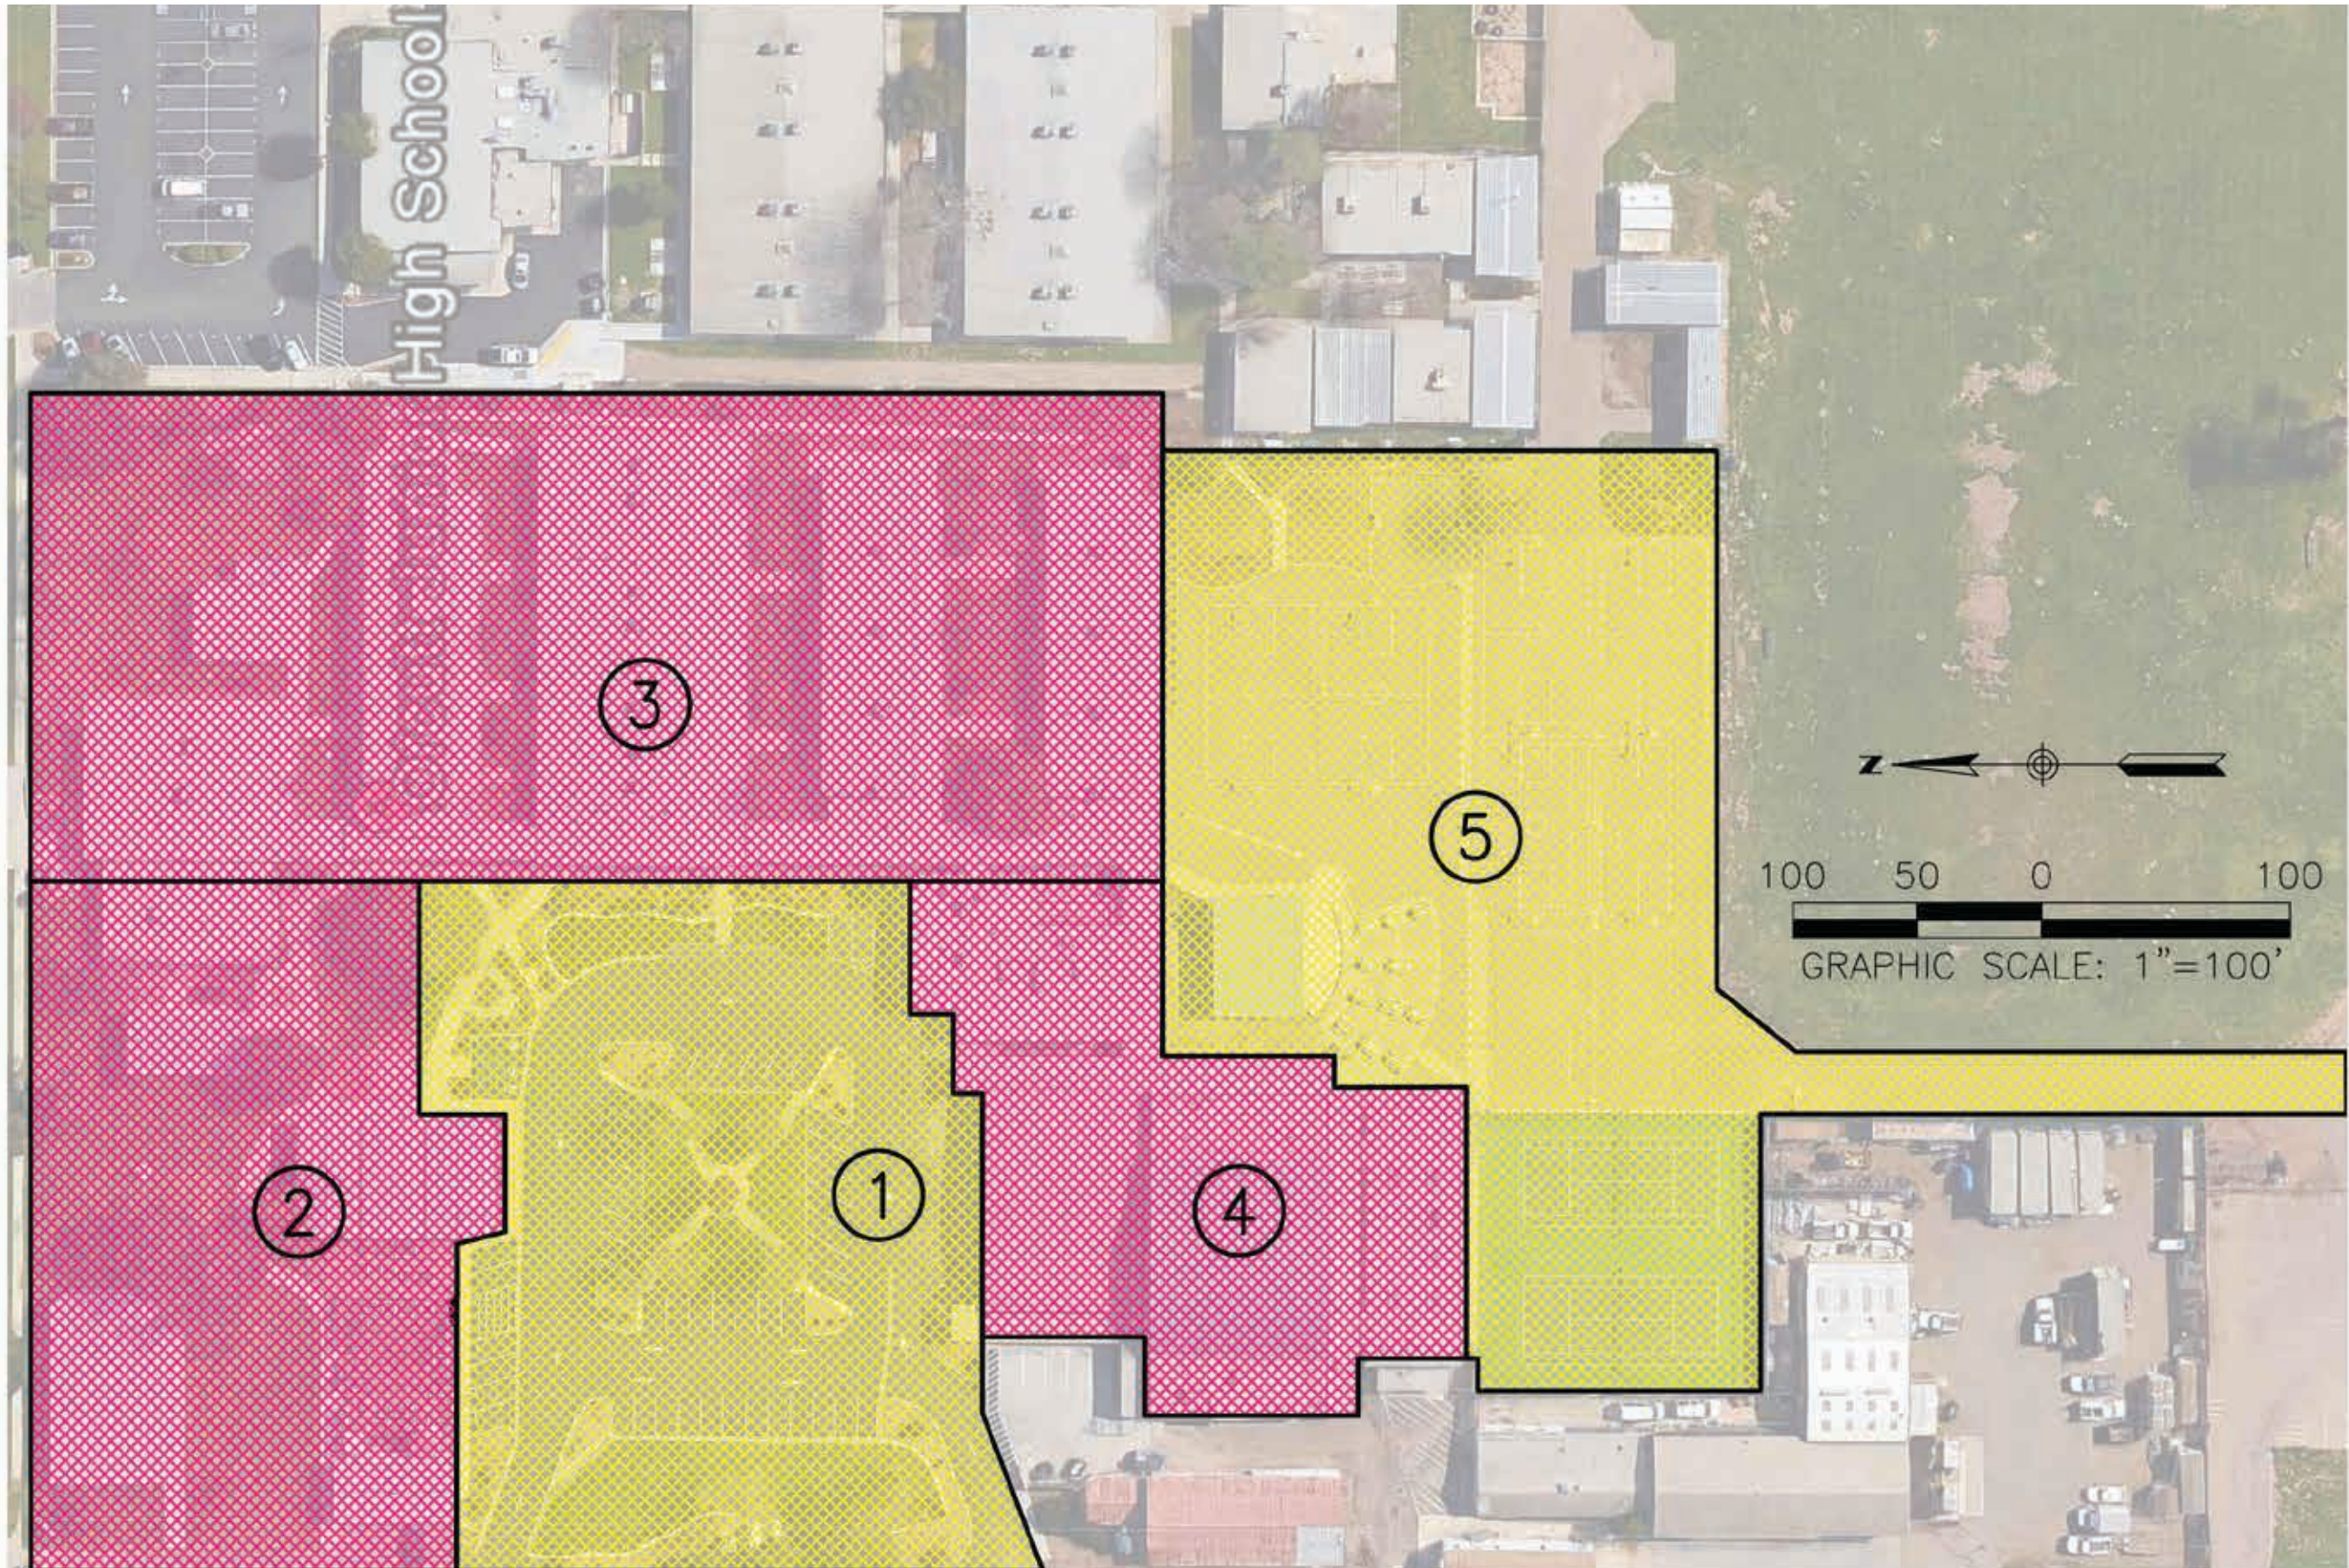
CIVIL ASSESSMENT

SUB-AREA	GENERAL DESCRIPTION	SUGGESTED REPAIR / MAINTENANCE
1	The asphalt pavement is in good condition, however, the ADA stalls and ramps are not ADA compliant.	Remove and Replace ADA Curb Ramp Remove and Replace Sidewalk Remove Existing and Widen ADA Unloading Zone Re-Stripe ADA Stall on the South Side Remove and Reconstruct Parking Lot Planters
2	A majority of the sidewalk in this area is not ADA compliant and should be replaced. The sidewalk running parallel to Pinal Ave is not ADA compliant. It is unclear if this sidewalk is on school property but it has been included in this assessment.	Remove and Replace Sidewalk Install Ramp Handrails Construct New Concrete ADA Ramp
3	Portions of sidewalk are not ADA compliant and need replacement. Metal sidewalk plates should be removed and new sidewalk should be constructed along with regrading of the landscape to allow drainage. Concrete and rails at bridge need repair.	Remove and Replace Sidewalk Repair Failing Structural Concrete at Bridge Remove and Replace Bridge Rails Regrade Landscape to Drain

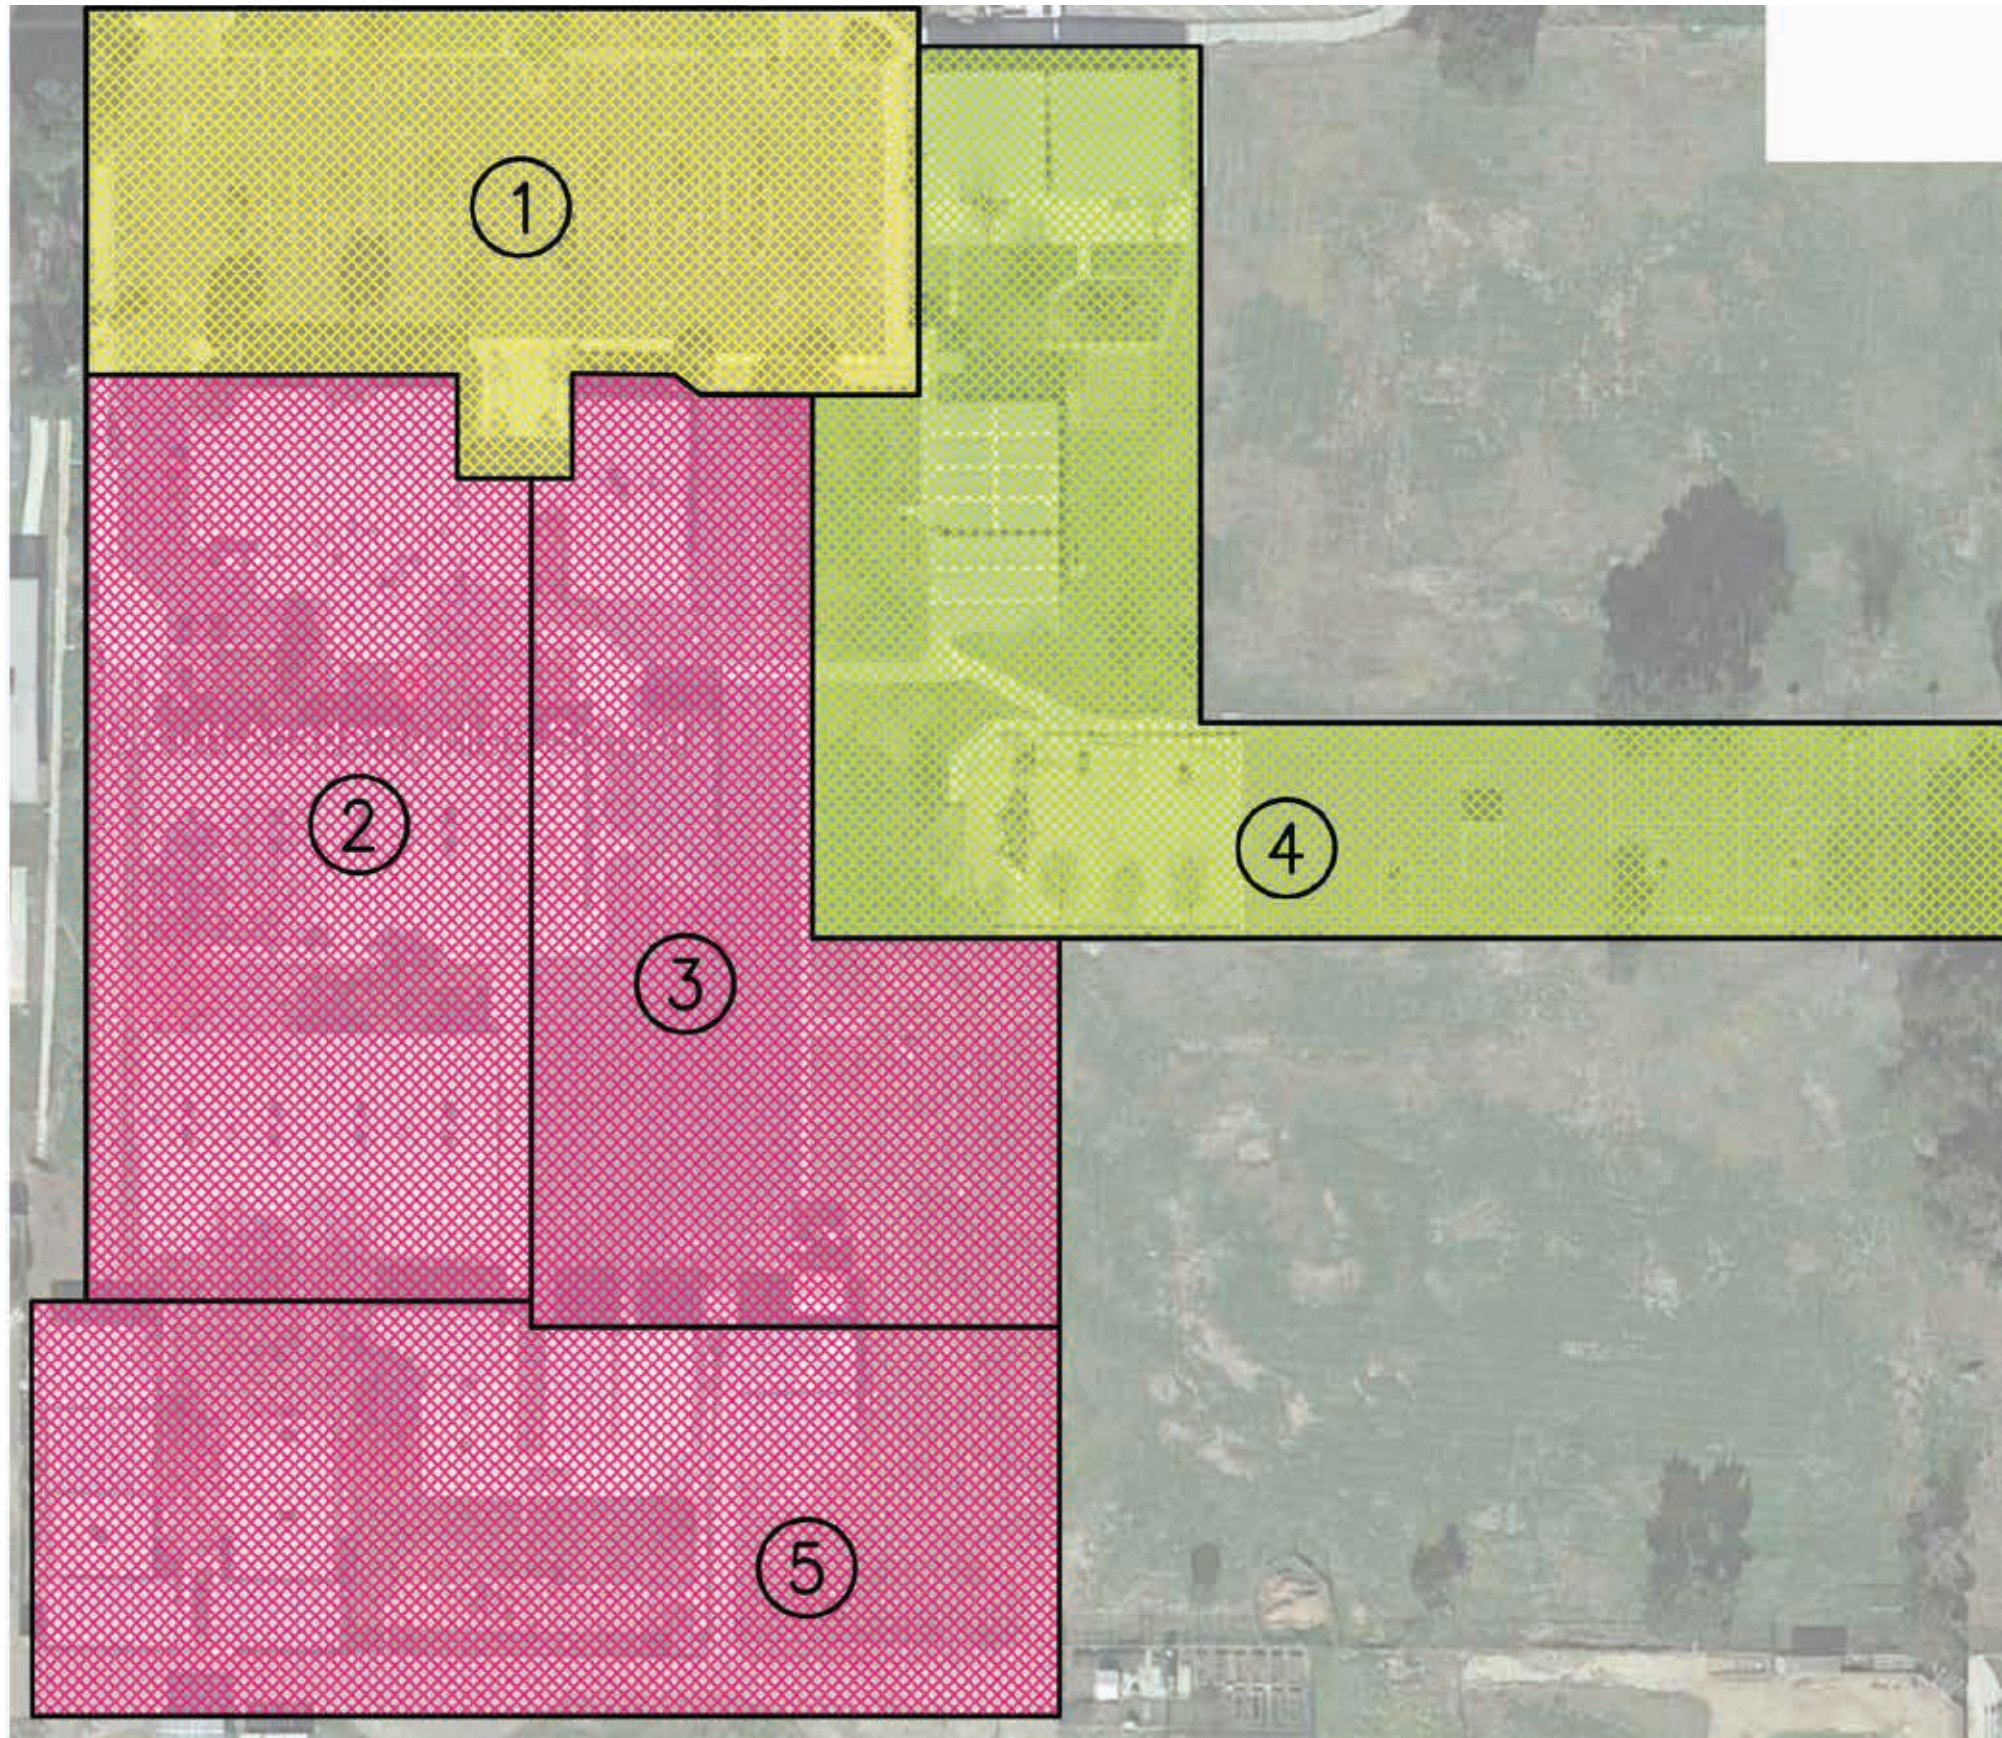
CIVIL ASSESSMENT / ORCUTT ACADEMY HIGH SCHOOL

SUB-AREA	GENERAL DESCRIPTION	SUGGESTED REPAIR / MAINTENANCE
1	Asphalt in good condition but there are portions of the parking lot and sidewalk that are not ADA compliant.	Remove and Replace Sidewalk Construct New Concrete ADA Ramps Remove and Replace Asphalt
2	The emergency access road needs to be widened to meet current fire codes. Significant ponding occurs in front of Rooms 5-8. Portions of sidewalk are not ADA compliant. Dumpsters need a new concrete pad to limit damage to asphalt.	Remove and Replace Sidewalk Install Underground Storm Drain Pipe Regrade Landscape to Drain Install Drainage Inlet Construct New Concrete Dumpster Pads Remove and Reconstruct Widened Access Road
3	Asphalt pavement is in poor condition and should be replaced. The walk to the eating area as well as the eating area itself is not ADA compliant. The asphalt should be removed, regraded, and replaced. A portion of the sidewalk ponds.	Remove and Replace Sidewalk Remove and Replace Asphalt

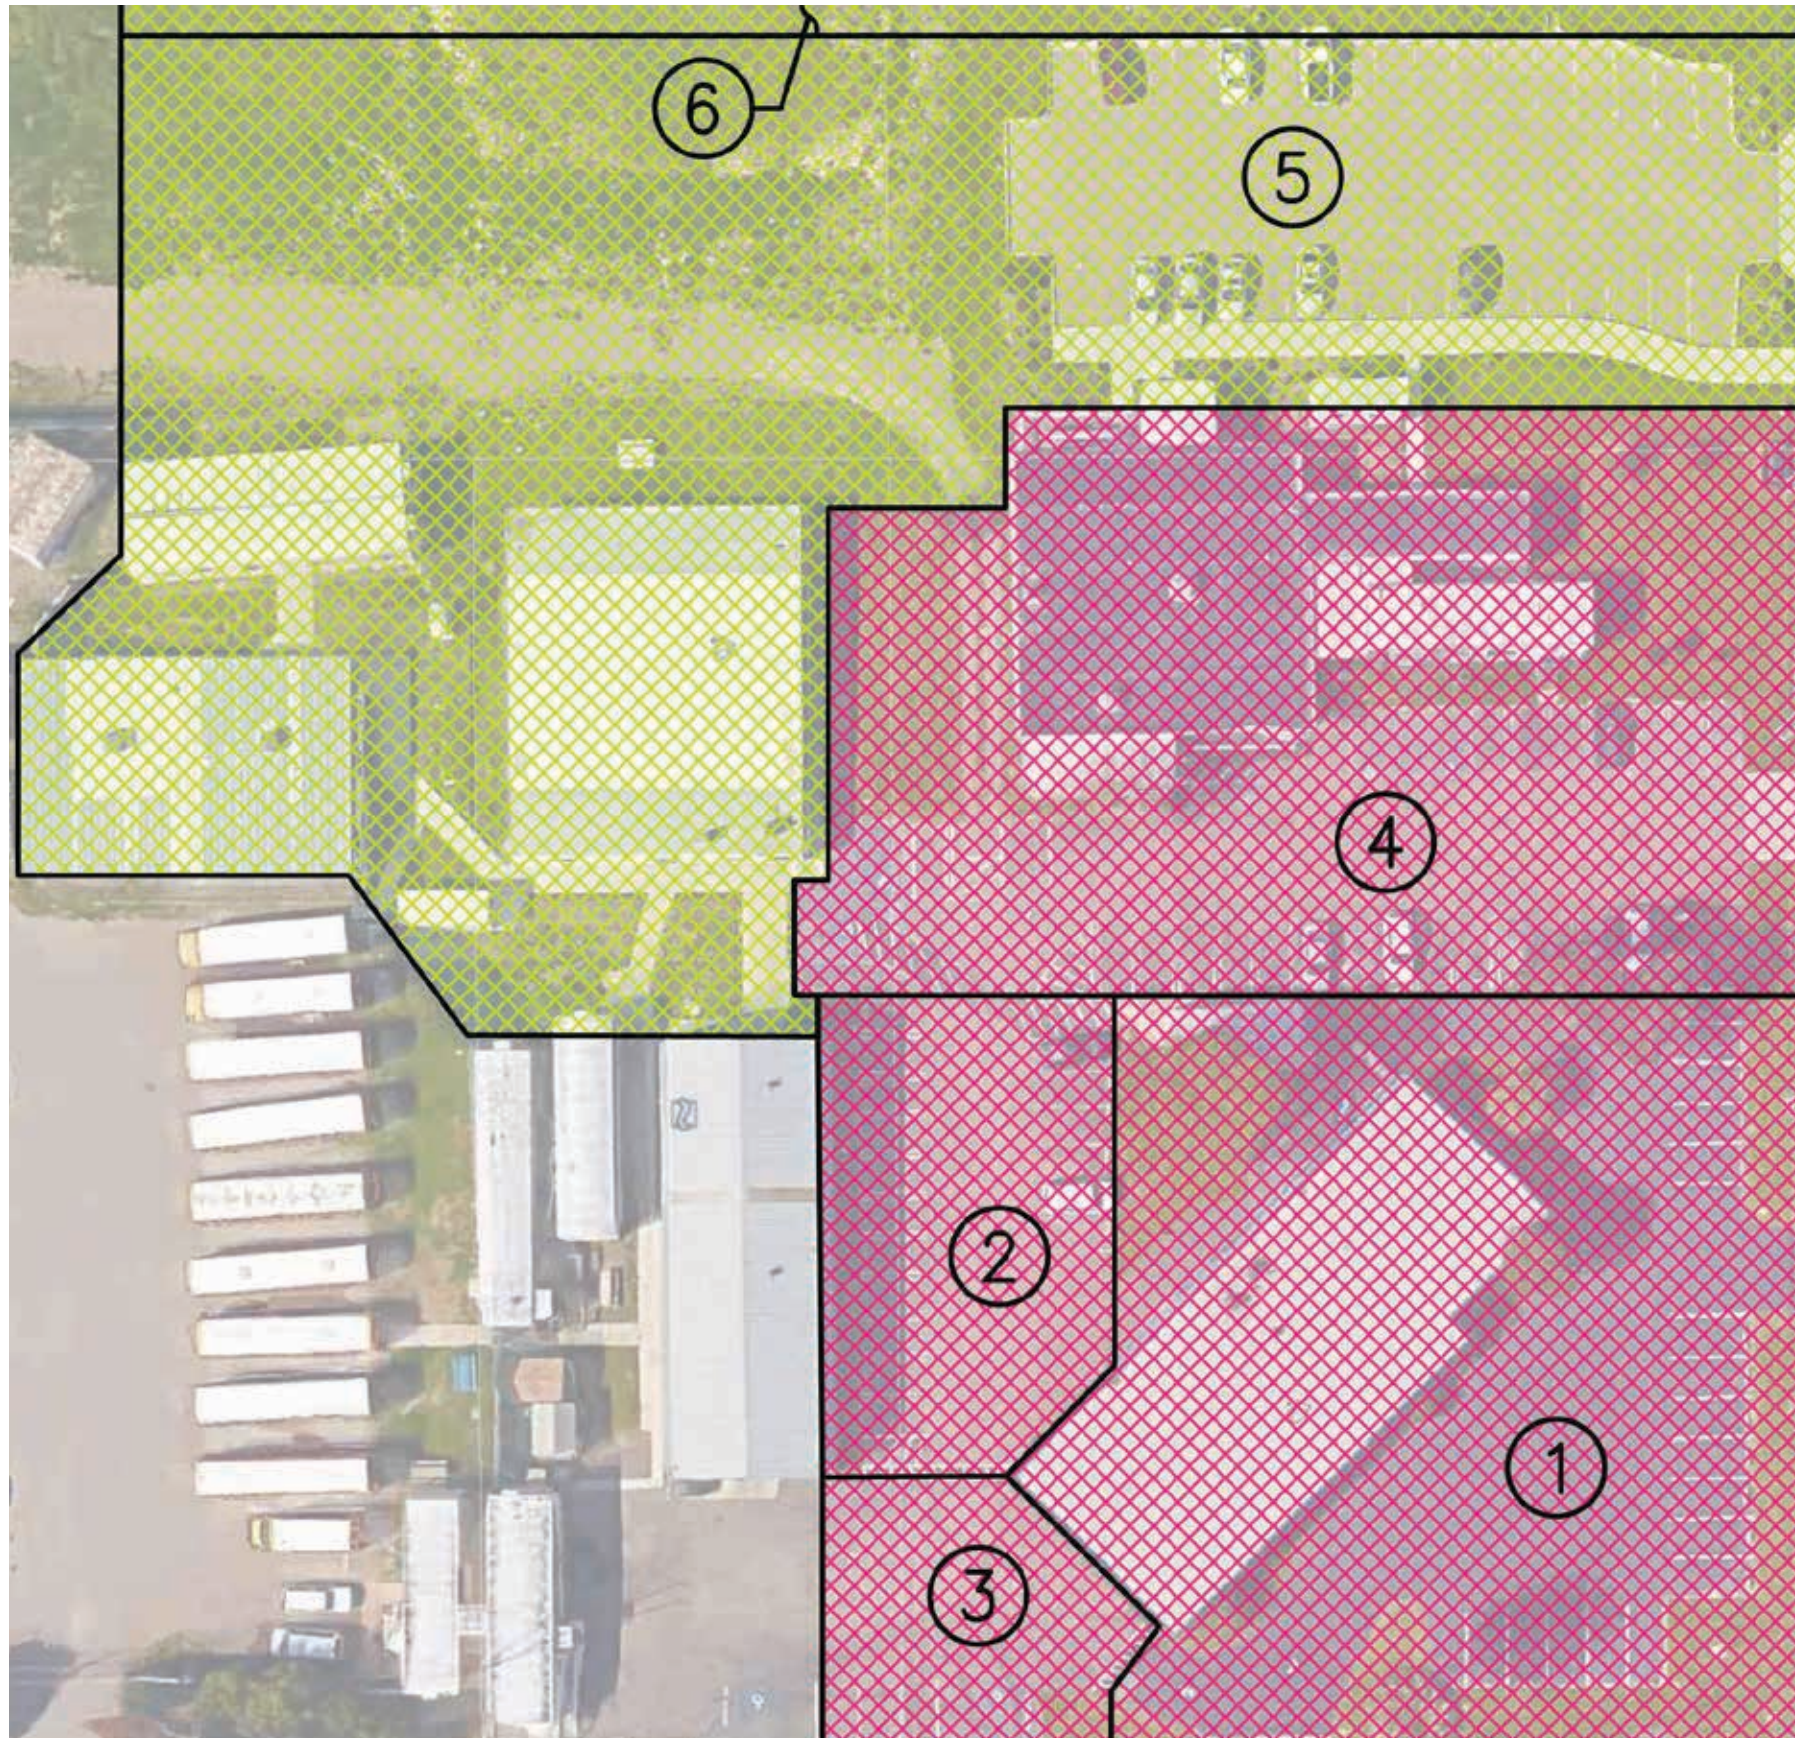
CIVIL ASSESSMENT / DISTRICT OFFICE

SUB-AREA	GENERAL DESCRIPTION	SUGGESTED REPAIR / MAINTENANCE
1	There are no ADA stalls or path of travel. The asphalt is weathered and does not have adequate drainage. Tree root concerns. No sidewalks allow for ADA pedestrian access from the street.	Remove and Replace Asphalt New Sidewalk Re-Stripe New ADA Stall & Signage
2	Parking lot does not drain properly and needs a surface drain connecting to Area 4. There are currently no ADA stalls. Tree root issues in driveway behind D.O. building. Sidewalk at Building B is not ADA compliant.	New ADA Stall Double Seat Coat Asphalt New Concrete Gutter for Drainage New Sidewalk Re-Stripe
3	Additional PCC will be needed to accommodate delivery and trash trucks. Parking lot also does not drain properly.	Remove Asphalt Construct New 7" Thick Concrete Parking Lot Adjust Utility Vault to Grade Re-Stripe
4	Parking lot does not drain properly and needs a surface drain connecting to Area 2. New ADA stalls are needed at south end and existing ADA stalls need to be redesigned.	New ADA Stalls Remove and Replace Asphalt New Concrete Gutter for Drainage Detention Basin Re-Stripe
