ORCUTT UNION SCHOOL DISTRICT SITE ASSESSMENT & MASTER PLAN

SVA ARCHITECTS, INC.

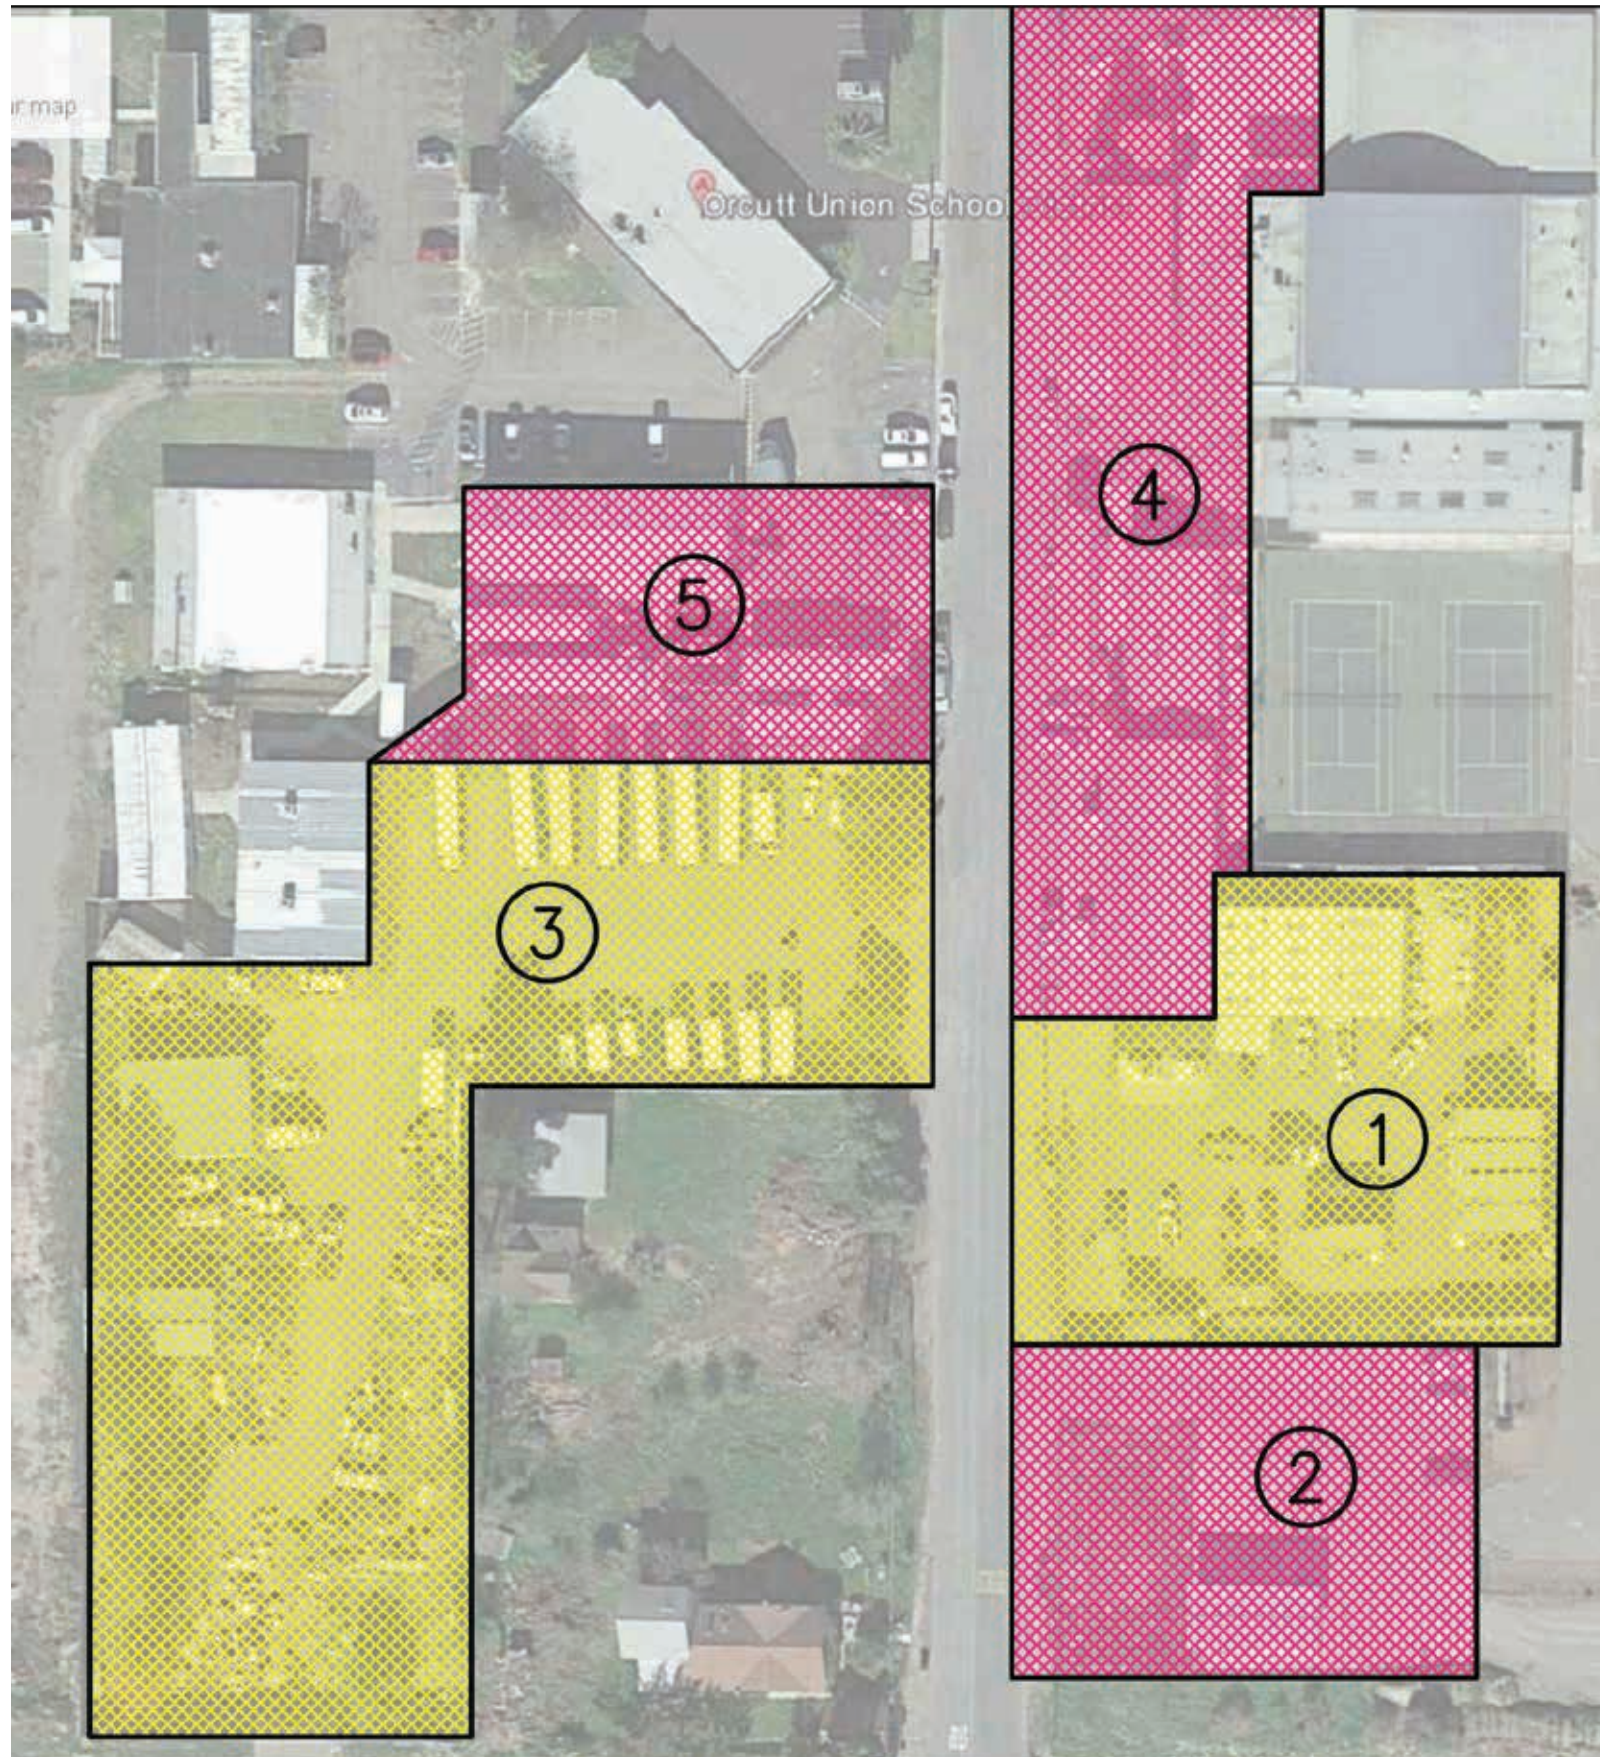
CIVIL ASSESSMENT / MAINTENANCE, OPERATIONS & TRANSPORTATION (M.O.T.)

SUB-AREA	GENERAL DESCRIPTION	SUGGESTED REPAIR / MAINTENANCE
1	This area is an unpaved gravel parking lot that is maintained regularly by the school district maintenance staff. Although this is a low maintenance parking lot it potentially may have negative stormwater impacts.	Maintain Gravel Lot (Do Nothing) Pave New Asphalt Surface
2	Asphalt pavement parking lot is weathered and needs seal coat maintenance. Gravel road distributes too much gravel debris on the parking lot. Ponding exists in the middle of the parking lot and needs replacement.	Remove and Replace Asphalt Double Seal Coat Construct Asphalt/Concrete Transition Re-Stripe
3	This area is an unpaved gravel parking lot that is maintained regularly by the school district maintenance staff. Although this is a low maintenance parking lot it potentially may have negative stormwater impacts.	Maintain Gravel Lot (Do Nothing) Pave New Asphalt Surface
