ORCUTT UNION SCHOOL DISTRICT SITE ASSESSMENT & MASTER PLAN

SVA ARCHITECTS, INC.

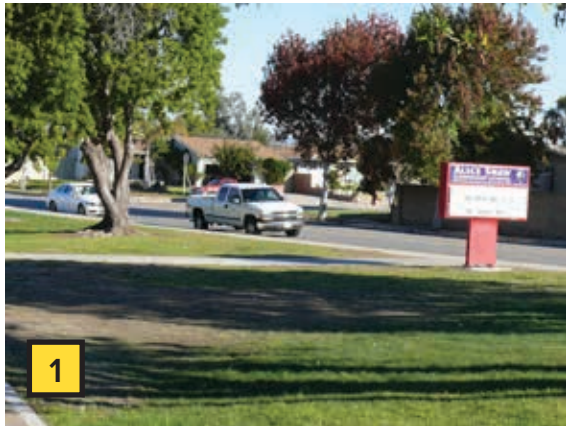
1. LANDSCAPE AREA ALONG HILLVIEW ROAD

Existing Condition:
Dilapidated turf area with no shrub planting. Turf appears in fair condition.

Recommendation:
Add low-water use plant material as a compliment to the existing turf. Add new drip irrigation system for shrub planting and reconfigure spray system for the turf.

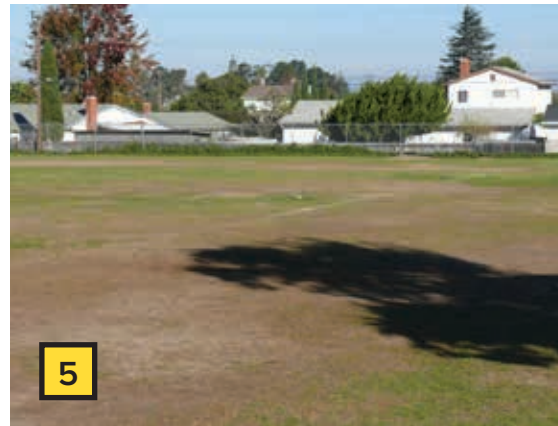
5. OPEN PLAY ATHLETIC FIELDS

Existing Condition:
Dilapidated turf, compacted soil, and irrigation coverage is lacking.

Recommendation:
Till and amend the soil, repair irrigation systems and re-sod and or re-seed the entire area.

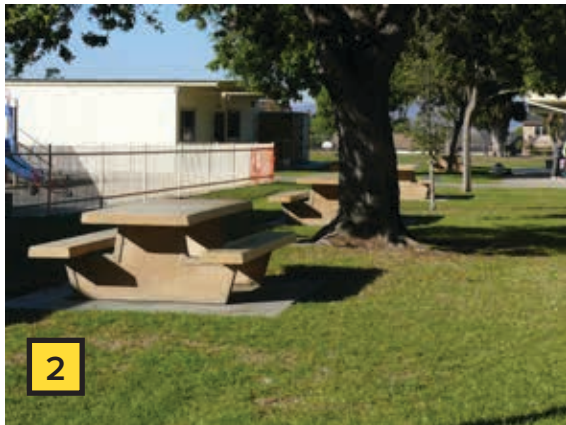
2. TABLE SEATING INSIDE CENTER OF CAMPUS

Existing Condition:
Existing tables located in turfgrass area. Non-accessible locations.

Recommendation:
Install new accessible paving/pathway to each table.

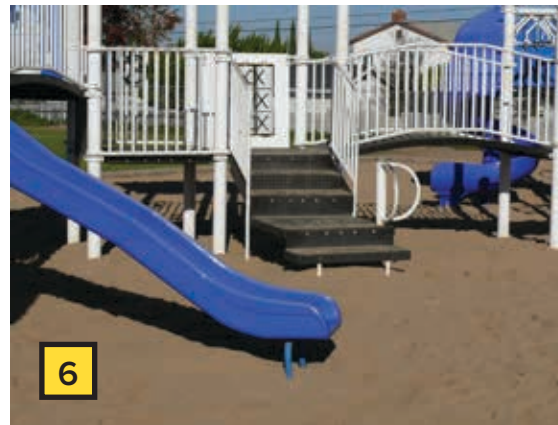
6 & 7. PRIMARY PLAY AREA AT NORTH FIELDS

Existing Condition:
Areas are not accessible with only sand for the fall protection. There is no access to the transfer stations on the play equipment and from the slides or other equipment back to the transfer stations.

Recommendation:
Add rubberized fall zone material that is accessible from the entry ramp to the transfer station and to the slide areas and other equipment, or change all material to an accessible material like Fibar etc. material to an accessible material like Fibar etc.

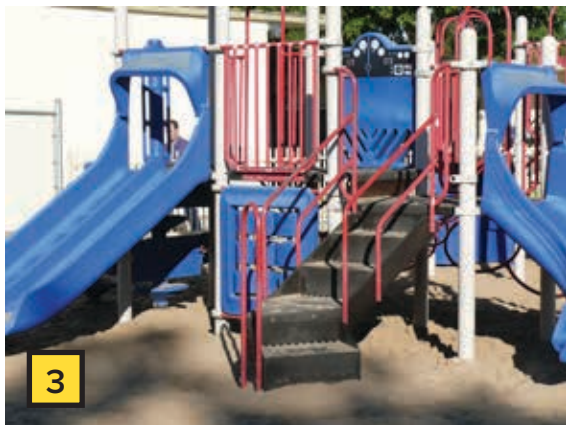
3. KINDERGARTEN PLAY AREA ADJ. TO BLDG. 020 COURT

Existing Condition:
Area is not accessible with only sand for the fall protection. There is no access to the transfer station on the play equipment and from the slides or other equipment back to the transfer station.

Recommendation:
Add rubberized fall zone material that is accessible from the entry ramp to the transfer station and to the slide areas and other equipment, or change all material to an accessible material like Fibar etc.

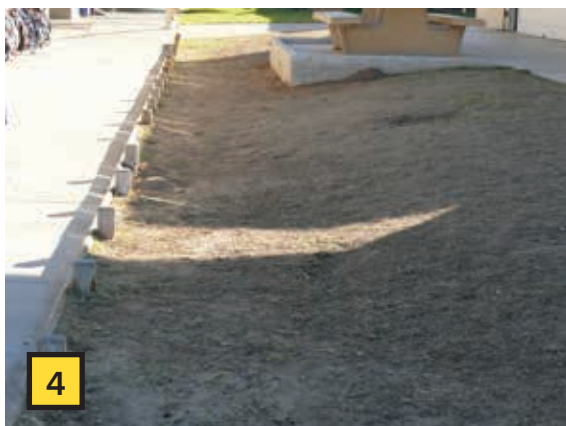
4. LANDSCAPE AREA ADJACENT TO ATHLETIC FIELD

Existing Condition:
Dilapidated or barren landscape area with no shrub or groundcover planting. Table seating.

Recommendation:
Add low-water use plant material (trees for shade, shrubs and groundcover) with new drip irrigation system.

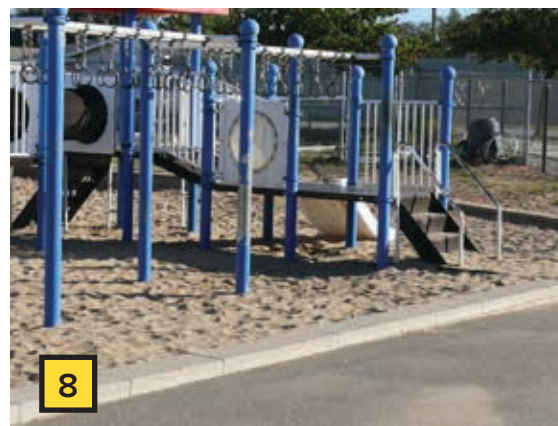
8. PRIMARY PLAY AREA NEAR BLDG. 040

Existing Condition:
Area is not accessible with only sand for the fall protection. There is no access to the transfer station on the play equipment and from the slides or other equipment back to the transfer stations. Box depth at SW corner exceeds 3-ft. drop off.

Recommendation:
Add rubberized fall zone material that is accessible from the entry ramp to the transfer station and to the slide areas and other equipment, or change all material to an accessible material like Fibar etc. Install safety railing along SW corner of box to prevent fall injuries.

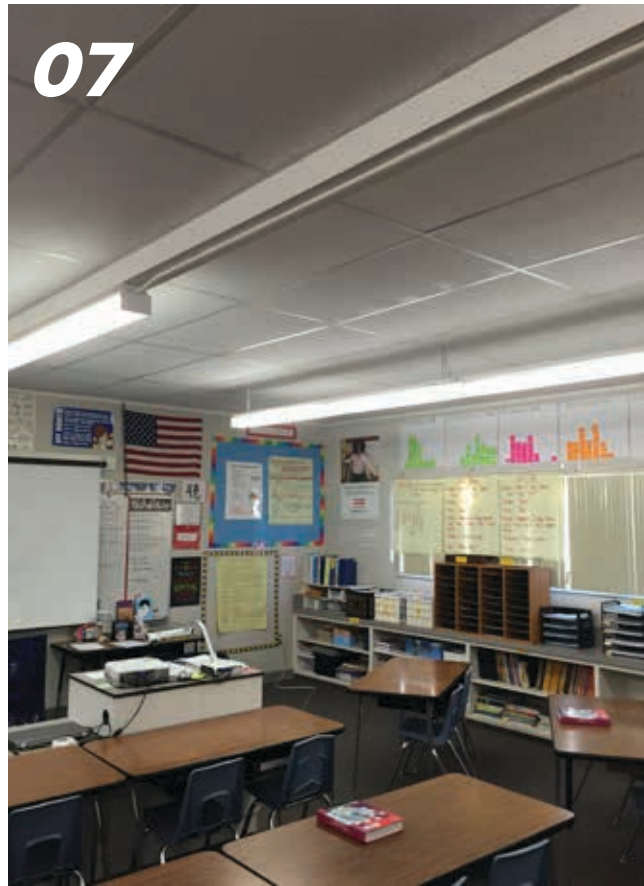
FIGURES	
01	Existing switchgear
02	Main switchboard
03	Existing switchgear
04	Existing switchgear
05	Existing Main switchboard #2
06	Typical panelboard
07	Typical classroom lighting
08	Typical corridor lighting
09	Emergency lighting
10	Exterior lighting
11	Exterior lighting
12	Parking lot lighting
13	Low voltage headend equipment
14	Desk mounted projector
15	MDF Rack
16	Low voltage equipment
17	Low voltage headend equipment
18	Fire Alarm control panel

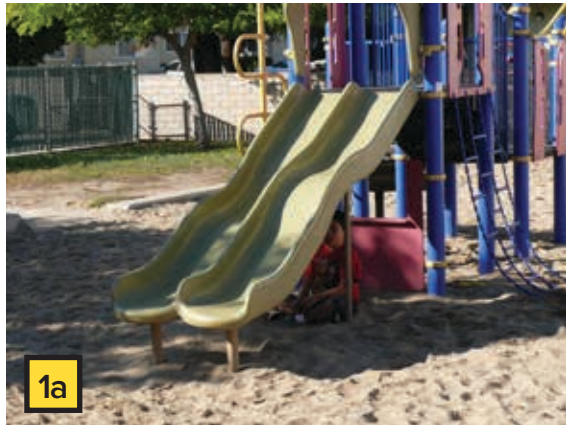
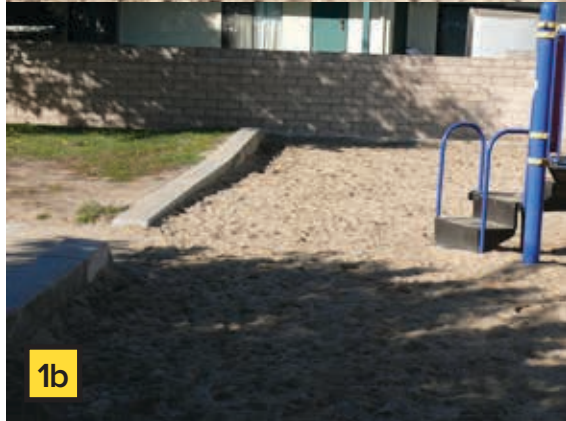
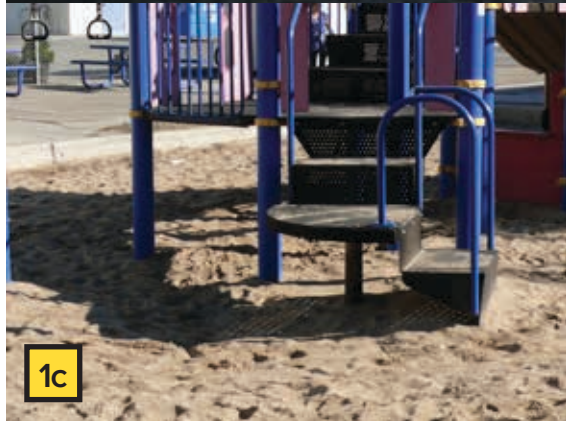
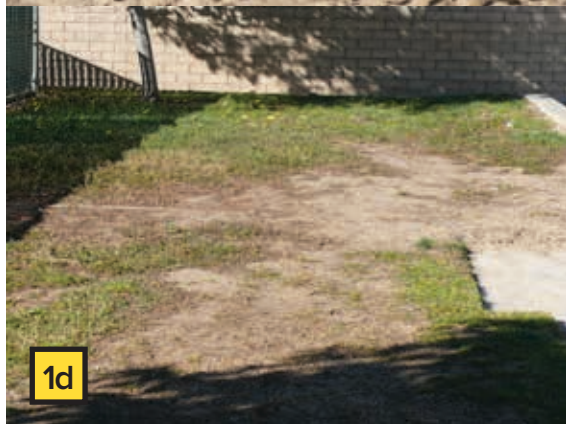
1a-1d. STUDENTS WITH SPECIAL NEEDS PLAY AREA

Existing Condition:
The play equipment area is not accessible for special needs with only sand for the fall protection. There is no access to the transfer station on the play equipment and from the slides or other equipment back to the transfer station. The cut in the concrete goes into sand and is not accessible. The existing turf area is hard packed, irrigation does not work and or cover the area and the hardcourt play surface has a drainage swale going through it and is not accessible.

Recommendation:
Add rubberized fall zone material that is accessible from the entry ramp to the transfer station and to the slide areas and other equipment, or change all material to an accessible material like Fibar etc. Till, amend repair irrigation systems and re-sod and or re-seed. Review all hardscape bike track in the play area and adjust to be all accessible. Install drain inlets and remove concrete swale within the play yard area.

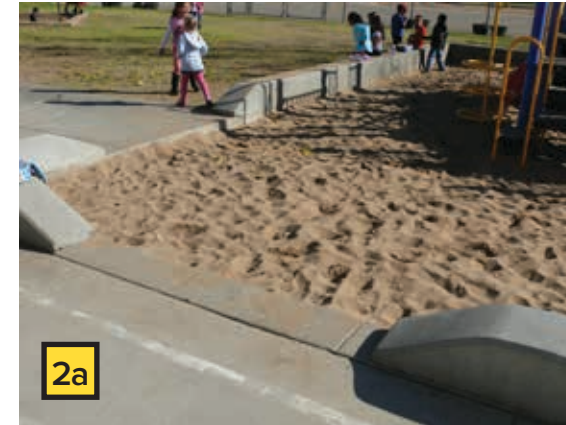
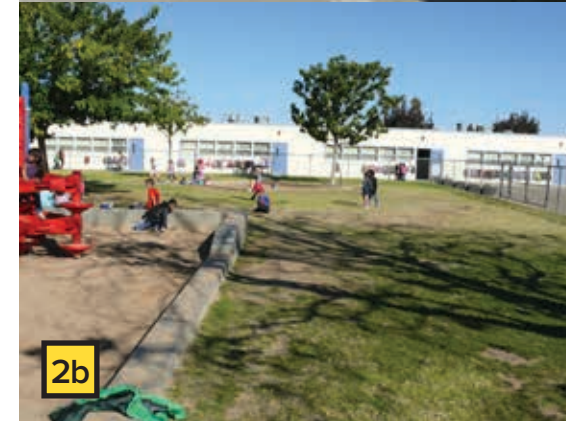
2a & 2b. KD PLAY AREA AND ADJACENT TURF

Existing Condition:
The play equipment area is not accessible with only sand for the fall protection. There is no access to the transfer station on the play equipment and from the slides or other equipment back to the transfer station. The cut in the concrete goes into sand and is not accessible. The existing turf area is hard packed, irrigation does not work and/or has inadequate coverage.

Recommendation:
Add rubberized fall zone material that is accessible from the entry ramp to the transfer station and to the slide areas and other equipment, or change all material to an accessible material like Fibar, or another comparable material. Till, amend, repair irrigation systems and re-sod and or re-seed.

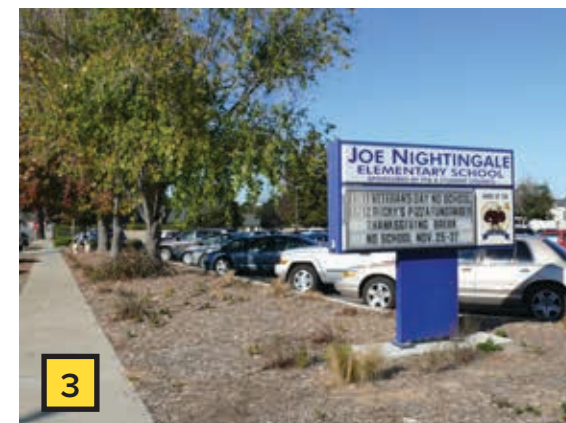
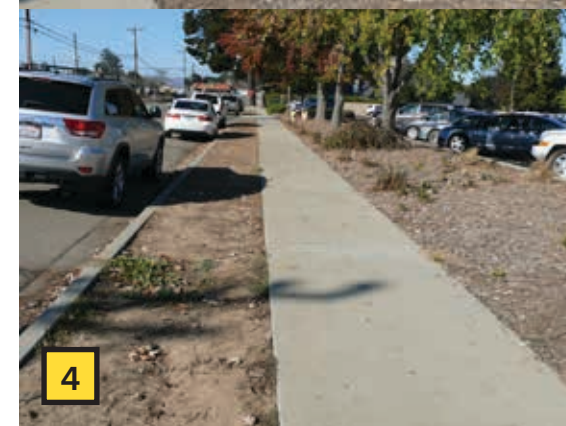
3 & 4. PLANTERS ALONG WINTER RD.

Existing Condition:
Irrigation system is not operative. Minimal plant material.

Recommendation:
Till and amend the soil, add native and or drought tolerant plant material and drip style irrigation. Plant low ground cover with a maximum height of 12" to 24" and low water demand plant material.

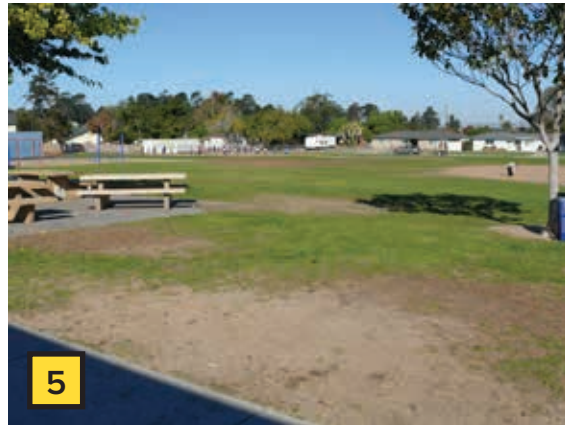
5. TURF AREA WITH TABLES

Existing turf area adjacent to the hardcourt and table seating area as well as the adjacent open play field area has a compacted condition and lacks adequate irrigation system.

Till and amend the soil, repair irrigation systems and re-sod and or re-seed entire area.

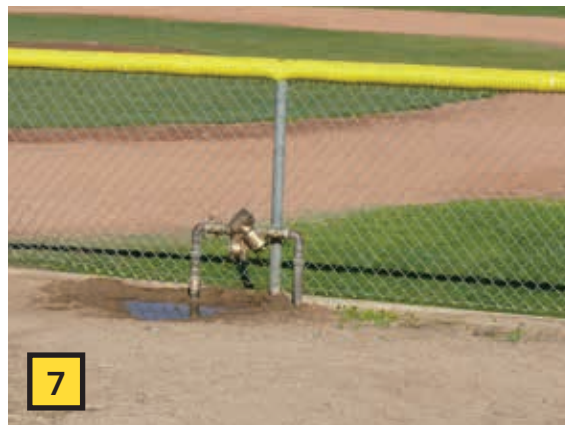
7 & 8. LITTLE LEAGUE BALL FIELDS

Area is in ok condition except for the exiting backflow prevention device is leaking and in need of repair.

Have the Reduced Pressure Backflow Device tested, serviced, and repaired.

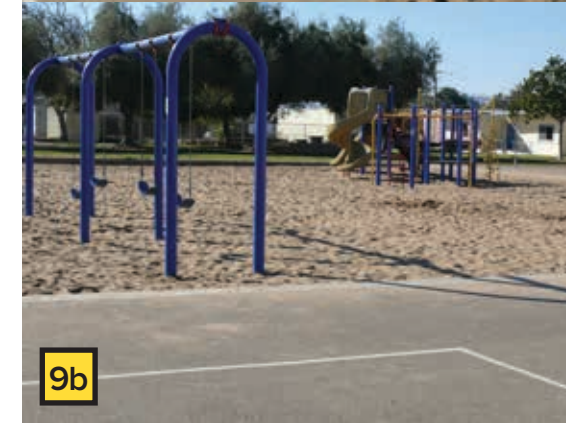
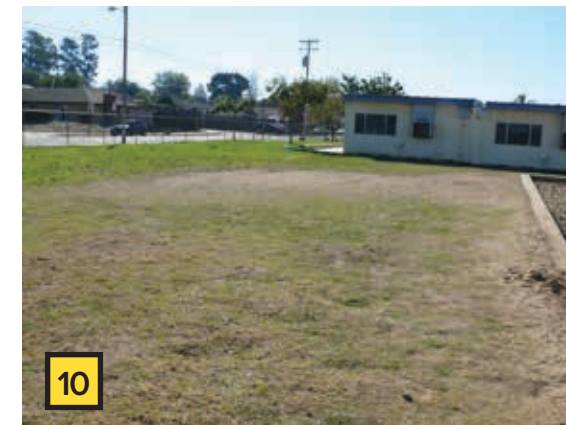
10 & 11. OPEN PLAY TURF AREA

Open play turf area needs repairs. Rodent and gopher holes throughout and lack of irrigation coverage.

Need rodent eradication set up on a monthly contract with exterminator company. Till and amend the soil, repair irrigation systems and re-sod and/or re-seed if it is intended for practice use. If the District determines not to have it as a practice turf area, remove turf and irrigation, install bark mulch and/or decomposed granite dependent upon the ultimate use.

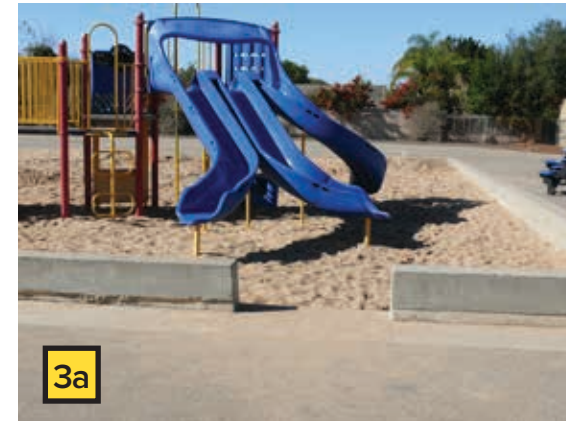
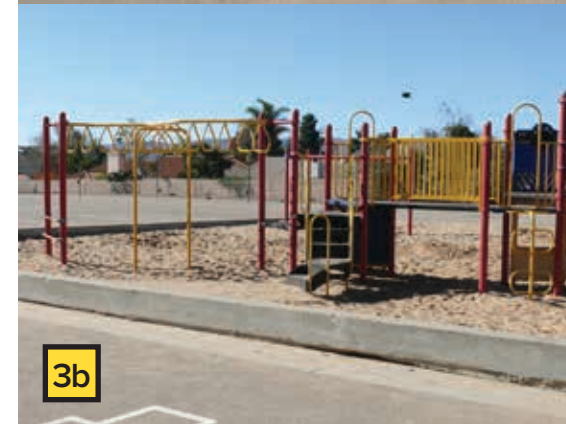
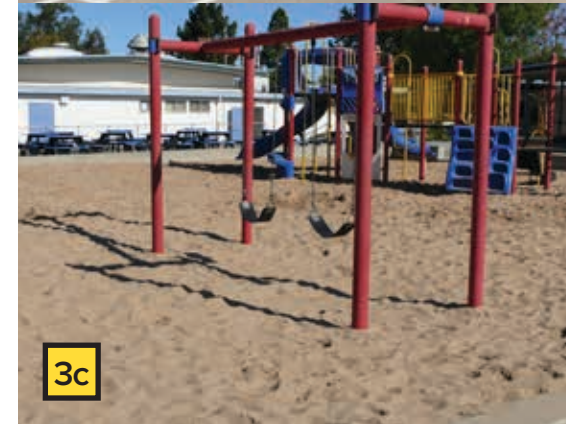
3a - 3c. PRIMARY PLAY AREA

Add rubberized fall zone material that is accessible from the entry ramp to the transfer station and to the slide areas and other equipment, or change all material to an accessible material like Fibar etc. Till, amend repair irrigation systems and re-sod and or re-seed. Install accessible gate hardware on all gates and install new concrete at all entries to meet code.

Add rubberized fall zone material that is accessible from the entry ramp to the transfer station and to the slide areas and other equipment, or change all material to an accessible material like Fibar or another comparable material.

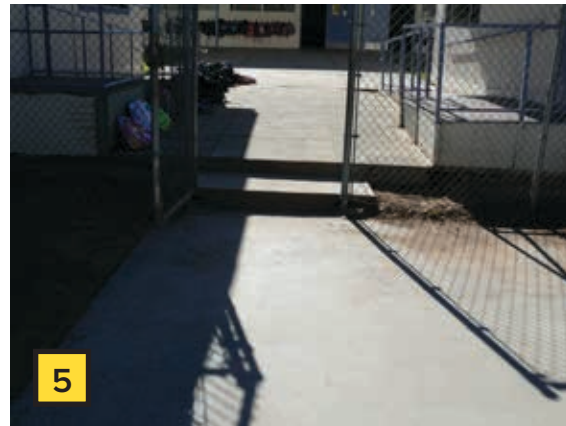
5. KINDERGARTEN PLAY AREA

Existing Condition:

Recommendation:

Remove step and install a correct landing at the gate and move step further away from the proposed landing per code. Install accessible hardware on the gate.

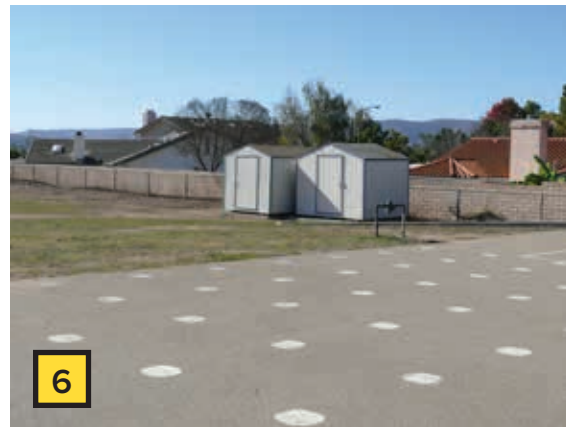
6. OPEN TURF PLAY AREA

Existing Condition:

Open play turf area needs repairs. Rodent and gopher holes through out and lack of irrigation coverage.

Recommendation:

Need rodent eradication set up on a monthly contract with exterminator company. Till and amend the soil, repair irrigation systems and re-sod and/or re-seed if it is intended for practice use.

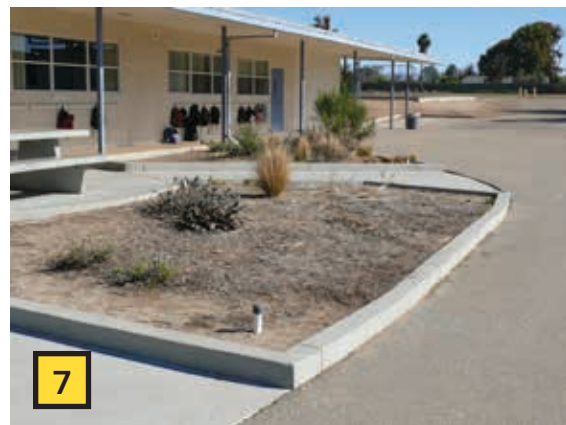
7. PLANTERS SOUTH OF BUILDING

Existing Condition:

Recommendation:

Till and amend the soil, add native and or drought tolerant plant material with a maximum height of 12" to 24" and drip style irrigation. Include at least two trees for shading of the hardscape.

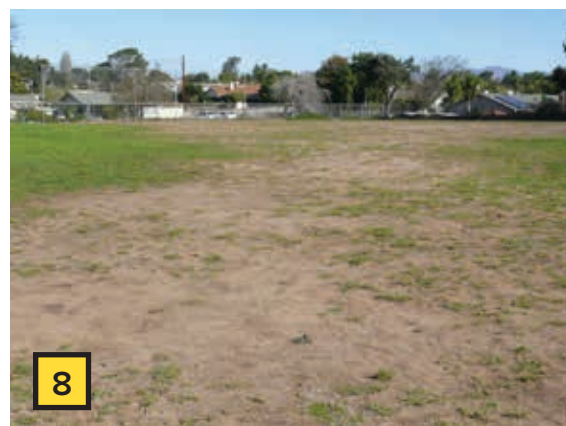
8. OPEN TURF PLAY AREA

Existing Condition:

Open play turf area needs repairs. Rodent and gopher holes through out and lack of irrigation coverage.

Recommendation:

Need rodent eradication set up on a monthly contract with exterminator company. Till and amend the soil, repair irrigation systems and re-sod and/or re-seed if it is intended for practice use.

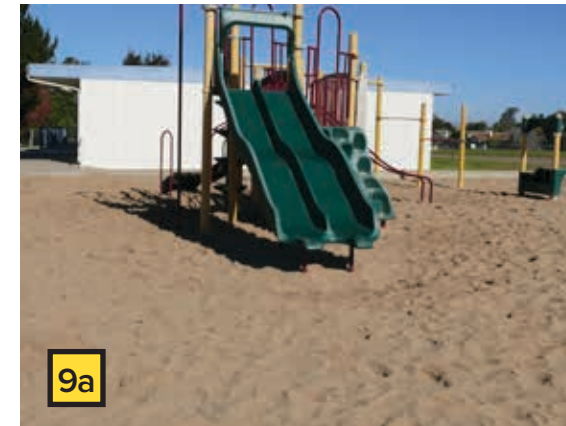
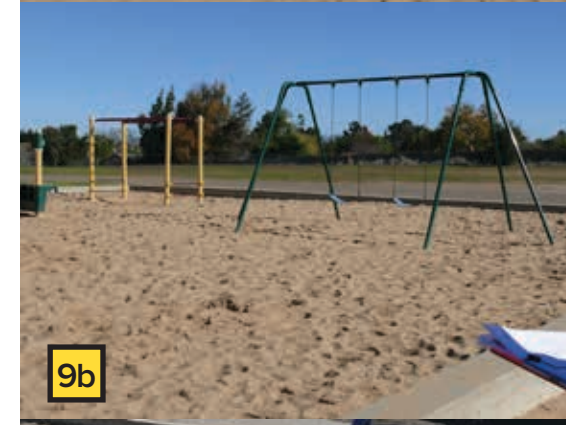
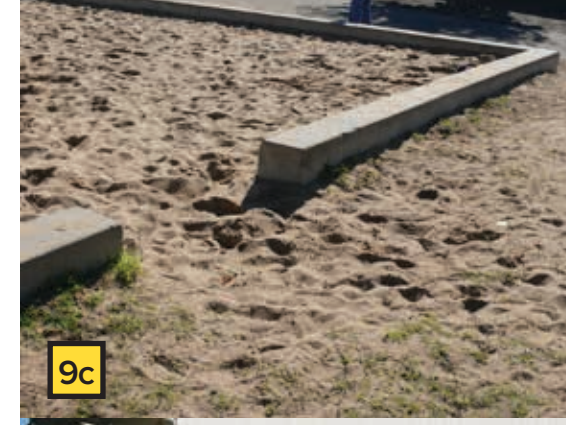
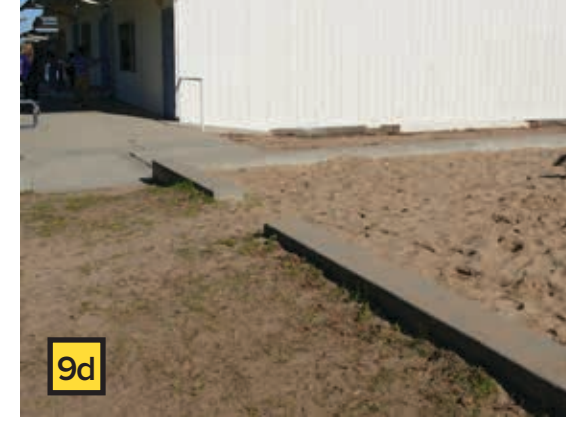
9a - 9d. PRIMARY PLAY AREA

Existing Condition:

Area is not accessible with only sand for the fall protection. There is no access to the transfer station on the play equipment and from the slides or other equipment back to the transfer station. No accessible mats under the swings and no accessible access to them. The cut in the concrete curb goes from existing turf and goes into sand and is not accessible. Photos 9a - 9d

Recommendation:

Add rubberized fall zone material that is accessible from the entry ramp to the transfer station and to the slide areas and other equipment, or change all material to an accessible material like Fibar etc. Add an accessible sidewalk from the path of travel to the play box.

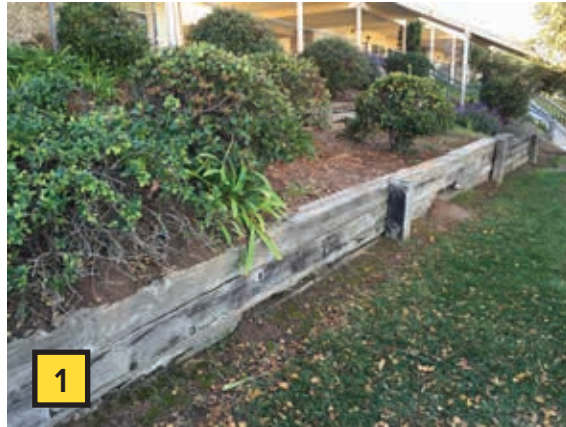
1. PLANTERS ADJACENT TO ADMINISTRATION BLDG.

Existing Condition:
 Damaged and/or dilapidated wood retaining walls.
 Plant material is adequate with existing drip irrigation.

Recommendation:
 Replace wood walls with new concrete or block walls.
 Repair existing drip systems where required.

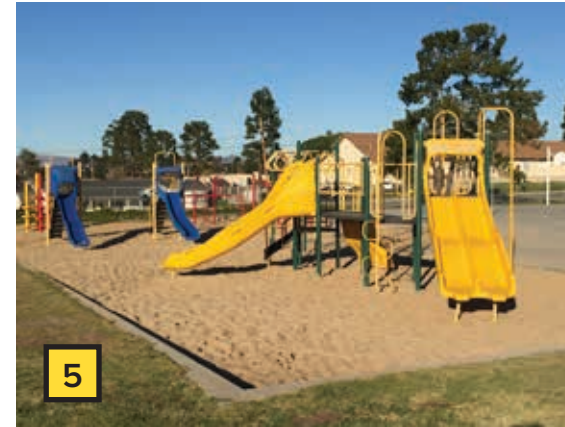
5. PRIMARY PLAY AREA ADJ. TO LOWER FIELD

Existing Condition:
 Area is not accessible with only sand for the fall protection. There is no access to the transfer station on the play equipment and from the slides or other equipment back to the transfer station.
 Fall zones are inadequate (too close to hard surfaces).

Recommendation:
 Add rubberized fall zone material that is accessible from the entry ramp to the transfer station and to the slide areas and other equipment, or change all material to an accessible material like Fibar etc. Enlarge play box to minimum fall zone dimensions.

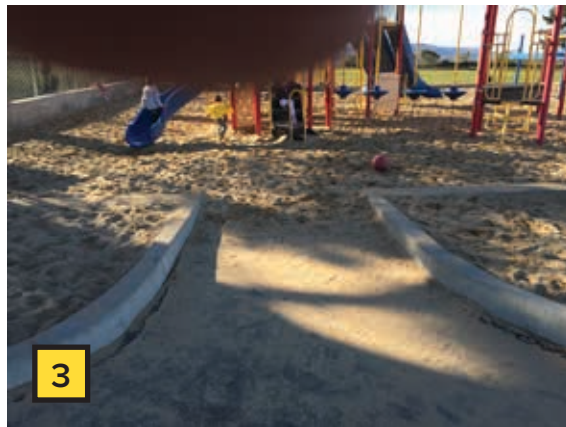
3. PRIMARY PLAY AREA ADJ. TO UPPER FIELD

Existing Condition:
 Area is not accessible with only sand for the fall protection. There is no access to the transfer station on the play equipment and from the slides or other equipment back to the transfer station.

Recommendation:
 Add rubberized fall zone material that is accessible from the entry ramp to the transfer station and to the slide areas and other equipment, or change all material to an accessible material like Fibar, etc.

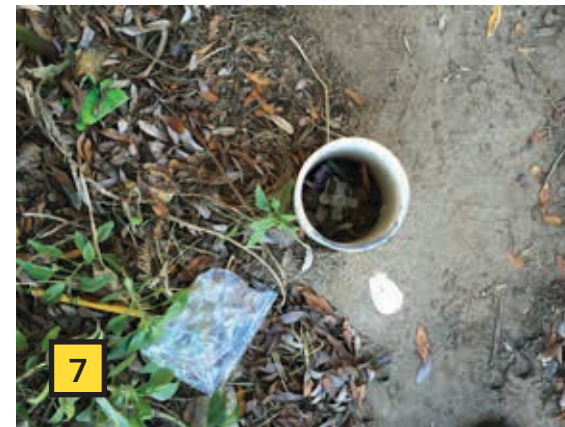
7. EXISTING IRRIGATION VALVE AT NORTH CLASSROOM

Existing Condition:
 Existing non-compliant irrigation valve (may lack proper backflow prevention).

Recommendation:
 Replace ex. valve with new electric valve with water supplied from protected irrigation system with reduced pressure device. Note no RP device was found on site at the time of inspection. Connect electric valve to existing controller and/or new central control system.

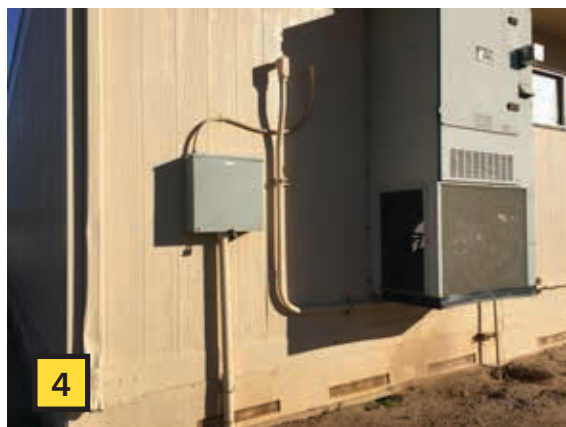
4. EXISTING IRRIGATION CONTROLLER

Existing Condition:
 Outdated irrigation controller that's not weather or moisture sensor based.

Recommendation:
 Replace with new compliant stand-alone or central control system.

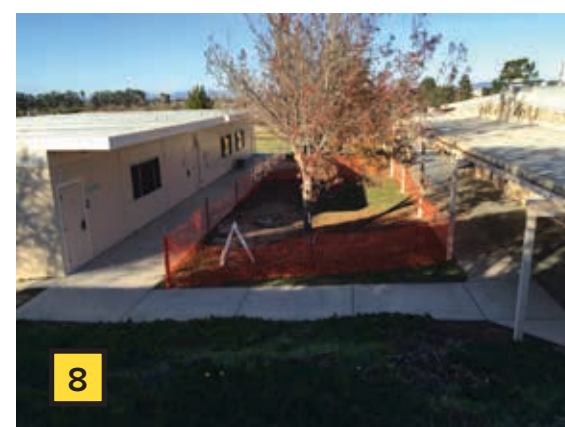
8. PLANTING AREA ADJACENT TO BLDGS. 100-110

Existing Condition:
 Damaged landscape area due in part to a drainage or sewer line repair.

Recommendation:
 Re-establish finish grade subsequent to utility repairs and replace turf with new sodded material. Verify operation of irrigation system and repair if necessary. Retain protective fencing until new turf is established.

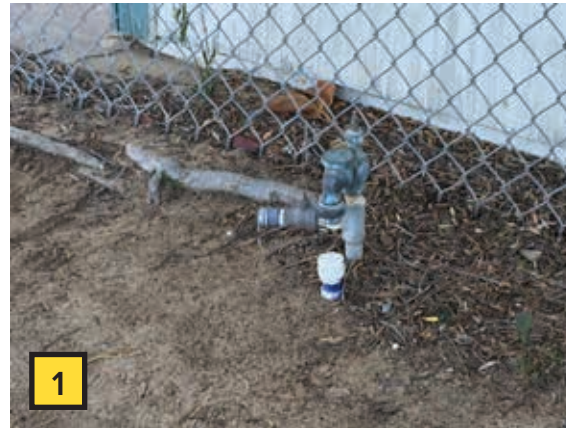
1

1. EXISTING IRRIGATION

Existing irrigation needs repair. Disconnect manual anti-siphon valves.

The campus irrigation systems has some manual anti-siphon valves that are disconnected and need upgrading. All valves should be connected to a reduced pressure type vacuum breaker and should be changed to automatic buried valves in a box connected to a centralize irrigation control system.

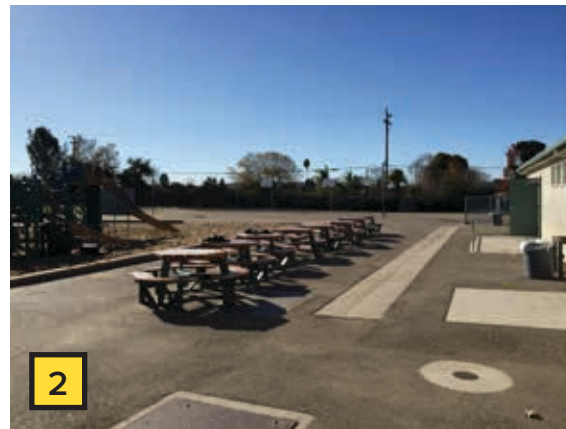
2

2. LUNCH SEATING AREA

Add canvas shade structures to the area to provide shade for the entire table areas. Make sure to provide shade cover and seating areas for accessible seating as well.

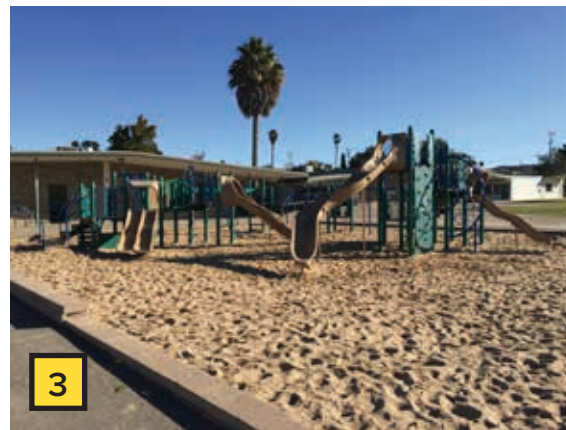
3

3. PRIMARY PLAY AREA #1

Add rubberized fall zone material that is accessible from the entry ramp to the transfer station and to the slide areas and other equipment, or change all material to an accessible material like Fibar etc.

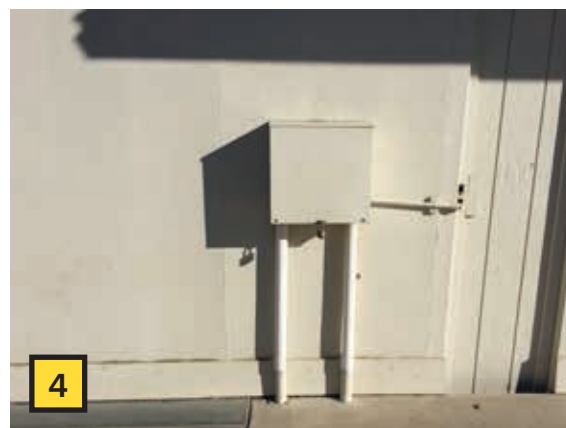
4

4. EXISTING IRRIGATION CONTROLLER

Outdated irrigation controller that's not weather or moisture sensor based.

Replace with compliant stand-alone or central control system.

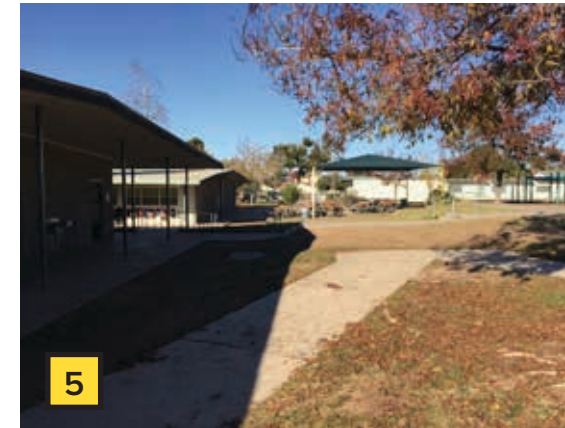
5

5. PLANTER AREA

Till and amend the soil, add native and or drought tolerant plant material with drip irrigation.

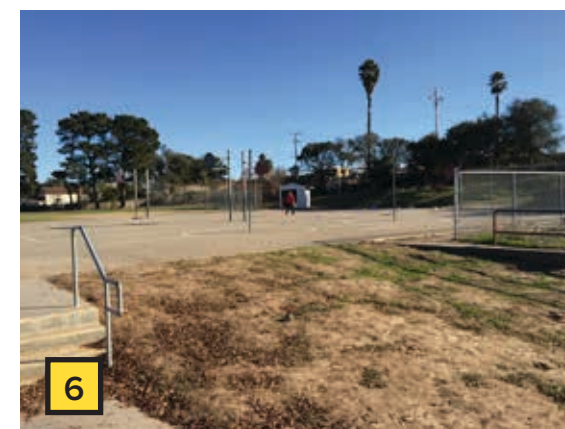
6

6. PLANTER AREA

Till and amend the soil, add native and or drought tolerant plant material with drip irrigation.

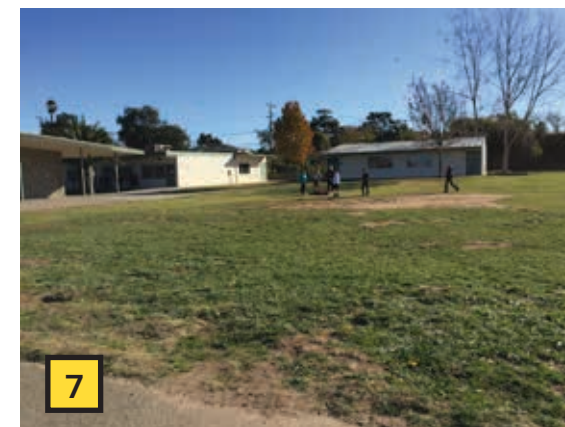
7

7. OPEN TURF PLAY AREA

Open play turf area needs repairs. Rodent and gopher holes through out and lack of irrigation coverage.

Need rodent eradication set up on a monthly contract with exterminator company. Till and amend the soil, repair irrigation systems and re-sod and/or re-seed if it is intended for practice use.

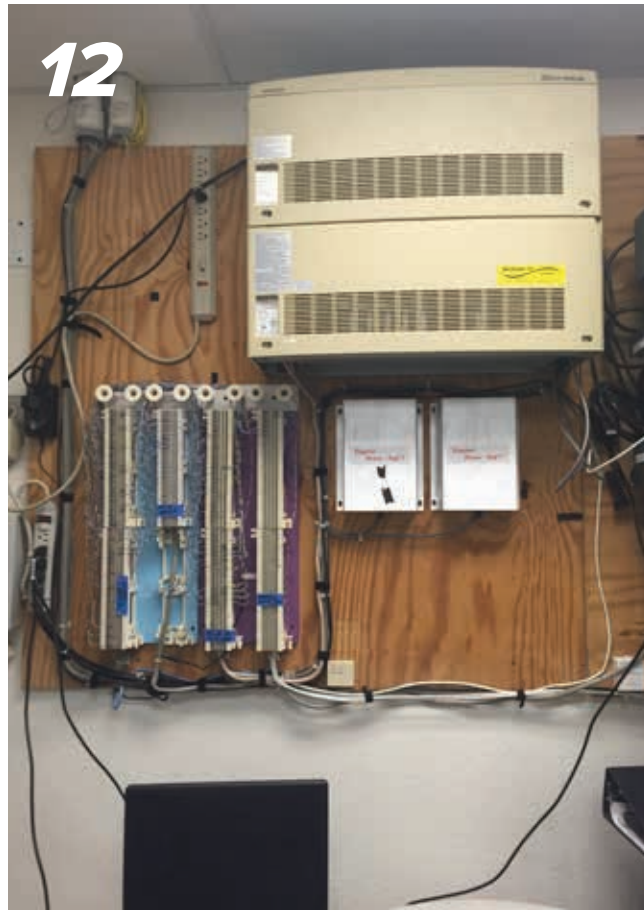
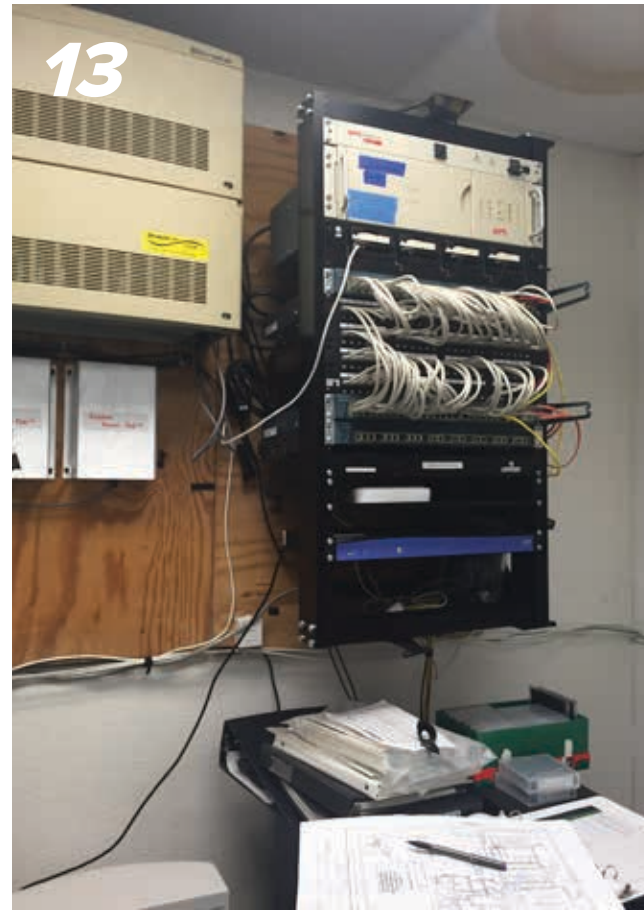
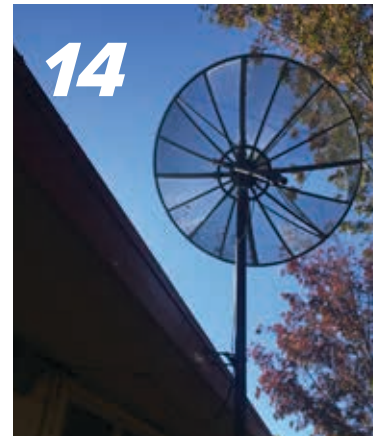
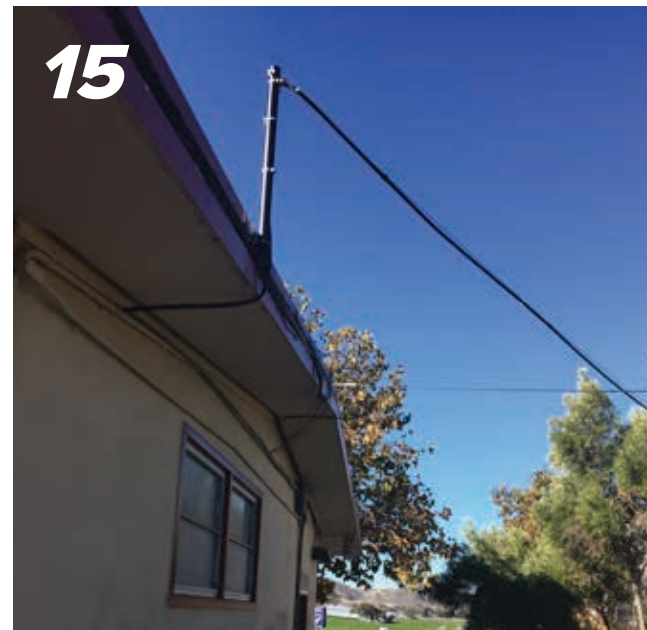
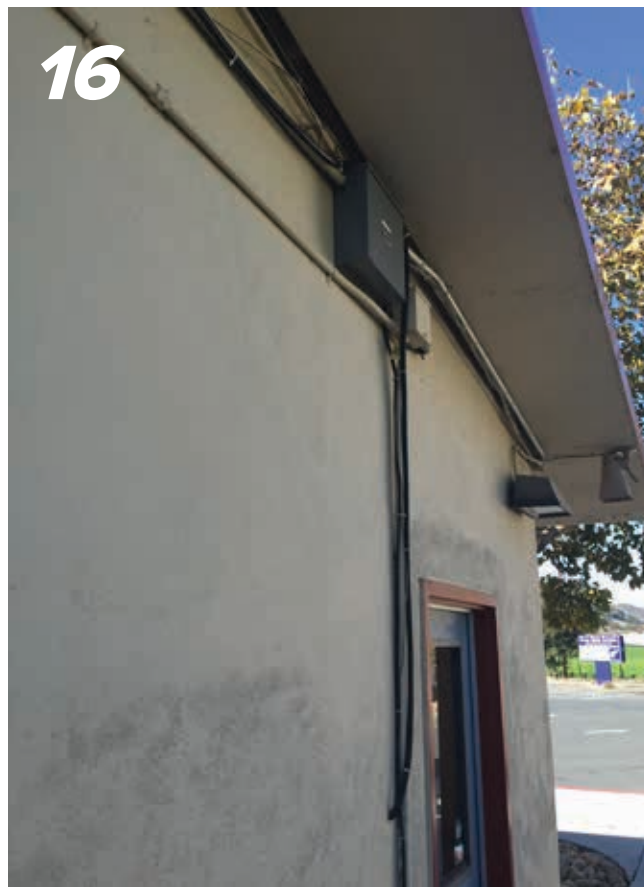
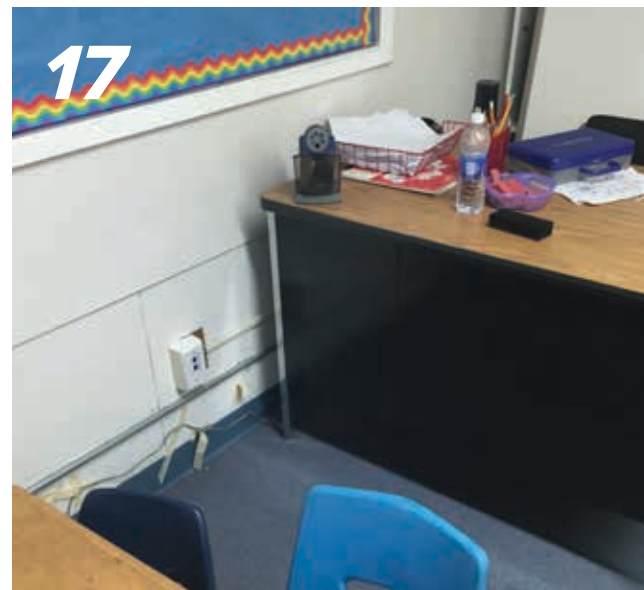
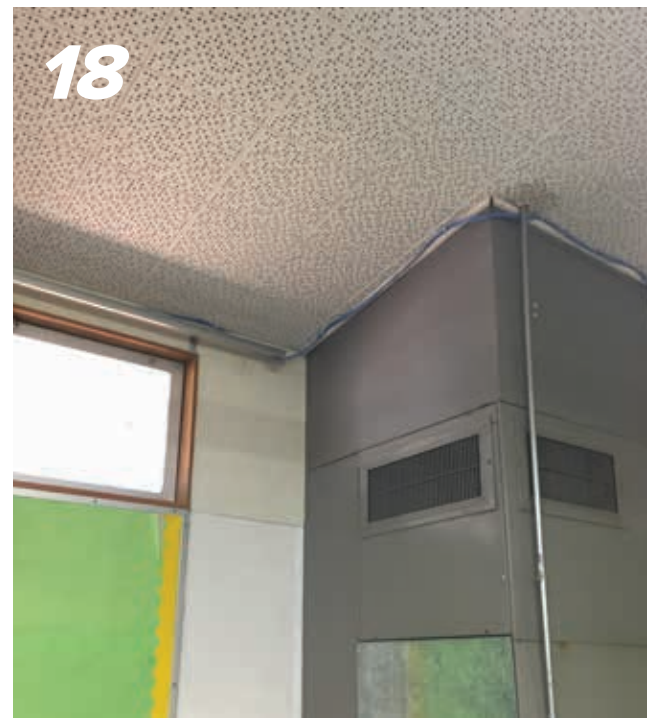
FIGURES

01	Main Switchboard
02	Main Switchboard
03	Typical Panel
04	Typical Panel
05	FTypical Classroom – Exposed Conduit
06	Typical Lighting
07	Exterior Lighting
08	Exterior Lighting
09	Existing Site Lighting
10	Typical Classroom TV
11	PA Speaker
12	Phone Headend Equipment
13	MDF Rack
14	Television System Antenna
15	Overhead Low Voltage Cabling
16	Exposed Exterior Low Voltage Cabling
17	Exposed Cabling
18	Exposed Cabling
