ORCUTT UNION SCHOOL DISTRICT SITE ASSESSMENT & MASTER PLAN

SVA ARCHITECTS, INC.

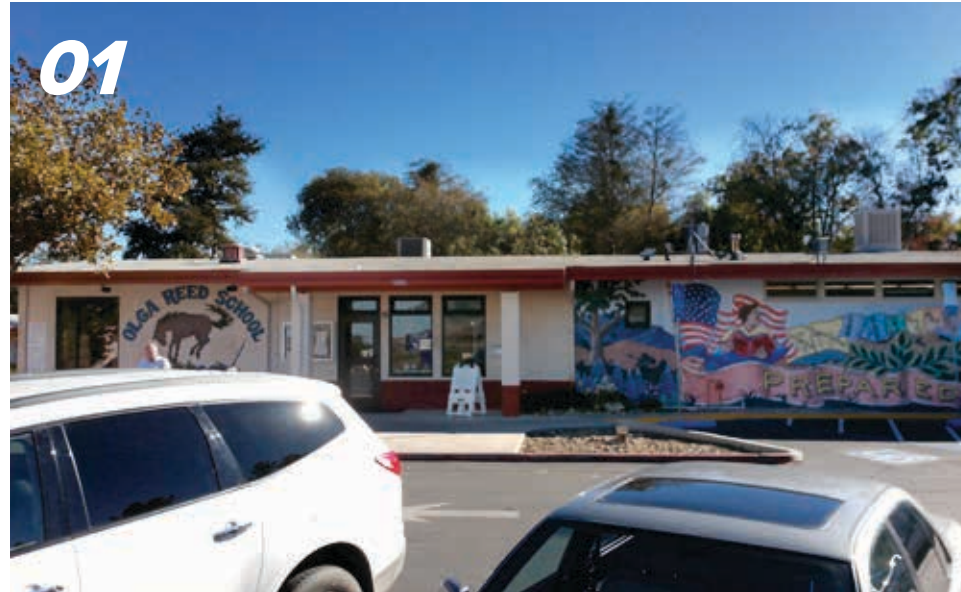
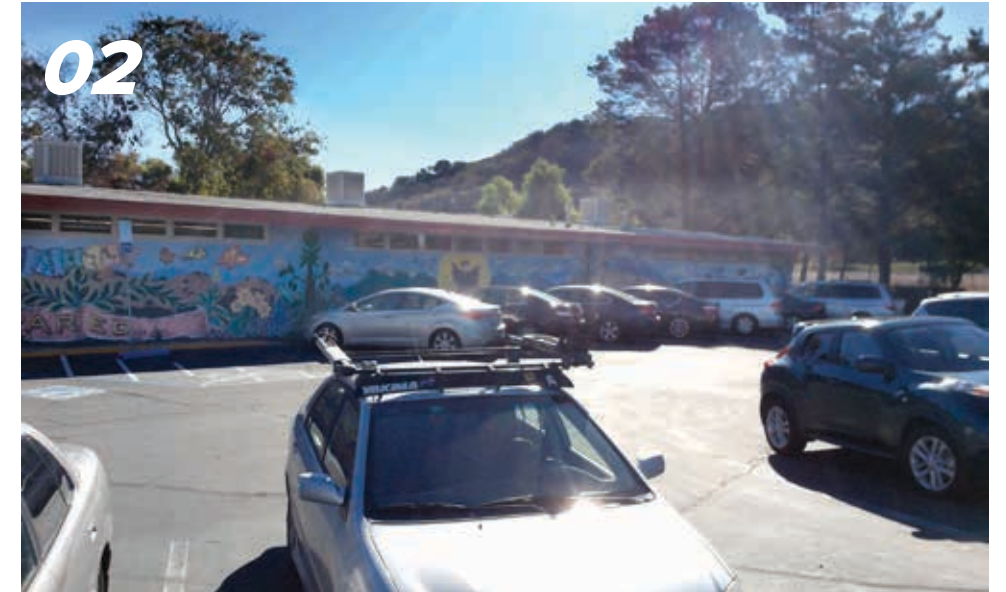
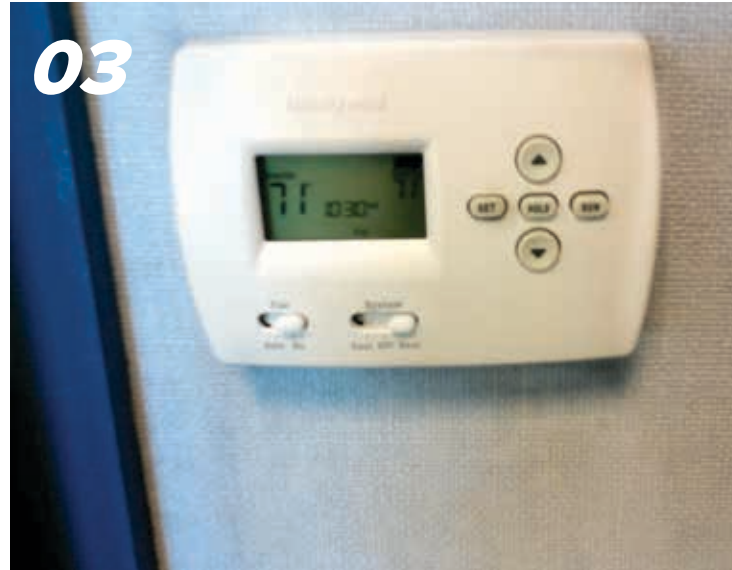
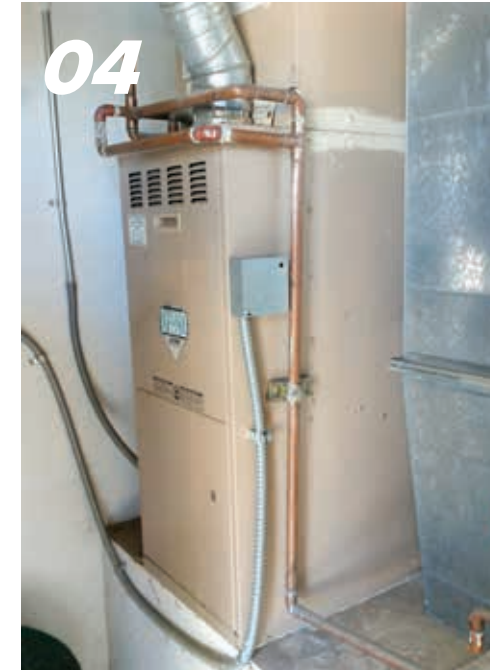
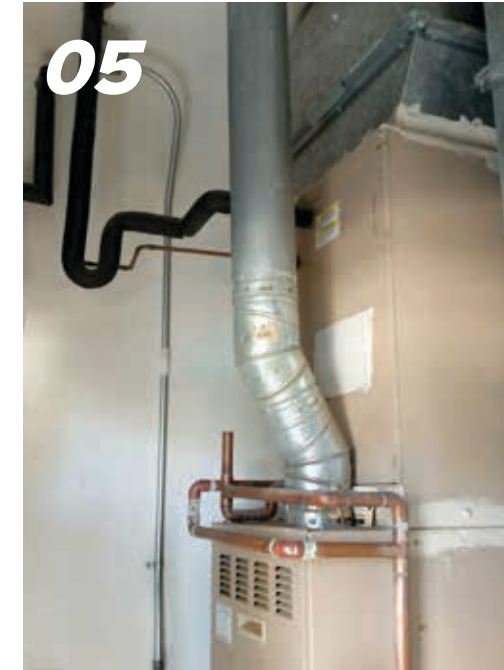
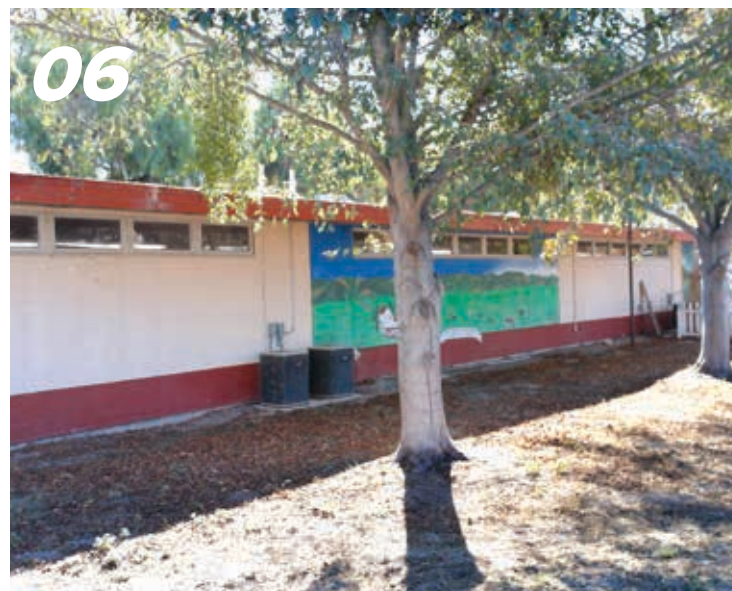
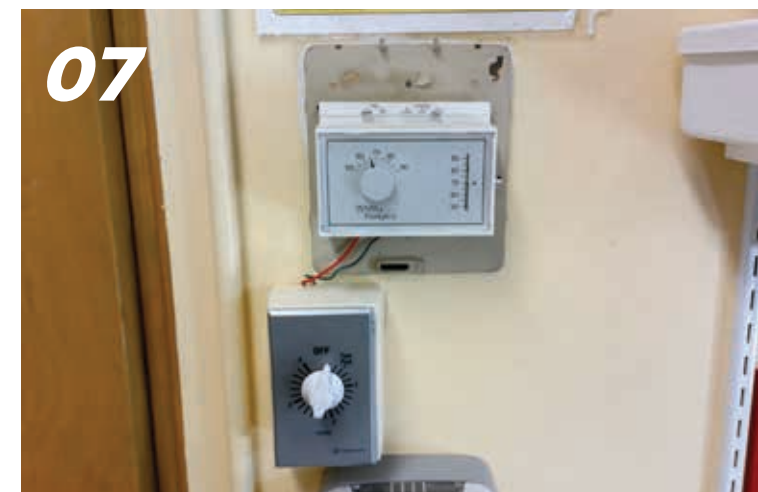
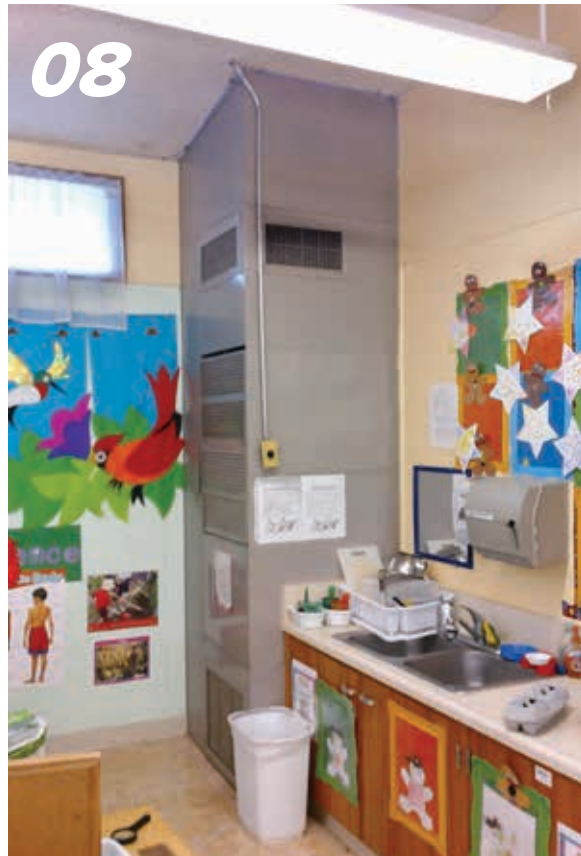
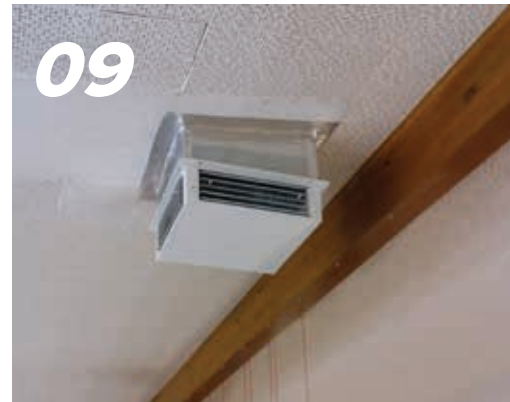
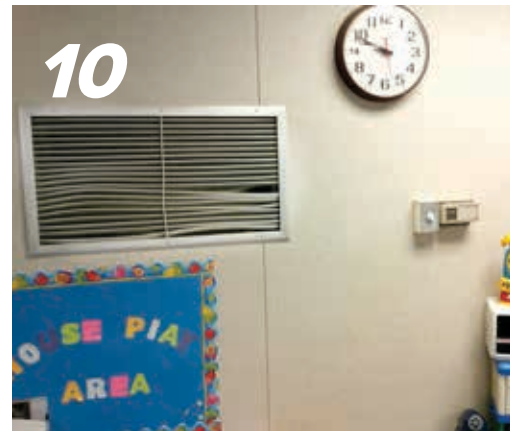
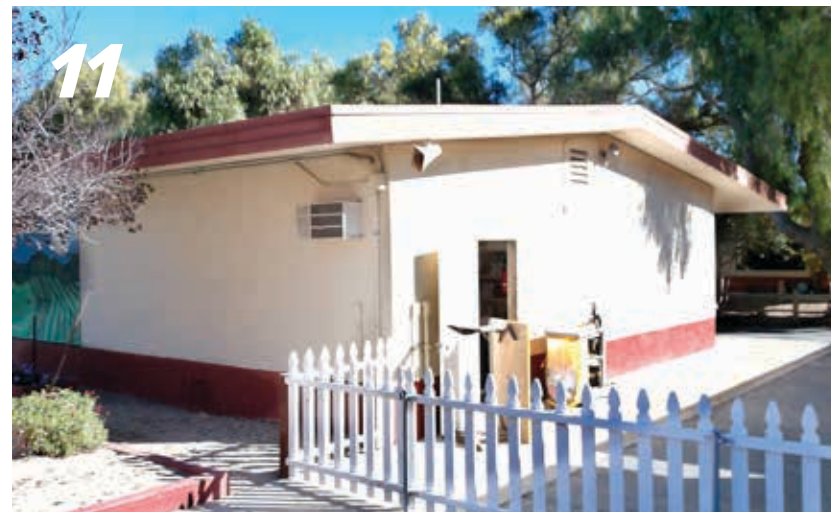
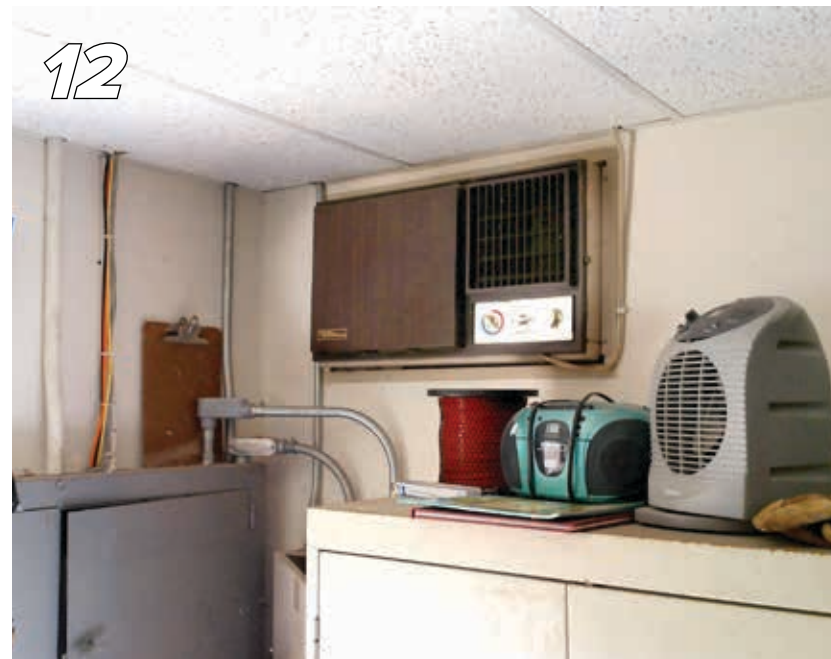
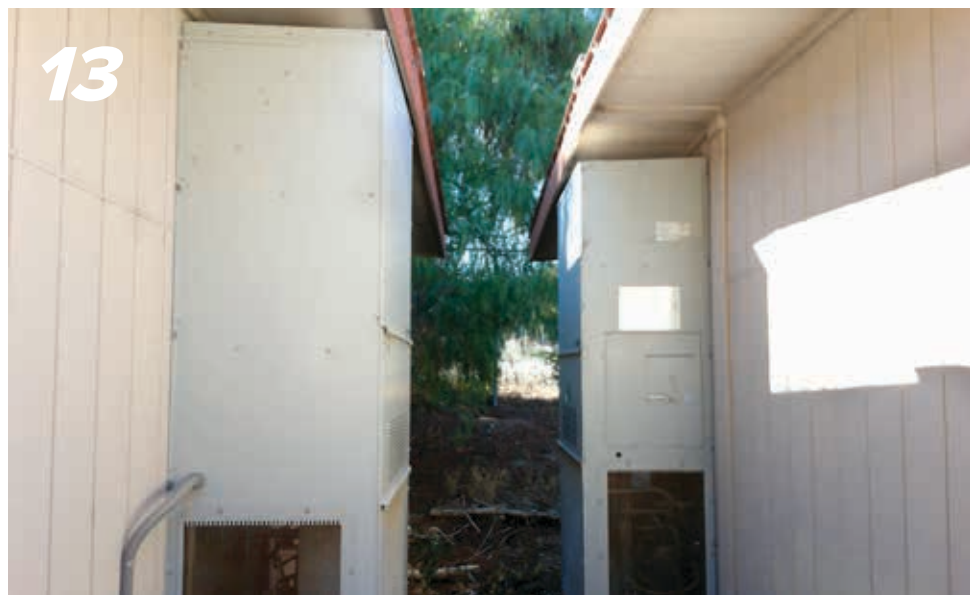
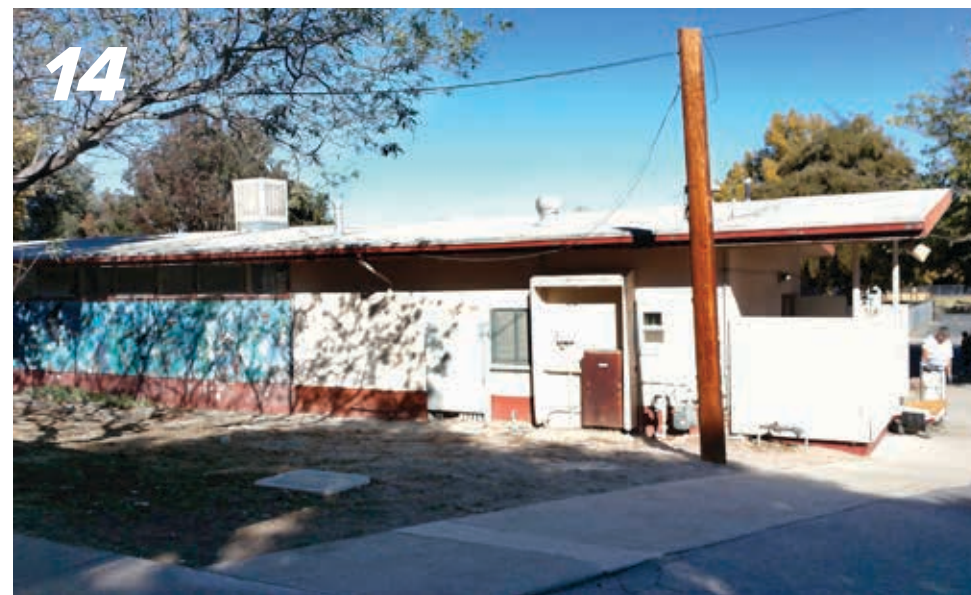
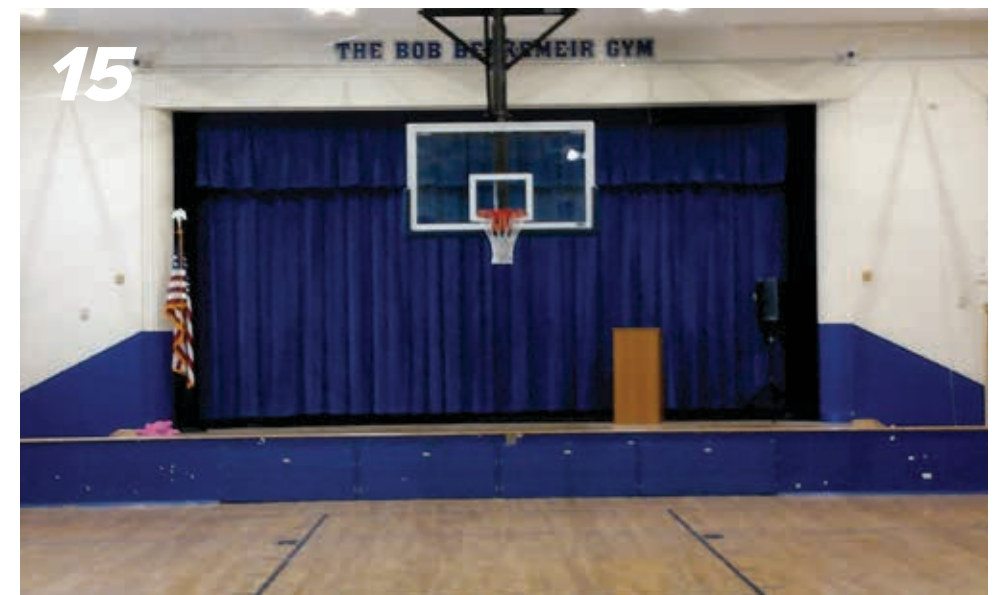
FIGURES

01	Admin Bldg with Evaporative Coolers
02	Admin Bldg with Evaporative Coolers
03	t-stat
04	Furnace
05	Furnance Flue
06	Condensing Units on Grade
07	T-Stat with 2-Hr Timer
08	Classroom AC Unit
09	Classroom Ductwork and Diffuser
10	Modular Classroom AC Unit Grille and T-Stat
11	Janitor Room with Wall Mount AC Unit
12	Janitor Room with Wall Mount AC Unit
13	Modular Building AC Units
14	Classroom Building with Evaporative Cooler
15	Gym with Wall Mount Grilles at State Area

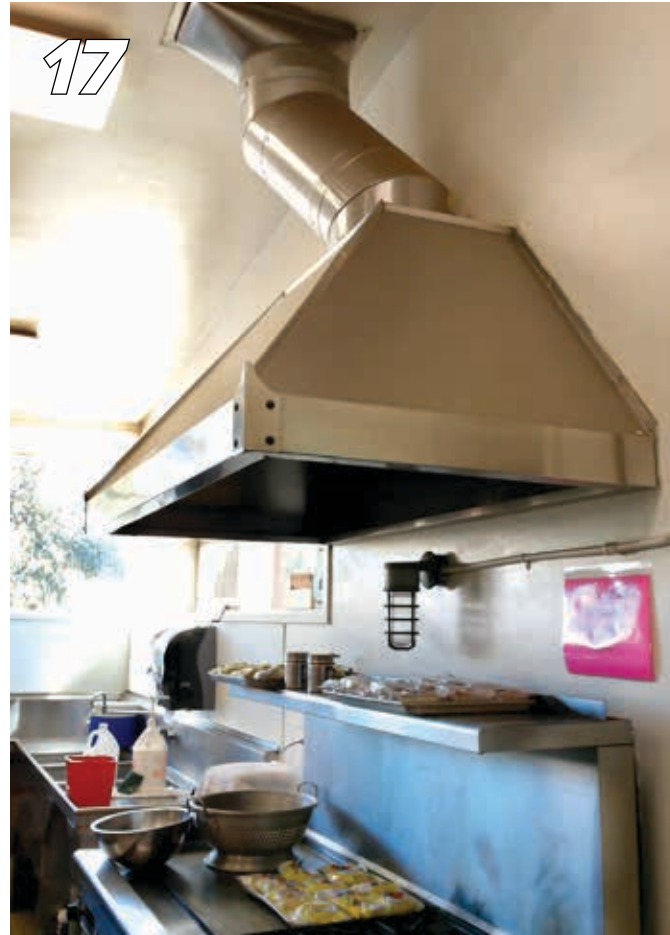
FIGURES	
16	T-Stat
17	Kitchen Hood
18	Furnance and Water Heater
19	Furnace and Ductwork
20	Split System Condensing Units
21	Rooftop Package Unit
22	Rooftop Package Unit
23	Rooftop Package Unit
24	Rooftop Package Unit (Condensate Pipe)
25	Condensing Units on grade
26	Classroom AC unit
27	t-stat
28	classroom bldg. evaporative cooler
29	modular classroom
30	t-stat

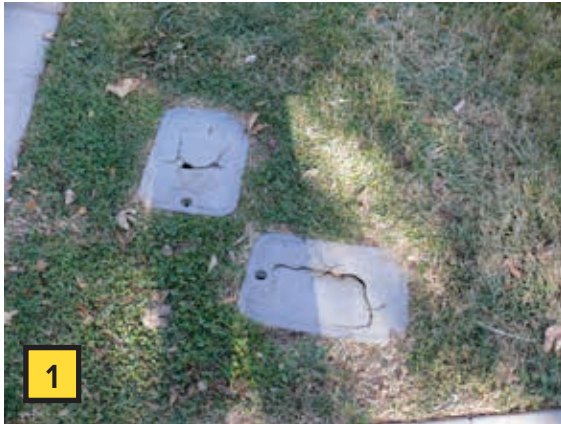
1. PLANTER AREA

Existing Condition:
Broken valve boxes in the walking area create walking hazards.

Recommendation:
Replace valve box lids and brand the numbers in the top associated with the correct valve numbers on the irrigation controllers.

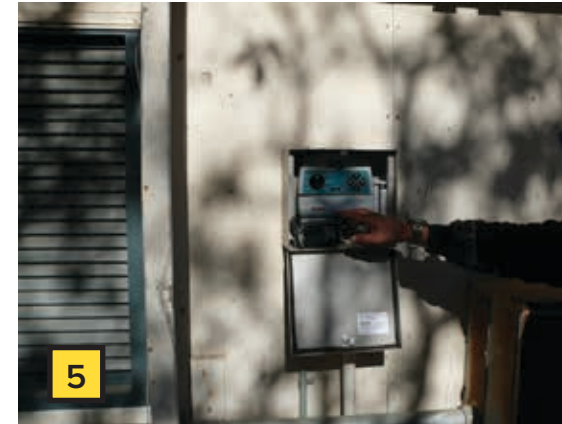
5. EXISTING IRRIGATION CONTROLLER

Existing Condition:
Outdated irrigation controller that's not weather or moisture sensor based.

Recommendation:
Replace with compliant stand-alone or central control system.

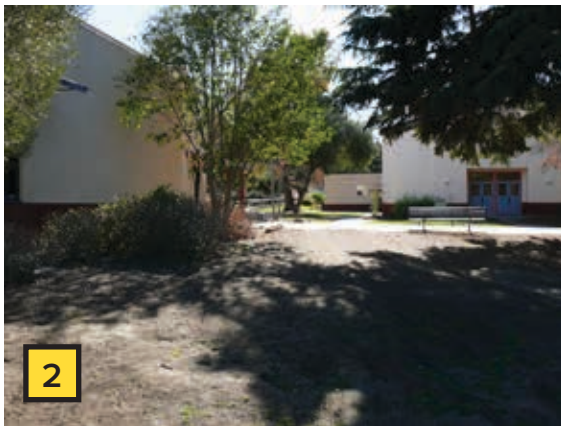
2. PLANTER AREA

Existing Condition:
The landscape area was let die do to water restrictions and this is an access area to the lower track and field.

Recommendation:
Install decomposed granite pathway between the two hardscape areas for access to the lower play fields. Install low growing drought tolerant planting on drip irrigation adjacent to the pathway.

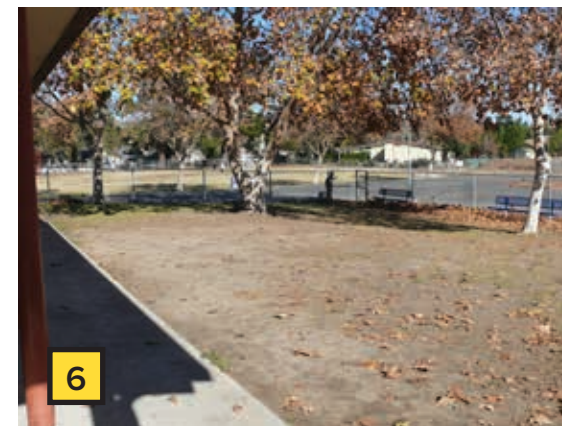
6. TURF USE AREA

Existing Condition:
Turf is heavily compacted and in need of repair. High volume foot traffic through the turf and seating areas.

Recommendation:
Need rodent eradication set up on a monthly contract with exterminator company. Till and amend the soil, repair irrigation systems and re-sod and or re-seed entire area. Determine circulation routes in and around the turf area and install pathways to benches and highly-concentrated student gathering areas.

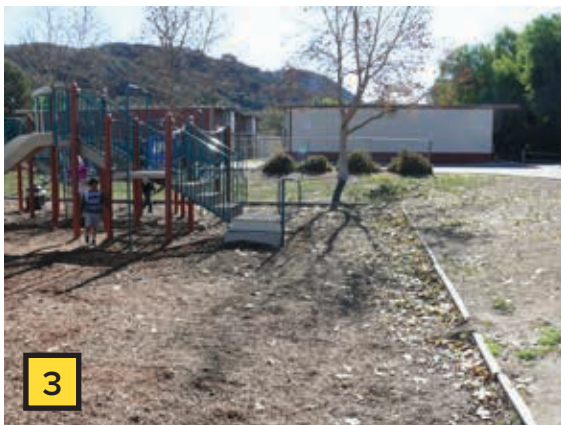
3. PRIMARY PLAY AREA

Existing Condition:
Existing primary play area has no accessible access to the equipment. Does appear to be compacted firbar and or just wood chips.

Recommendation:
Check depth of fall protection material should be a minimum of 12" deep, verify material is considered accessible. Change out material to Fibar and/or rubberized material.

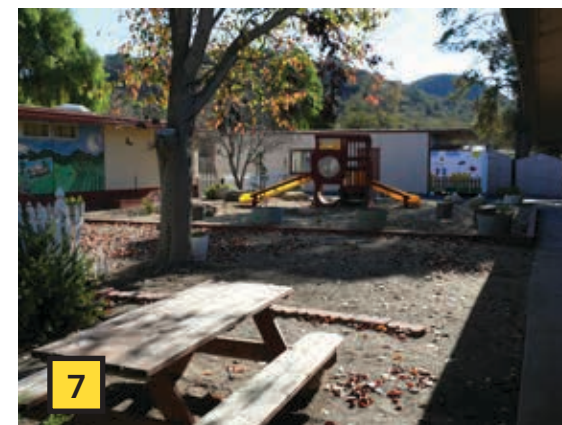
7. STUDENTS WITH SPECIAL NEEDS PLAY AREA

Existing Condition:
The play equipment area is not accessible for special needs with only sand for the fall protection. There is no access to the transfer station on the play equipment and from the slides or other equipment back to the transfer station. The cut in the concrete goes into sand and is not accessible.

Recommendation:
Add rubberized fall zone material that is accessible from the entry ramp to the transfer station and to the slide areas and other equipment, or change all material to an accessible material like Fibar etc.

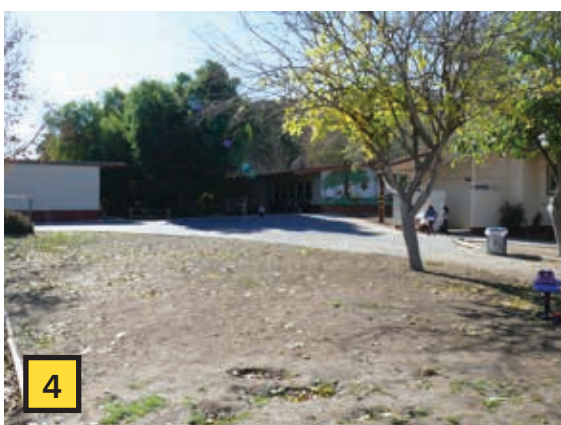
4. PLANTER AREA

Existing Condition:
No planting and or irrigation installed in planters.

Recommendation:
Till and amend the soil, add native and or drought tolerant plant material with drip irrigation.

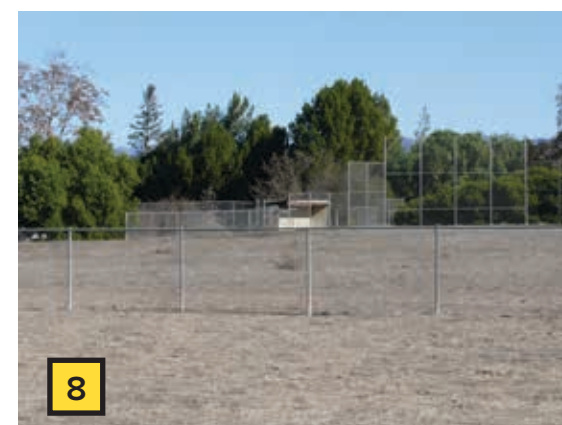
8. ATHLETIC FIELD

Existing Condition:
Existing ball field is abandoned and not in use, verify this is the adjacent park field.

Recommendation:
If the District does not intend to use any part of the ball field, fence off as not in use as there are safety concerns with rodent and gopher holes etc. remove all backstops and baseball or softball standards. If the district plans to refurbish, till amend, and install new irrigation as necessary.

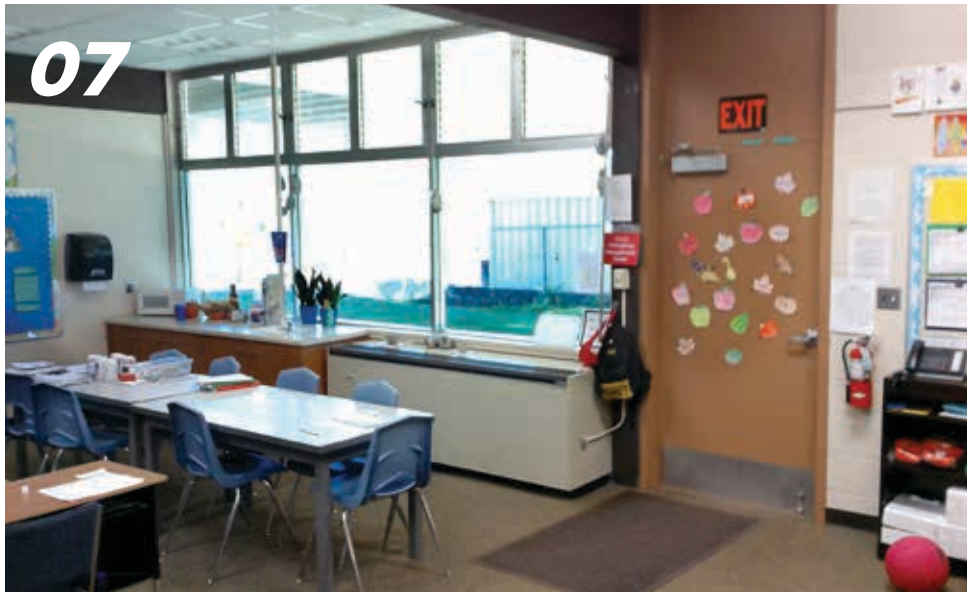
FIGURES	
01	Restroom Exhaust Fan
02	Evaporative Cooler Diffuser
03	Evaporative Cooler Control and Transfer Grille
04	Evaporative Cooler Control
05	Under Window Floor Mount Heater
06	Under Window Floor Mount Heater
07	Under Window Floor Mount Heater
08	Under Window Floor Mount Heater
09	Outside Air Grille for Wall Heater
10	Modular Bldg AC Unit
11	T-stat and 2-hr Timer
12	Evaporative Cooler

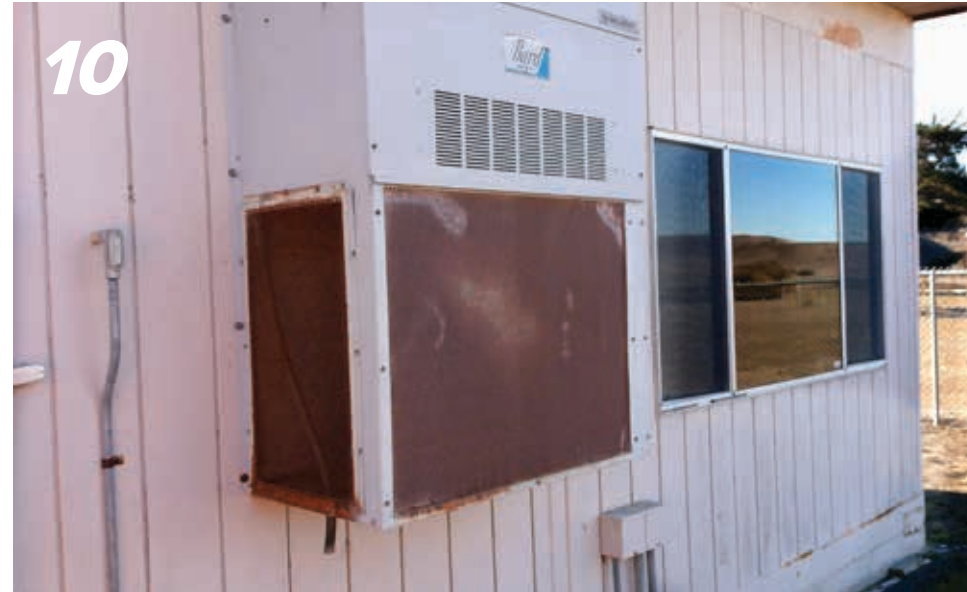
10

- The main building is served by floor mount furnace for each classroom and a shared evaporative cooler.
- The Modular building is served by an electric wall-hung unit. The unit is in fair condition
- Restrooms and miscellaneous spaces are served by exhaust fans and are generally in good condition.

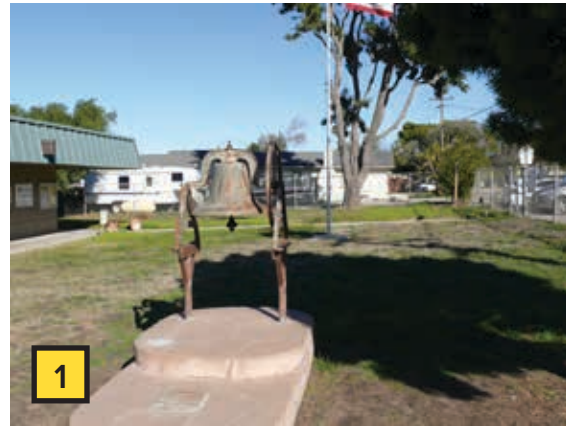
1. LANDSCAPE AREA AT FRONT OF BUILDING

Existing Condition:
Dilapidated turf area with no shrub planting. Turf appears in poor condition.

Recommendation:
Add low-water use plant material as a compliment to the existing turf. Add new drip irrigation system for shrub planting and reconfigure spray system for the turf.

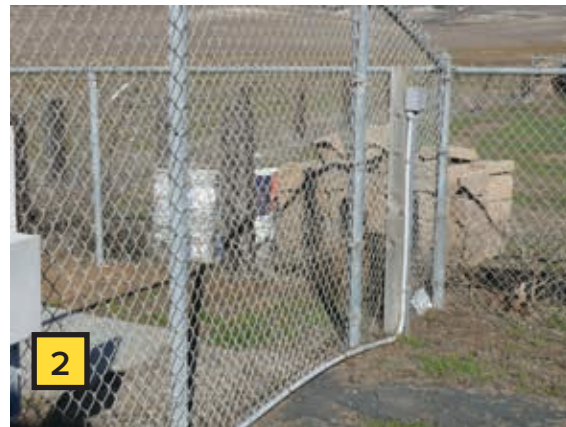
2. EXISTING IRRIGATION CONTROLLER

Existing Condition:
Outdated irrigation controller that's not weather or moisture sensor based.

Recommendation:
Replace with new compliant stand-alone or central control system.

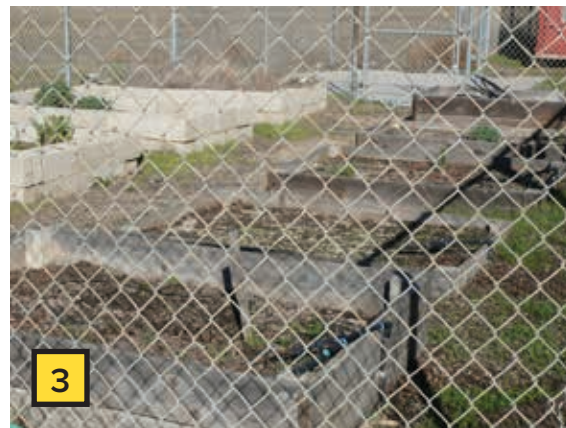
3. STUDENT GARDEN AREA

Existing Condition:
Dilapidated garden area with wood and concrete block boxes. Limited accessibility due to surface materials.

Recommendation:
Renovate with new concrete or ACQ wood boxes. Repair irrigation systems and expand if necessary to each box. Replace unpaved areas with accessible surfacing such as decomposed granite.

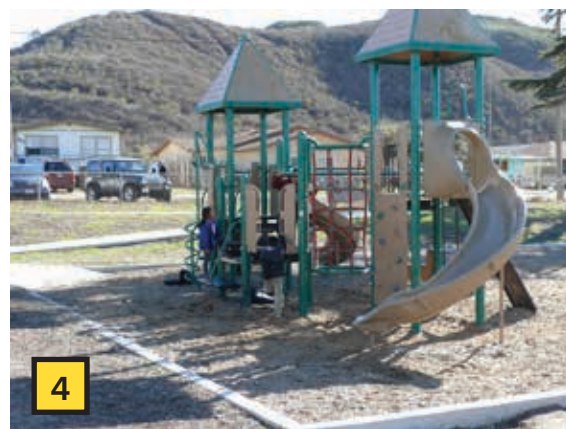
4. PRIMARY PLAY AREA

Existing Condition:
Area is not accessible with only sand for the fall protection. There is no access to the transfer station on the play equipment and from the slides or other equipment back to the transfer station.

Recommendation:
Add rubberized fall zone material that is accessible from the entry ramp to the transfer station and to the slide areas and other equipment, or change all material to an accessible material like Fibar etc.

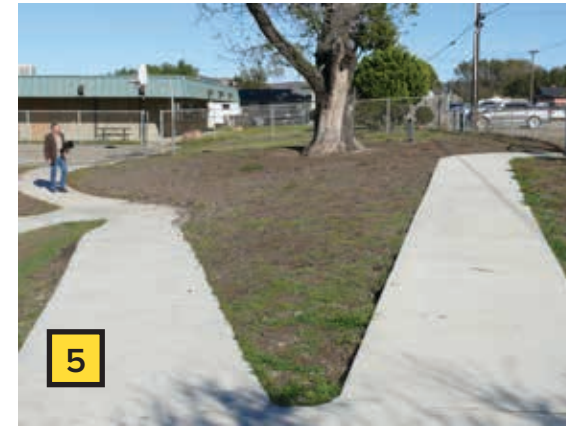
5. LANDSCAPE AREA ADJACENT TO PLAY EQUIP. AREA

Existing Condition:
No existing landscaping surrounding the switchback walkways.

Recommendation:
Install new low-water use accent planting and add new drip irrigation system.

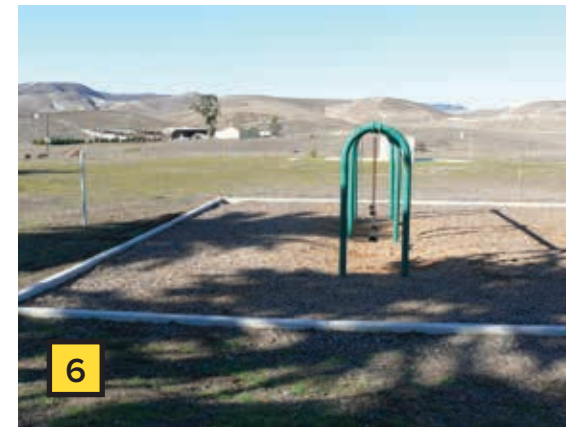
6. PRIMARY PLAY AREA - SWINGS

Existing Condition:
Area is not accessible with only sand for the fall protection.

Recommendation:
Add rubberized mats below each swing, and change all material to an accessible material like Fibar etc.

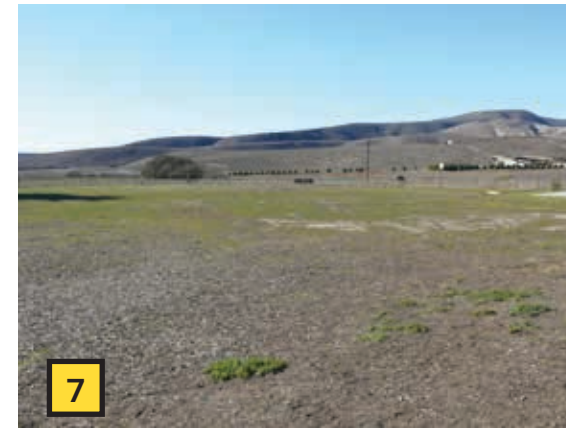
7. OPEN PLAY ATHLETIC FIELDS

Existing Condition:
Dilapidated turf, compacted soil, and irrigation coverage is lacking.

Recommendation:
Till and amend the soil, repair irrigation systems and re-sod and or re-seed the entire area.

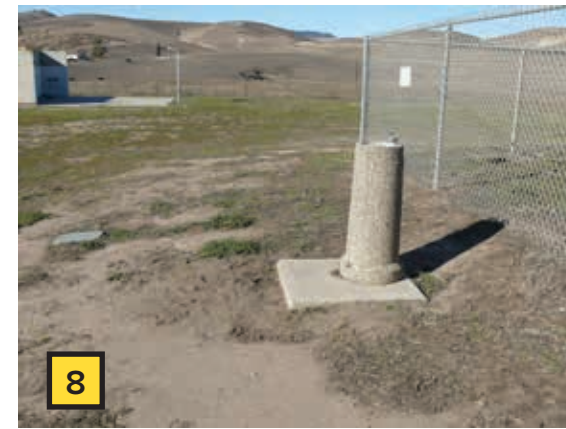
8. EXISTING DRINKING FOUNTAIN AT FIELD

Existing Condition:
Existing non-accessible drinking fountain.

Recommendation:
Replace with compliant "high-low" drinking fountain. Install accessible paving to fountain.

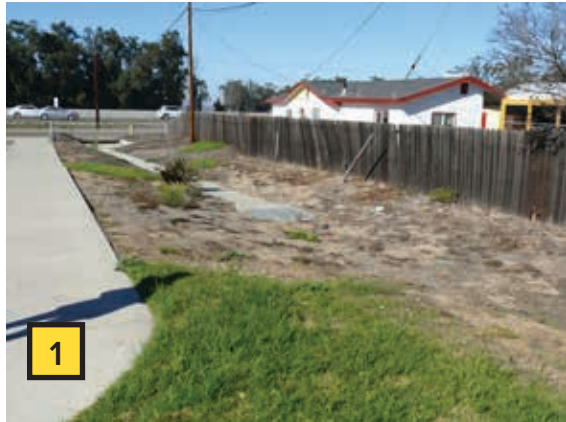
1 & 2. NORTHWEST LANDSCAPE PLANTER

Existing Condition:
No landscaping and or irrigation adjacent to drainage channel and up along the south property line.

Recommendation:
Till and amend the soil, add native and or drought tolerant plant material and drip style irrigation. Plant low ground cover with a maximum height of 12” and low water demand plant material.

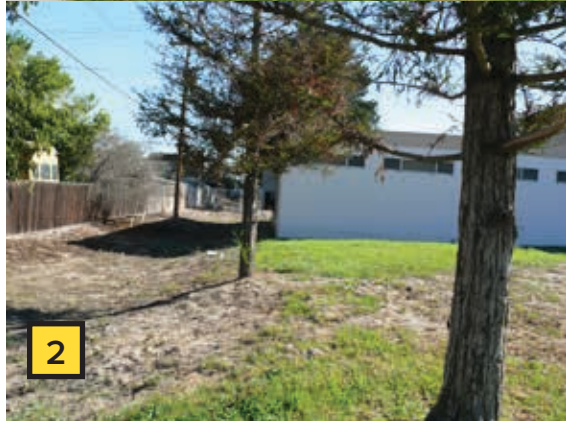
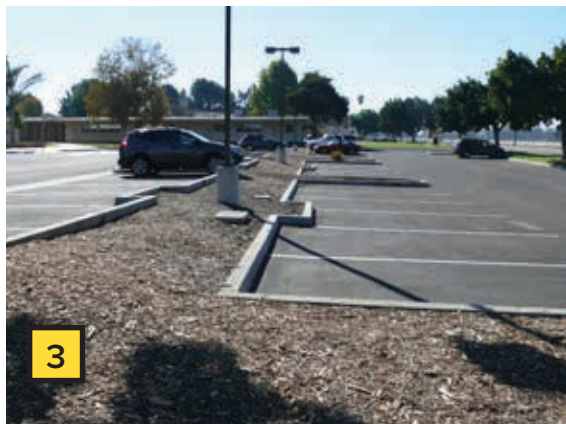
3. PARKING LOT PLANTER

Existing Condition:
Bark much in the parking islands, broken irrigation not operable.

Recommendation:
Install automatic drip system, till amend the soil and install medium-height, maximum 36” plant material.

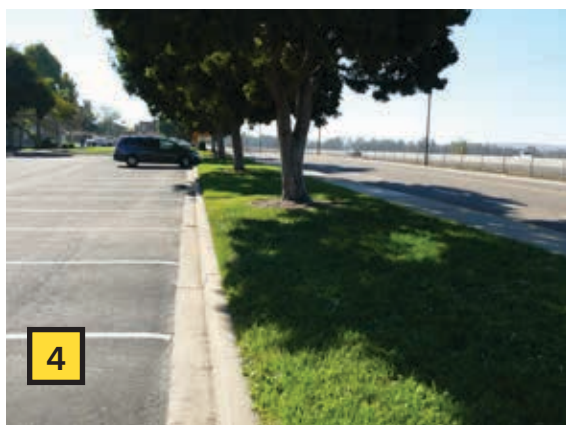
4. PLANTER ALONG ORCUTT ROAD

Existing Condition:
Existing turf areas in street parkways. Overhead spray irrigation systems are in adequate condition.

Recommendation:
Install automatic drip system, till amend the soil and plant medium height maximum 36” drought-tolerant plant material.

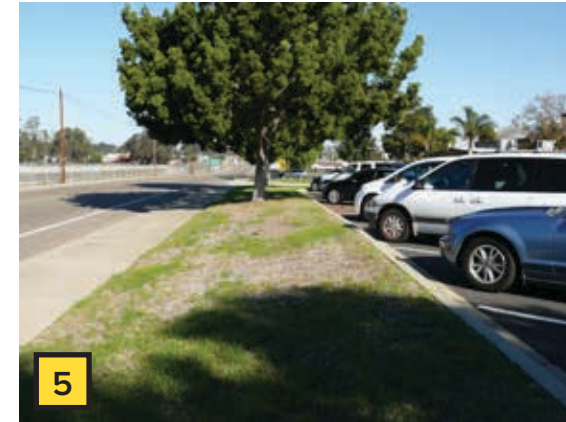
5. PLANTER ALONG ORCUTT ROAD

Existing Condition:
Existing turf areas in street parkways. Overhead spray irrigation systems are in adequate condition.

Recommendation:
Install automatic drip system, till amend the soil and plant medium height maximum 36” drought-tolerant plant material.

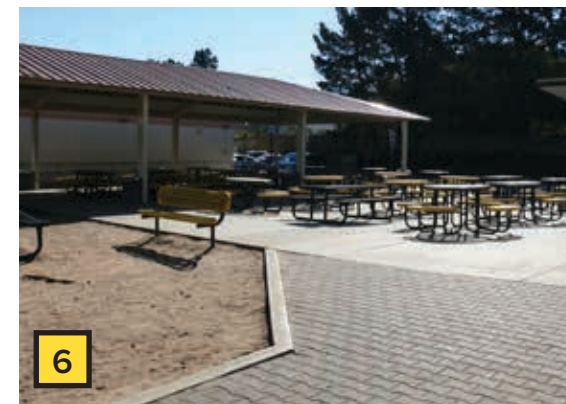
6 & 7. OUTDOOR DINING PATIO

Existing Condition:
Dirt at seating areas, erosion potential and long term maintenance problem.

Recommendation:
Install interlocking concrete pavers in the seating areas and or decomposed granite.

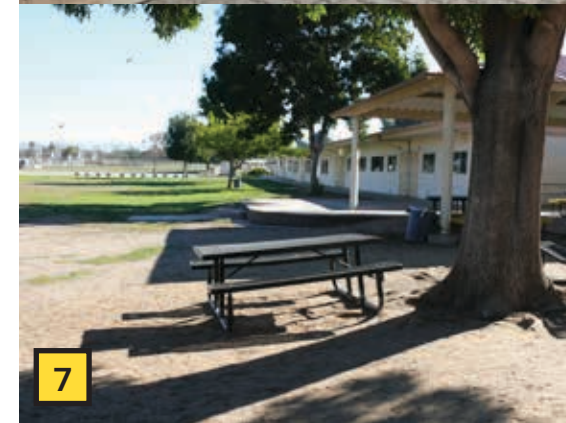
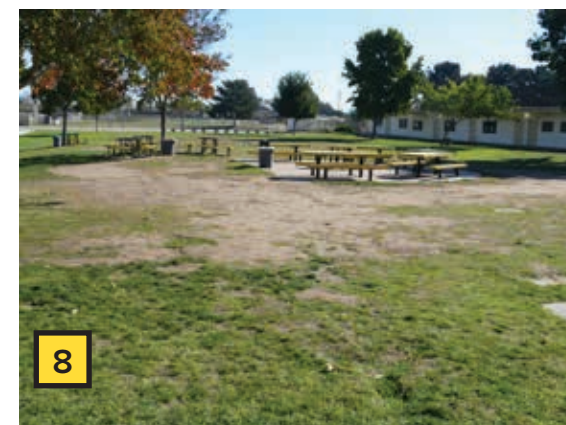
8. CAMPUS CORE TURF AREA

Existing Condition:
Campus core turf area is compacted and needs repair.

Recommendation:
Need rodent eradication set up on a monthly contract with exterminator company. Till and amend the soil, repair irrigation systems and re-sod and or re-seed entire area.

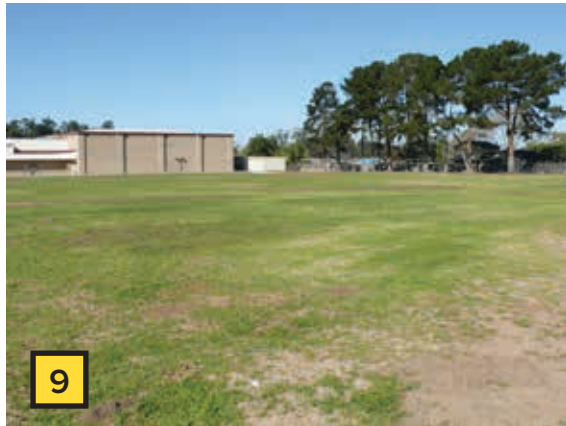
9. OPEN PLAY AND PRACTICE SPORTS TURF AREA

Existing Condition:
Severe gopher and rodent problem, compacted soil, and irrigation coverage is lacking.

Recommendation:
Need rodent eradication set up on a monthly contract with exterminator company. Till and amend the soil, repair irrigation systems and re-sod and or re-seed entire area.

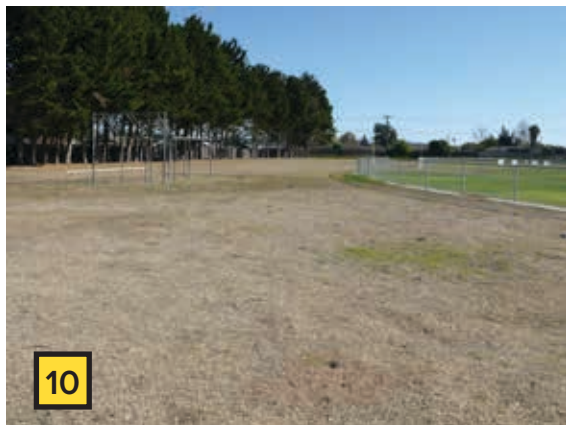
10-12. OPEN TURF ADJACENT TO SOFTBALL FIELDS

Existing Condition:
Currently not being irrigated. Severe gopher and rodent problems. No fall protection installed around exercise stations.

Recommendation:
Need rodent eradication set up on a monthly contract with exterminator company. Till and amend the soil, repair irrigation systems and re-sod and/or re-seed if it is intended for practice use. If the District determines not to have it as a practice turf area, remove turf and irrigation, install bark mulch and or decomposed granite and install fall protection under exercise stations.

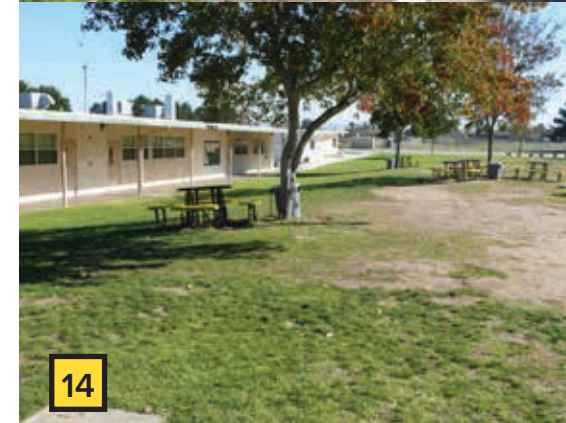
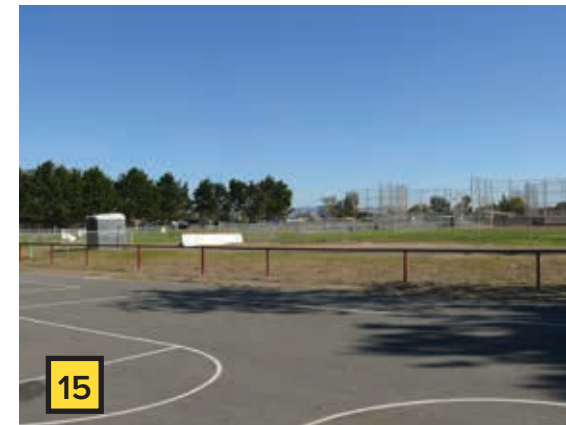
15 & 16. BASEBALL AND SOFTBALL FIELDS

Existing Condition:
Fields have gopher and rodent damage. Irrigation system and coverage appear adequate.

Recommendation:
Need rodent eradication set up on a monthly contract with exterminator company. Till and amend the soil, repair irrigation systems and re-sod and/or re-seed.

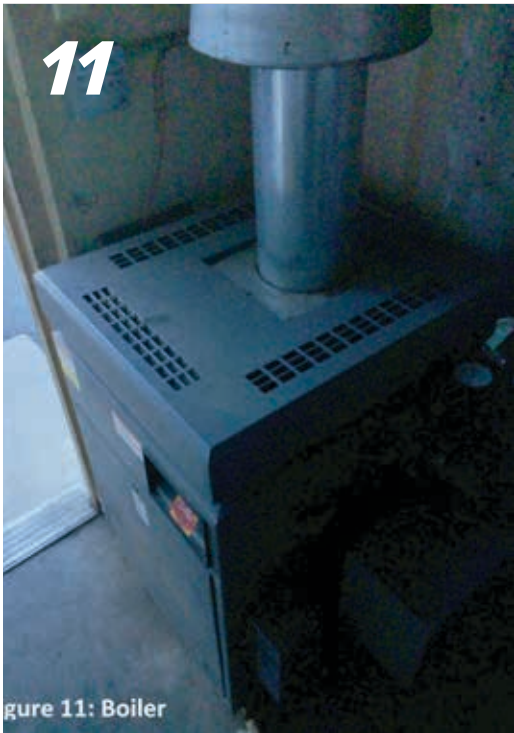
11

Figure 11: Boiler

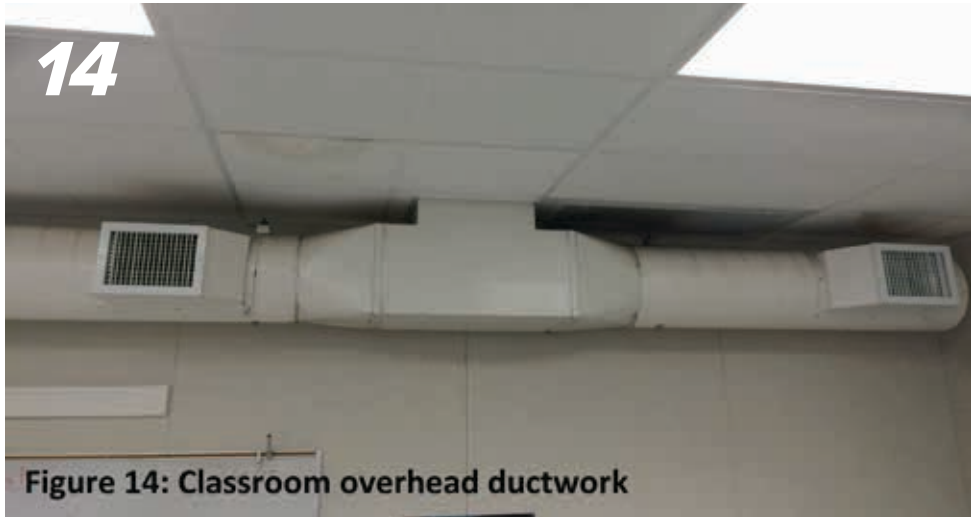
14

Figure 14: Classroom overhead ductwork

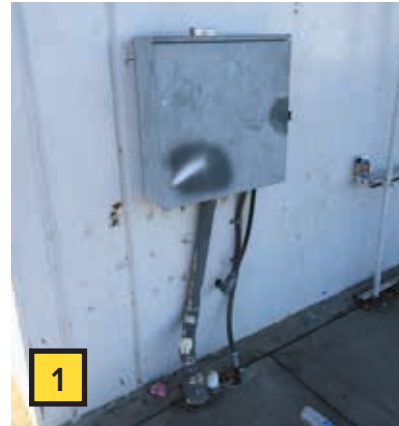
1. EXISTING IRRIGATION CONTROLLER

Existing Condition:
Outdated irrigation controller that's not weather or moisture sensor based.

Recommendation:
Replace with compliant stand-alone or central control system.

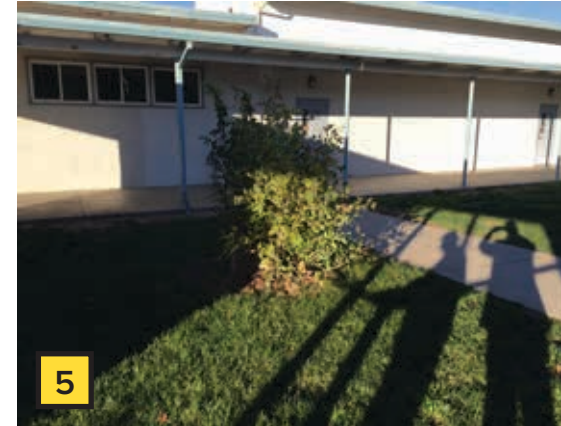
5. PLANTER BETWEEN BLDG. 10 & 20

Existing Condition:
Damaged tree.

Recommendation:
Replace with new tree and irrigate.

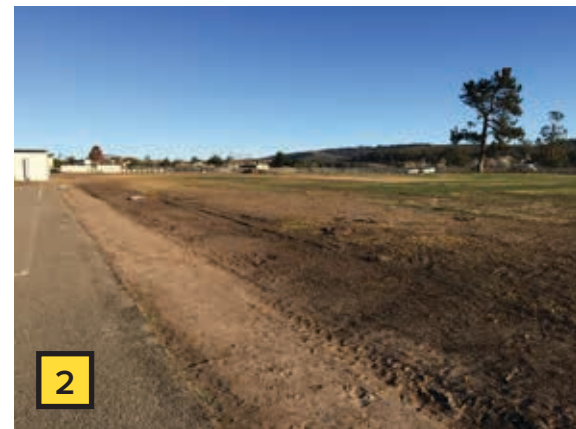
2. OPEN PLAY ATHLETIC FIELDS

Existing Condition:
Severe gopher and rodent problem, compacted soil, and irrigation coverage is lacking.

Recommendation:
Need rodent eradication set up on a monthly contract with exterminator company. Till and amend the soil, repair irrigation systems and re-sod and or re-seed entire area.

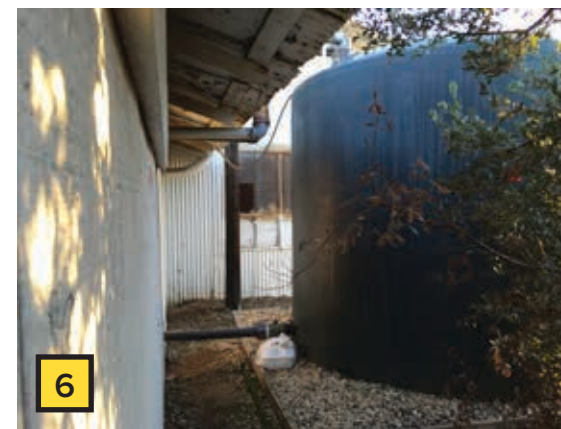
6. WELL AREA WEST OF BLDG. 70

Existing Condition:
Existing well system and tank.

Recommendation:
Verify operation with District on source (potable vs. not potable) and output (field irrigation vs. campus irrigation). Could not verify there was a reduced pressure device for field irrigation.

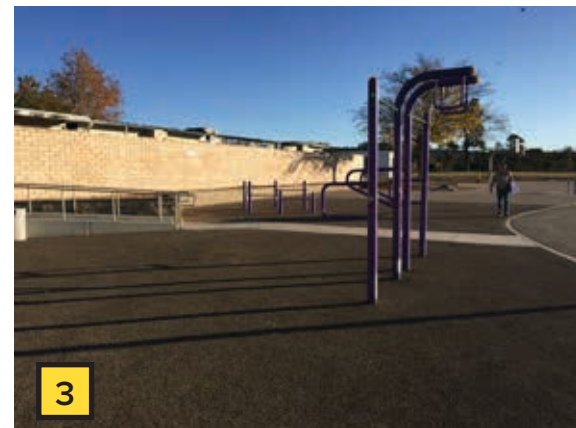
3. PLAY AREA

Existing Condition:
Play equipment fall zone too close to paving.

Recommendation:
Remove or relocate concrete path and asphalt paving outside of play equipment's fall zone.

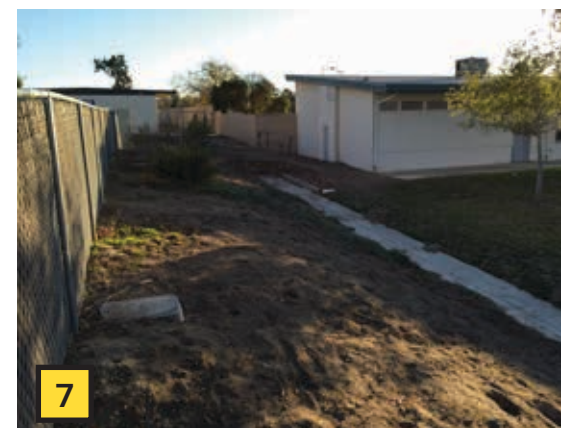
7. PLANTER AREA BETWEEN BLDG. 30 & 40

Existing Condition:
No planting and or irrigation installed in planters.

Recommendation:
Till and amend the soil, add native and or drought tolerant plant material with drip style irrigation.

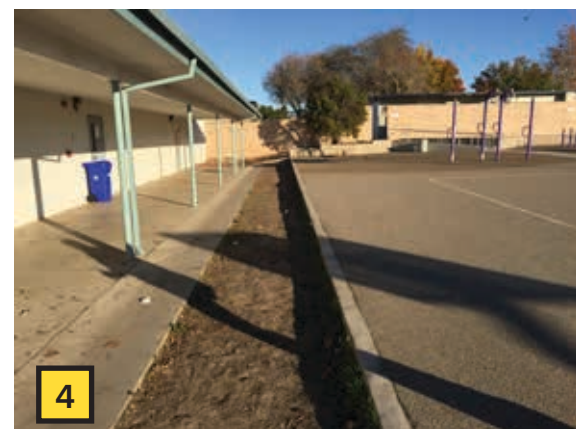
4. PLANTERS ADJACENT TO BASKETBALL COURTS

Existing Condition:
No planting and or irrigation installed in planters.

Recommendation:
Till and amend the soil, add native and or drought tolerant plant material with a maximum height of 12" to 24" with drip irrigation.

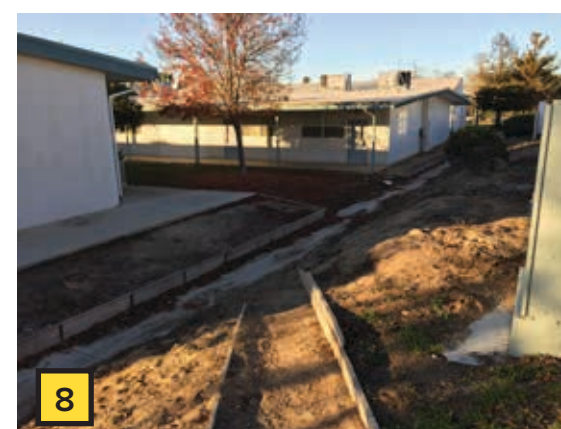
8. PLANTER AREA BETWEEN BLDG. 30 & 40

Existing Condition:
Non-accessible / hazardous pathway.

Recommendation:
Remove and replace with ADA accessible pathway/ramp.

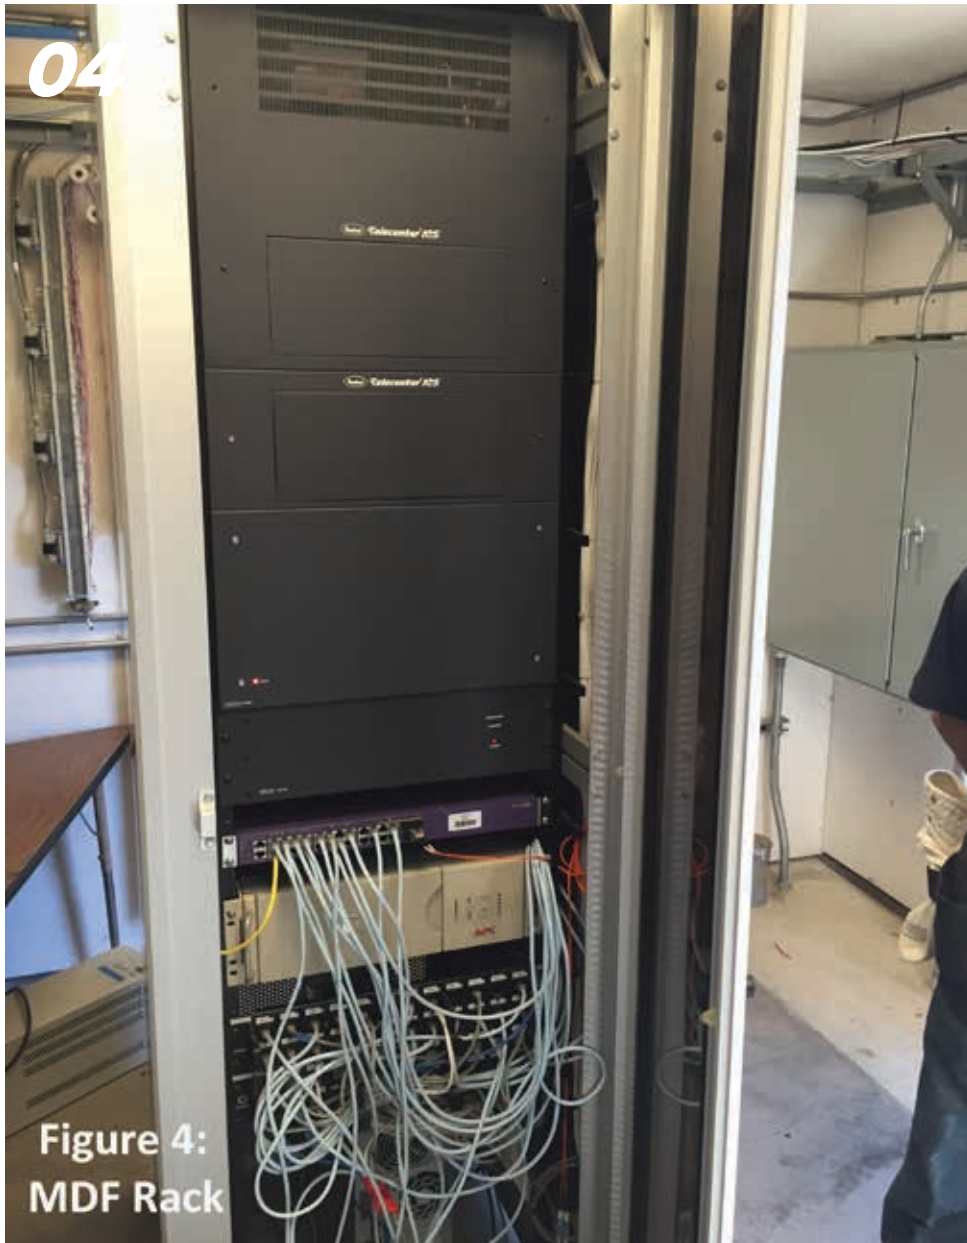
Figure 4:
MDF Rack
