ORCUTT UNION SCHOOL DISTRICT SITE ASSESSMENT & MASTER PLAN

SVA ARCHITECTS, INC.

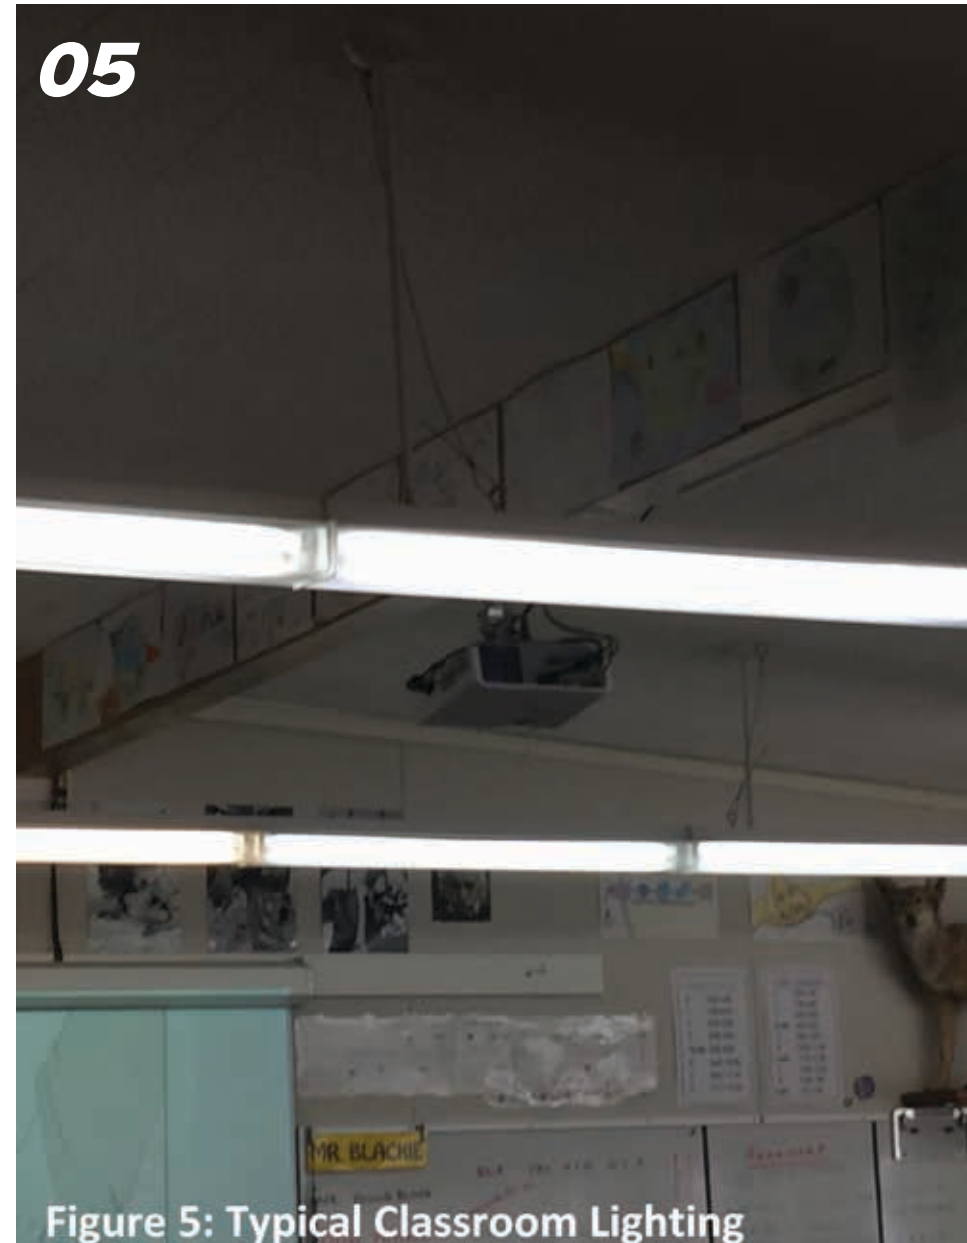
Figure 5: Typical Classroom Lighting

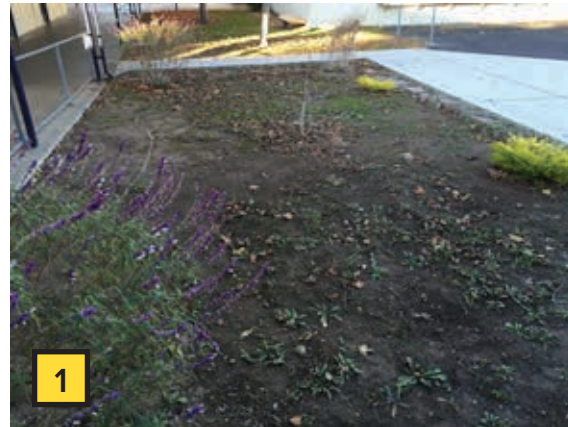
1. PLANTERS ADJACENT TO BASKETBALL COURTS

Existing Condition:
No planting and or irrigation installed in planters.

Recommendation:
Till and amend the soil, add native and or drought tolerant plant material with drip irrigation.

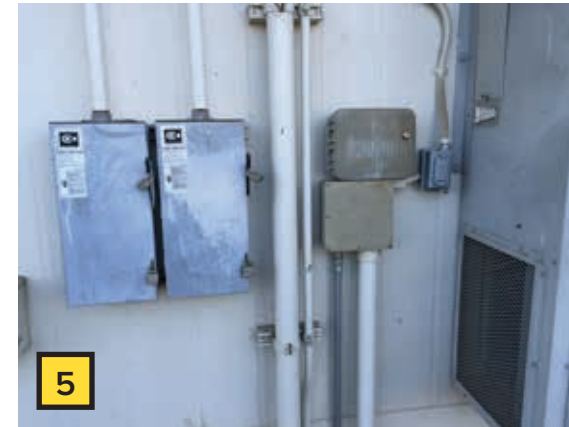
5. EXISTING IRRIGATION CONTROLLER

Existing Condition:
Outdated irrigation controller that's not weather or moisture sensor based.

Recommendation:
Replace with compliant stand-alone or central control system.

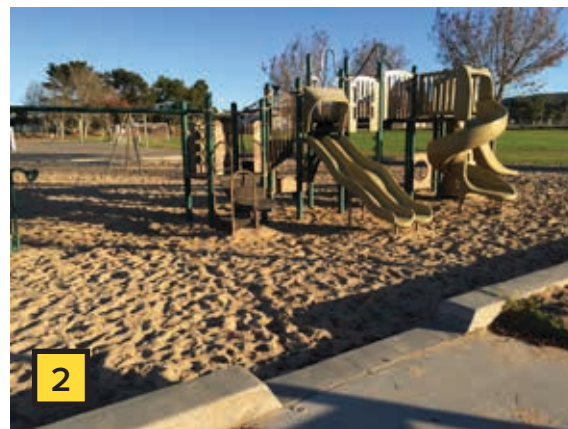
2. PRIMARY PLAY AREA

Existing Condition:
Area is not accessible with only sand for the fall protection. There is no access to the transfer station on the play equipment and from the slides or other equipment back to the transfer station. No accessible mats under the swings and no accessible access to them. The cut in the concrete curb goes from existing turf and goes into sand and is not accessible.

Recommendation:
Add rubberized fall zone material that is accessible from the entry ramp to the transfer station and to the slide areas and other equipment, or change all material to an accessible material like Fibar etc. Add an accessible sidewalk from the path of travel to the play box.

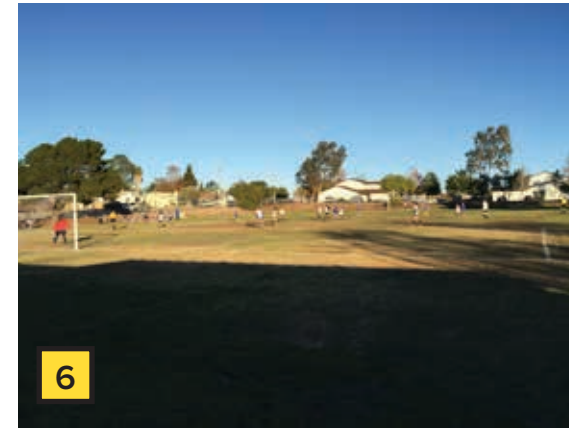
6. OPEN PLAY ATHLETIC FIELDS

Existing Condition:
Gopher and rodent problem, compacted soil, and irrigation coverage is lacking.

Recommendation:
Need rodent eradication set up on a monthly contract with exterminator company. Till and amend the soil, repair irrigation systems and re-sod and or re-seed entire area.

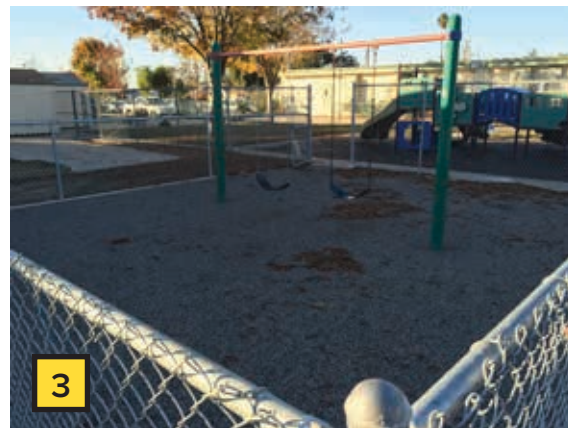
3. SWINGSET

Existing Condition:
Chain link fence appears to be within swingset fall zone.

Recommendation:
Verify all swingset fall zones are compliant.

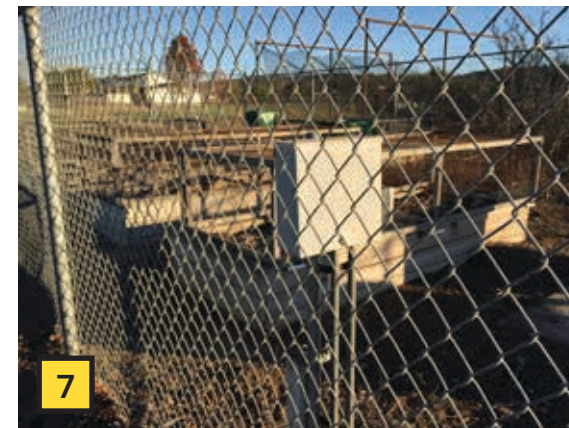
7. EXISTING IRRIGATION CONTROLLER

Existing Condition:
Outdated irrigation controller that's not weather or moisture sensor based.

Recommendation:
Replace with compliant stand-alone or central control system.

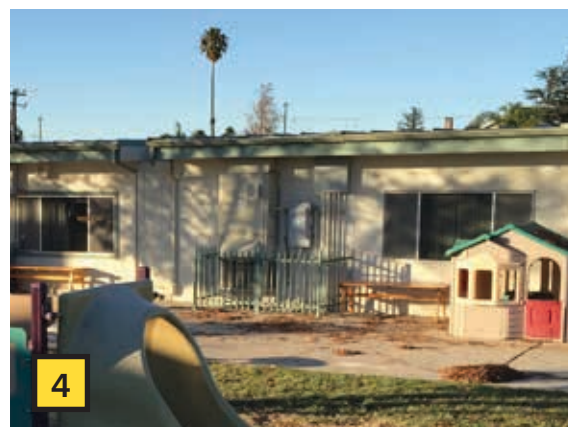
4. METAL FENCING ADJACENT TO PLAY AREA

Existing Condition:
Sharp metal fencing surrounding building equipment.

Recommendation:
Replace metal fencing with taller fencing.

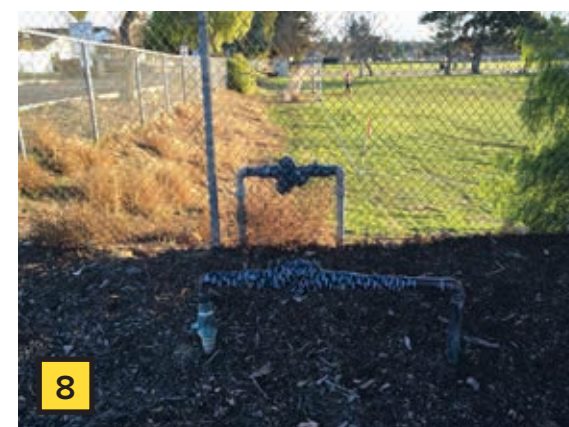
8. EXISTING BACKFLOW PREVENTER

Existing Condition:
Backflow appears corroded and unoperable.

Recommendation:
Verify operation or replace with new.

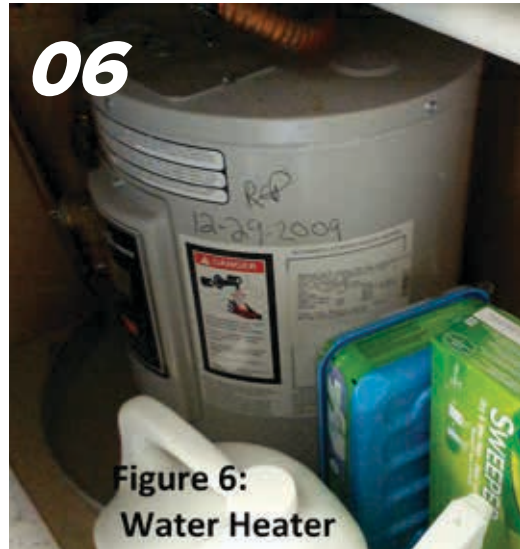
Figure 6: Water Heater

- Domestic hot water: There are three water heaters on the site. One serves the multi-use room, one serves the gym, and one serves the home economics room. The water heaters are all in good condition as they have been replaced within the last 5-years.
- Plumbing fixtures: contain standard flush valves
- Miscellaneous system: There is a well pump near the maintenance building. The pump has a variable speed drive and all components appear to be in fair condition.

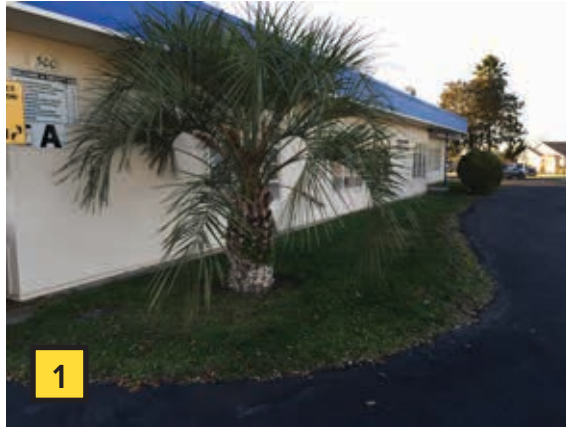
1. PLANTERS ADJACENT TO FRONT OFFICE BLDG.

Existing Condition:
Inappropriate landscape at front of building (turf area).

Recommendation:
Remove existing turf and replace with low-water use plant material. Install new drip irrigation system connected to new weather-based controller or new central control system.

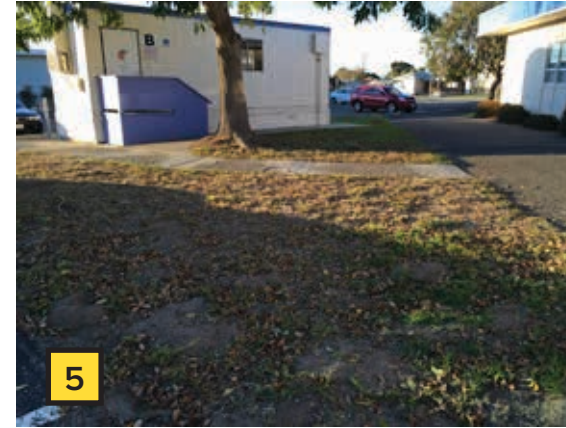
5. LANDSCAPE AREA BEHIND OFFICE BLDG.

Existing Condition:
Dilapidated turf area behind building. Apparent inoperable irrigation.

Recommendation:
Renovate turf area with new soil amendments and re-sod or re-seed. Verify irrigation system operation and connect to new weather-based controller or central control system.

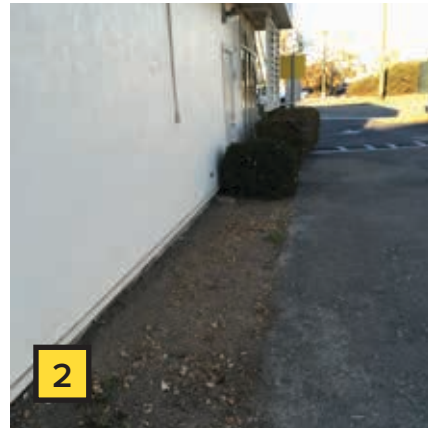
2. PLANTER AT EAST SIDE OF OFFICE BLDG.

Existing Condition:
Dilapidated landscape at side of building (bare dirt and minimal plants). Apparent inoperable irrigation.

Recommendation:
Renovate planter with new soil amendments and low-water use material. Install new drip irrigation system connected to new weather-based controller or new central control system.

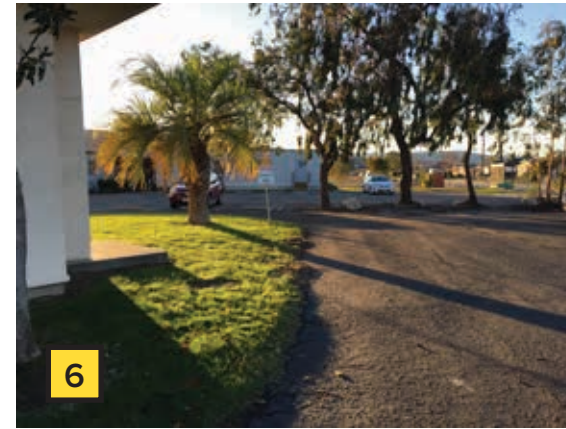
6. PLANTERS ADJACENT TO FRONT OFFICE BLDG.

Existing Condition:
Inappropriate landscape at west side of building (turf area).

Recommendation:
Remove existing turf and replace with low-water use plant material. Install new drip irrigation system connected to new weather-based controller or new central control system.

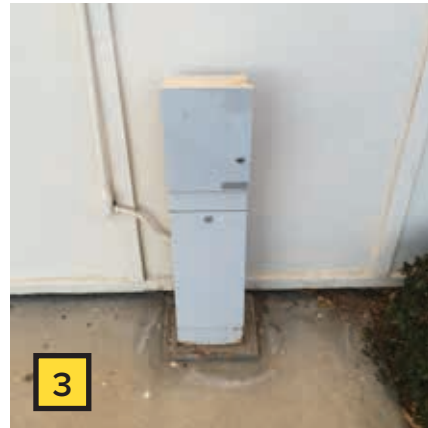
3. EXISTING IRRIGATION CONTROLLER

Existing Condition:
Outdated irrigation controller that's not weather or moisture sensor based.

Recommendation:
Replace with new compliant stand-alone or central control system.

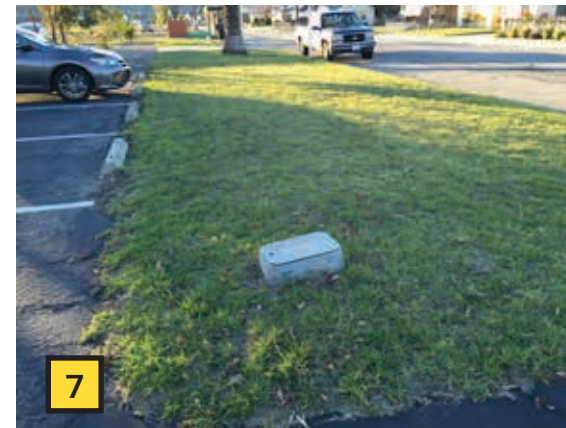
7. LANDSCAPE AREA ALONG SOARES AVENUE -WEST

Existing Condition:
Existing turf area with no shrub planting. Turf appears in relatively good condition. Existing irrigation valve box set above finish grade.

Recommendation:
Add low-water use plant material as a compliment to the existing turf. Add new drip irrigation system for shrub planting and reconfigure spray system for the turf. Lower the existing valve box flush with finish grade to prevent damage.

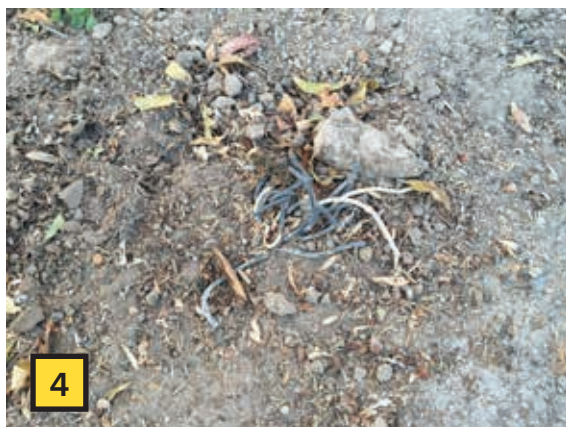
4. EXISTING IRRIGATION CONTROLLER

Existing Condition:
Irrigation control wires are cut and exposed to finish grade. Apparent inoperable irrigation.

Recommendation:
Repair control wires (splice with waterproof caps) in below grade valve box.

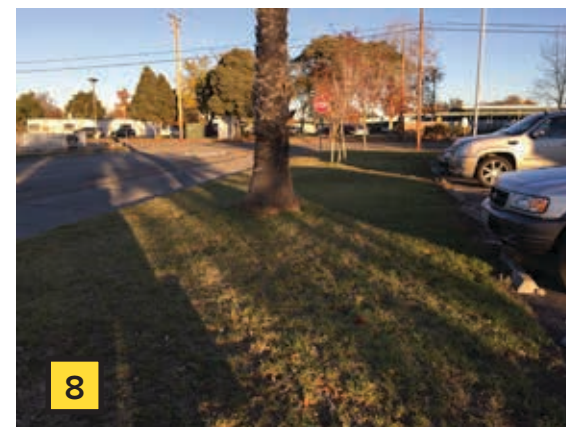
8. LANDSCAPE AREA ALONG SOARES AVENUE -EAST

Existing Condition:
Existing turf area with no shrub planting. Turf appears in fair condition.

Recommendation:
Add low-water use plant material as a compliment to the existing turf. Add new drip irrigation system for shrub planting and reconfigure spray system for the turf.
